# Preliminary Existing Condition Stability, Seepage and Settlement Evaluation

## Sacramento River and Georgiana Slough East Levees

Community of East Walnut Grove, California

Blackburn File No. 3139.x  
August 3, 2020

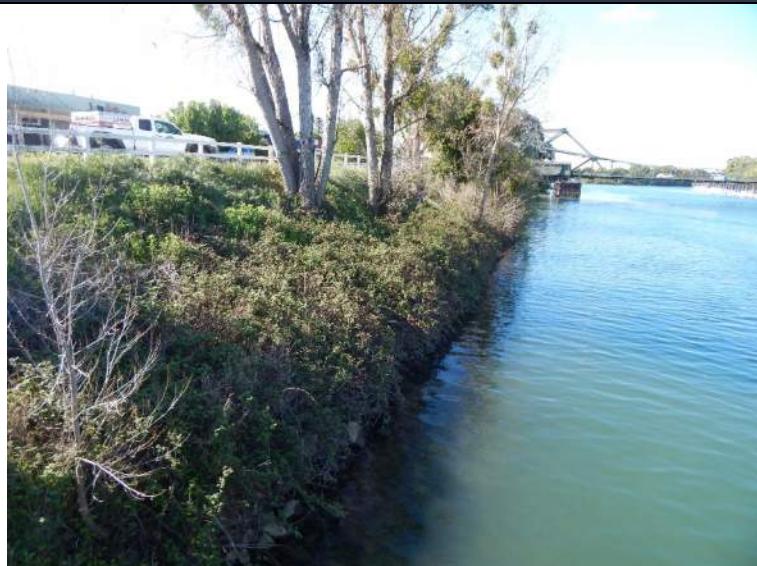
**Photo 1b: Waterside Slope**

Looking south along the waterside slope of Segment 128. The bridge over the Sacramento River can be seen in the background.

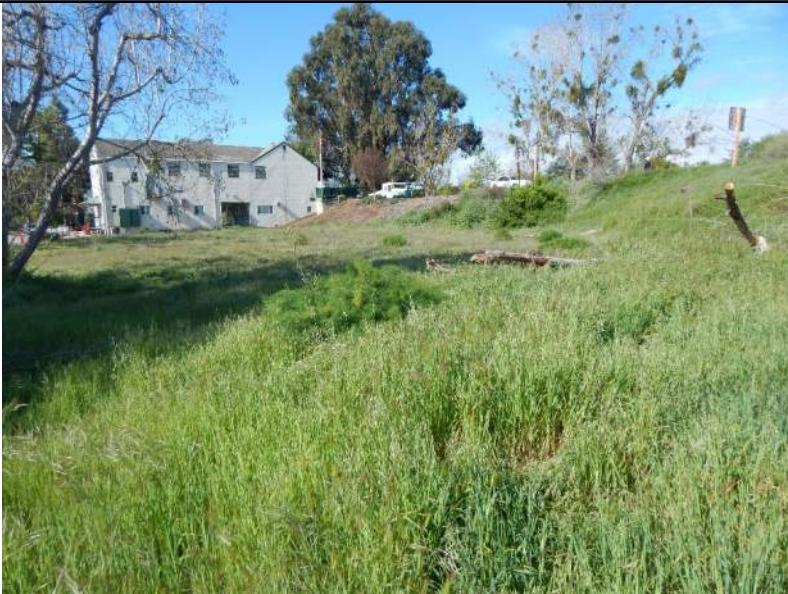
**Photo 2b: Landside Slope**

Looking south along the landside slope of Segment 128. The building in the background is typical of buildings encroaching upon the levee prism.
