**Geotechnical Assessment
Report**

**Delta Small Communities Flood Risk
Reduction Program – Community of
Hood**

Sacramento County, California

November 2020
Project 1800776

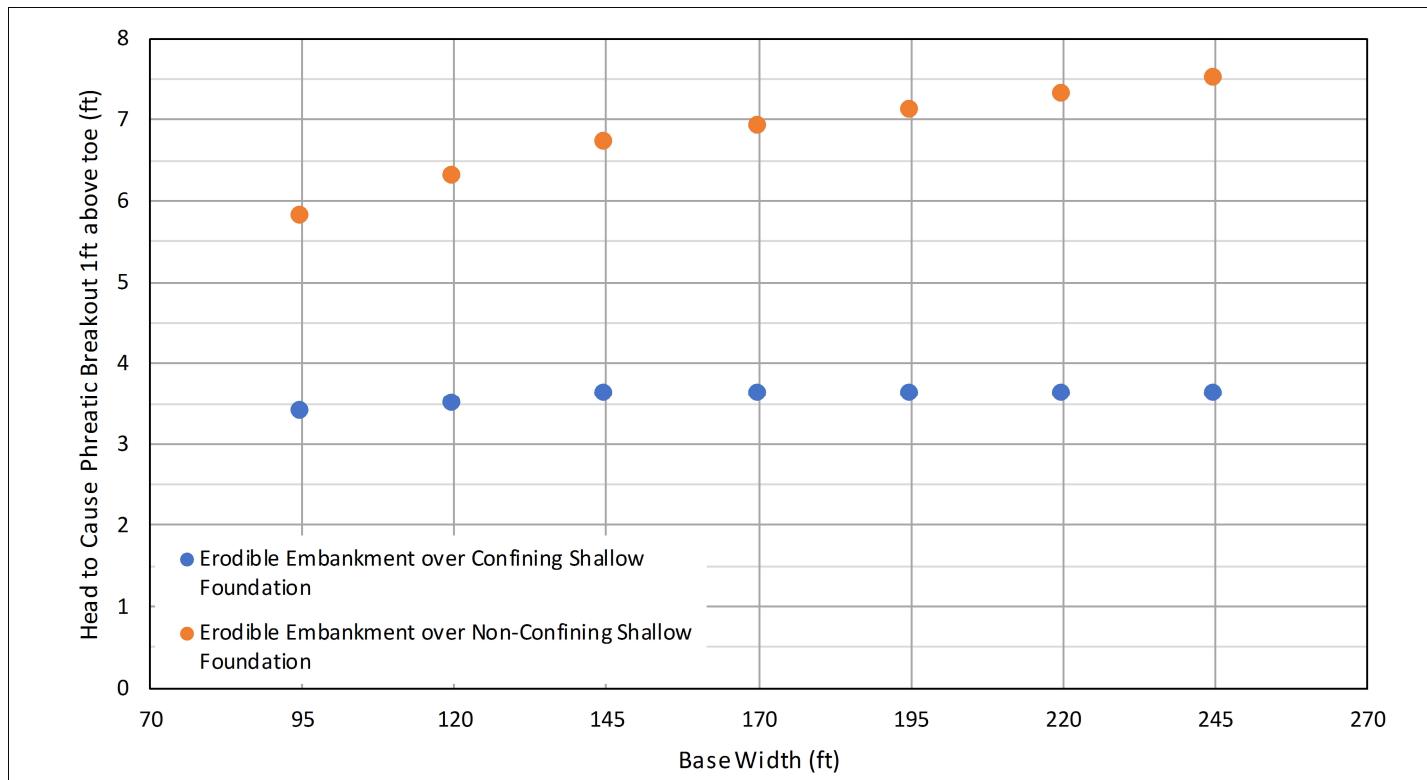
Figure 4

CRITERIA SUMMARY		Levee Base Width (feet)						
Analysis Case	Emb./Found.	95	120	145	170	195	220	245
		Head to Cause Through Seepage						
1	Erodible Embankment over Confining Shallow Foundation	3.4	3.5	3.6	3.6	3.6	3.6	3.6
2	Erodible Embankment over Non-Confining Shallow Foundation	5.8	6.3	6.7	6.9	7.1	7.3	7.5
