# UPDATED EXISTING GEOTECHNICAL DATA

## TECHNICAL MEMORANDUM Community of East Walnut Grove, California

California Department of Water Resources  
Small Community Flood Risk Reduction  
Program

March 2020

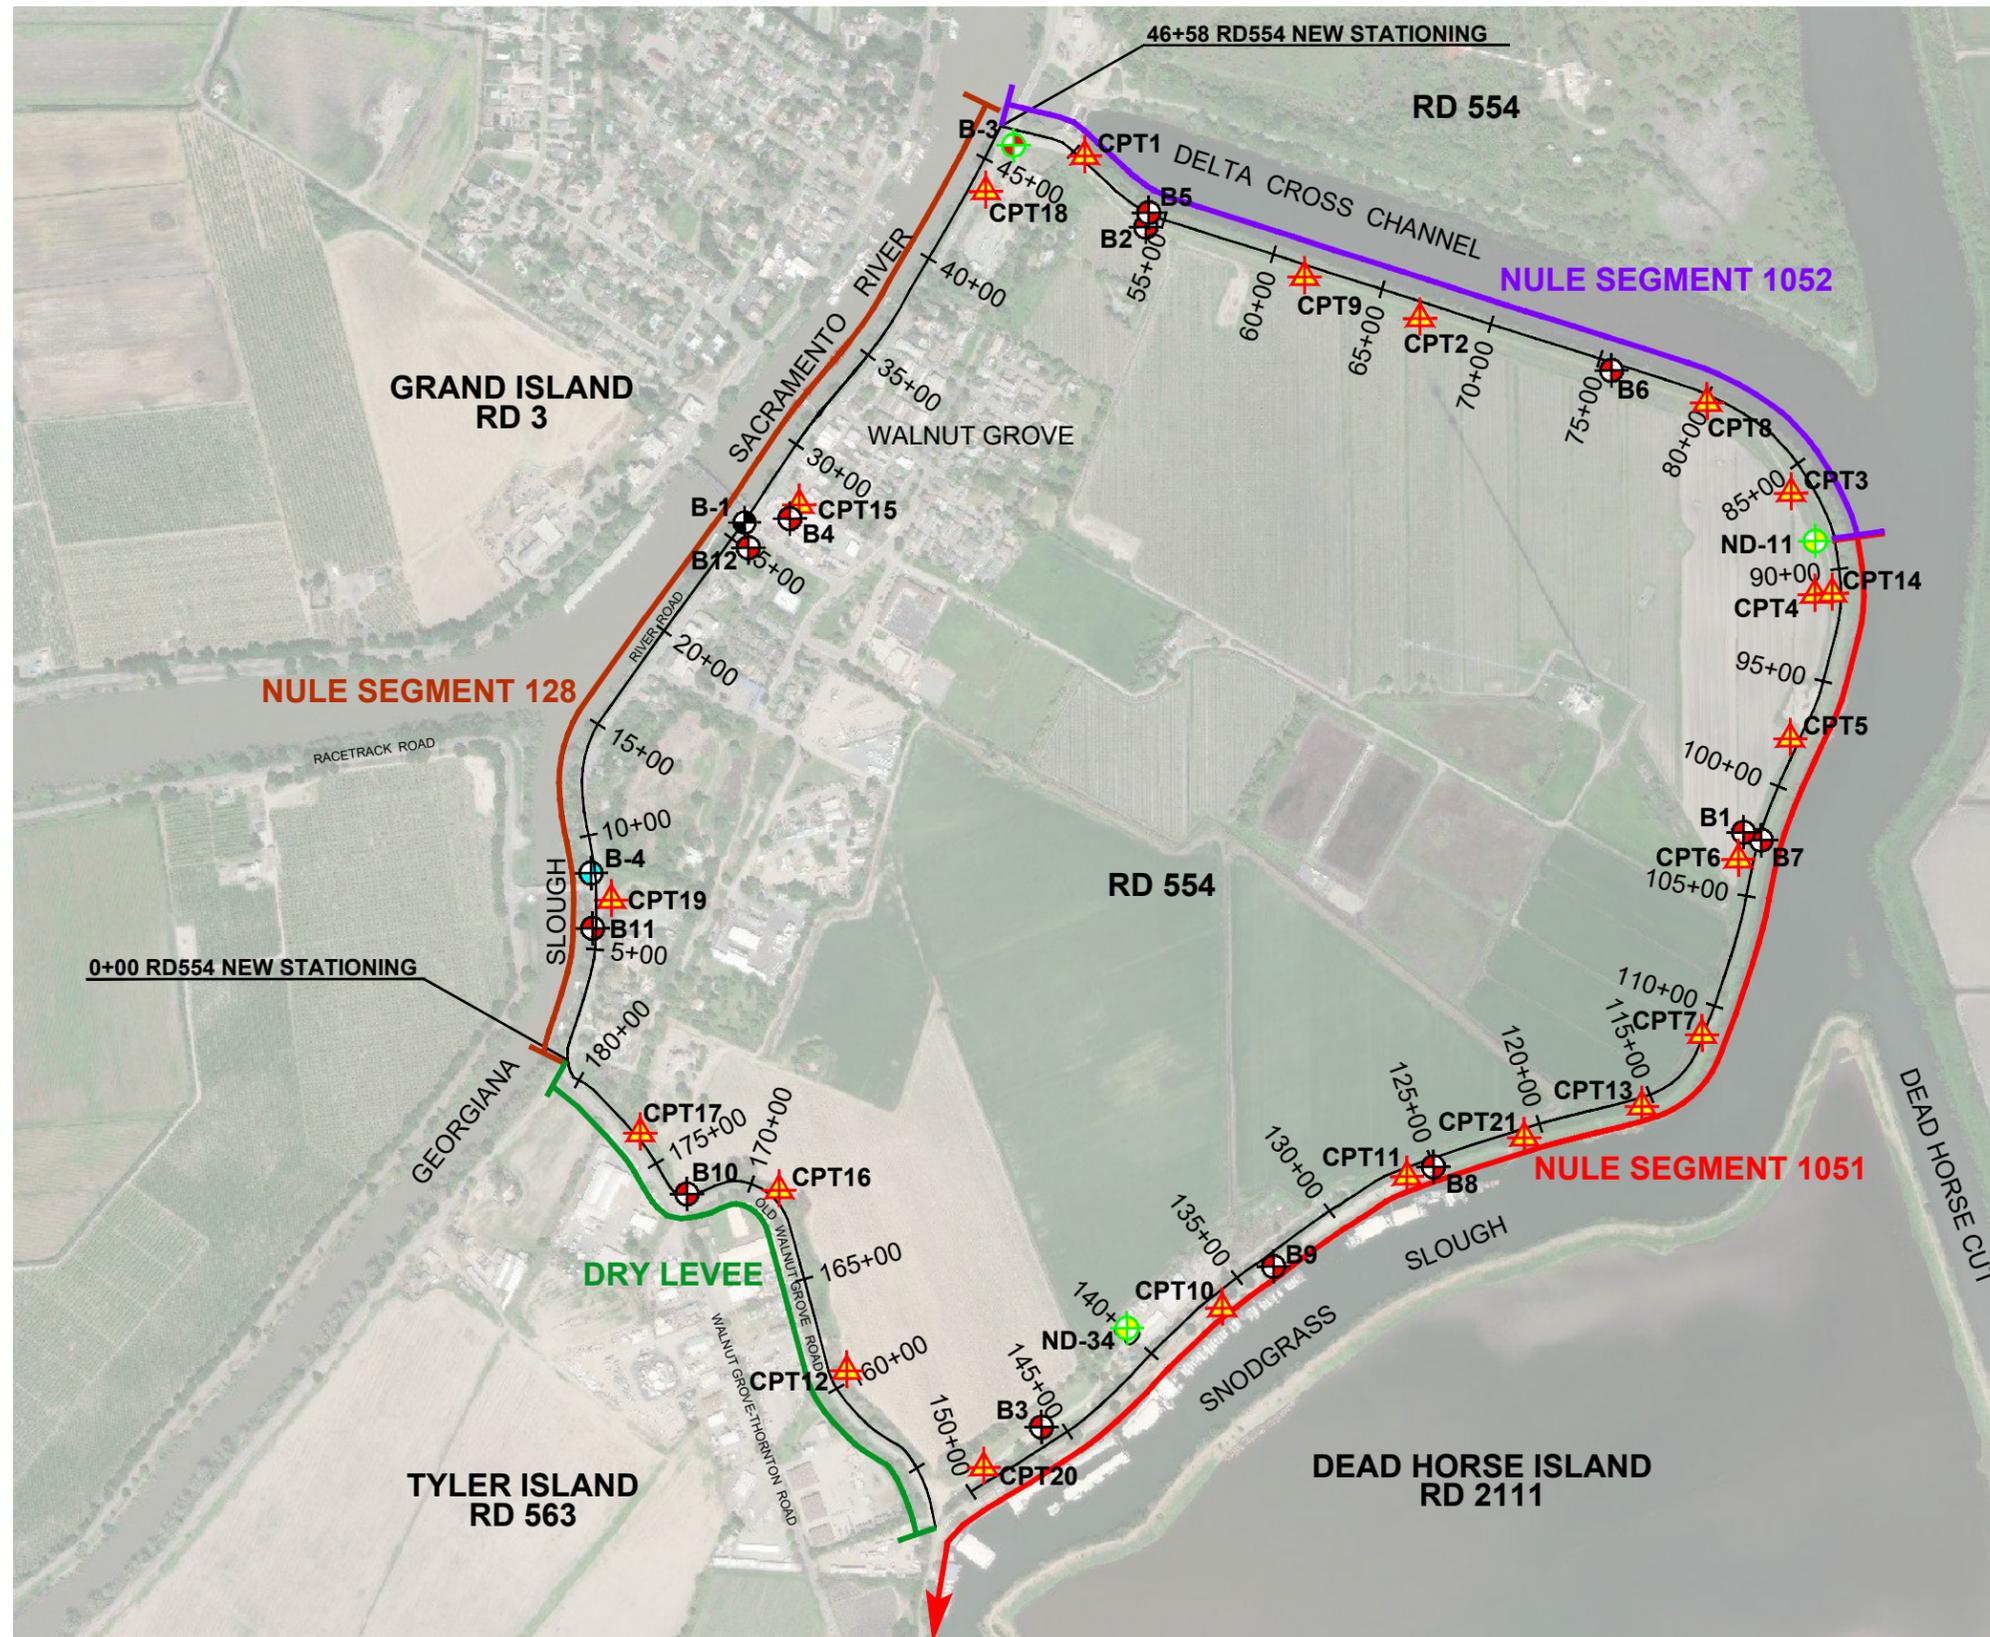
Figure 1

- B1 Approximate Boring Location (Raney)
- CPT2 Approximate CPT Location (Raney)
- B-4 Approximate Georgiana Slough Bridge Boring Location
- B-1 Approximate Sacramento River Bridge Boring Location
- B-3 Approximate Delta Cross Channel Bridge Boring Location
- ND-11 North Delta Seepage Monitoring Study
- RD 554 Stationing (Typical)

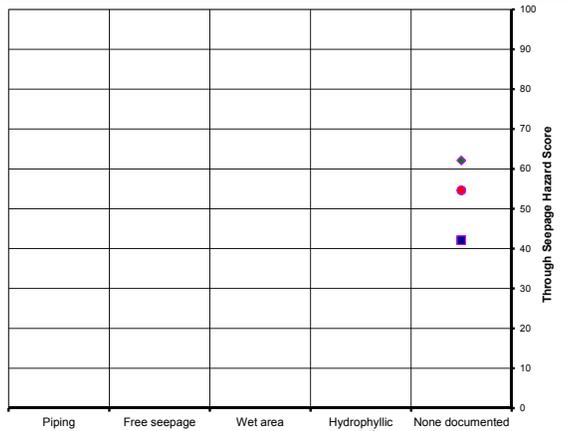
Underseepage Hazard Matrix, NULE Phase 1 Geotechnical Assessment

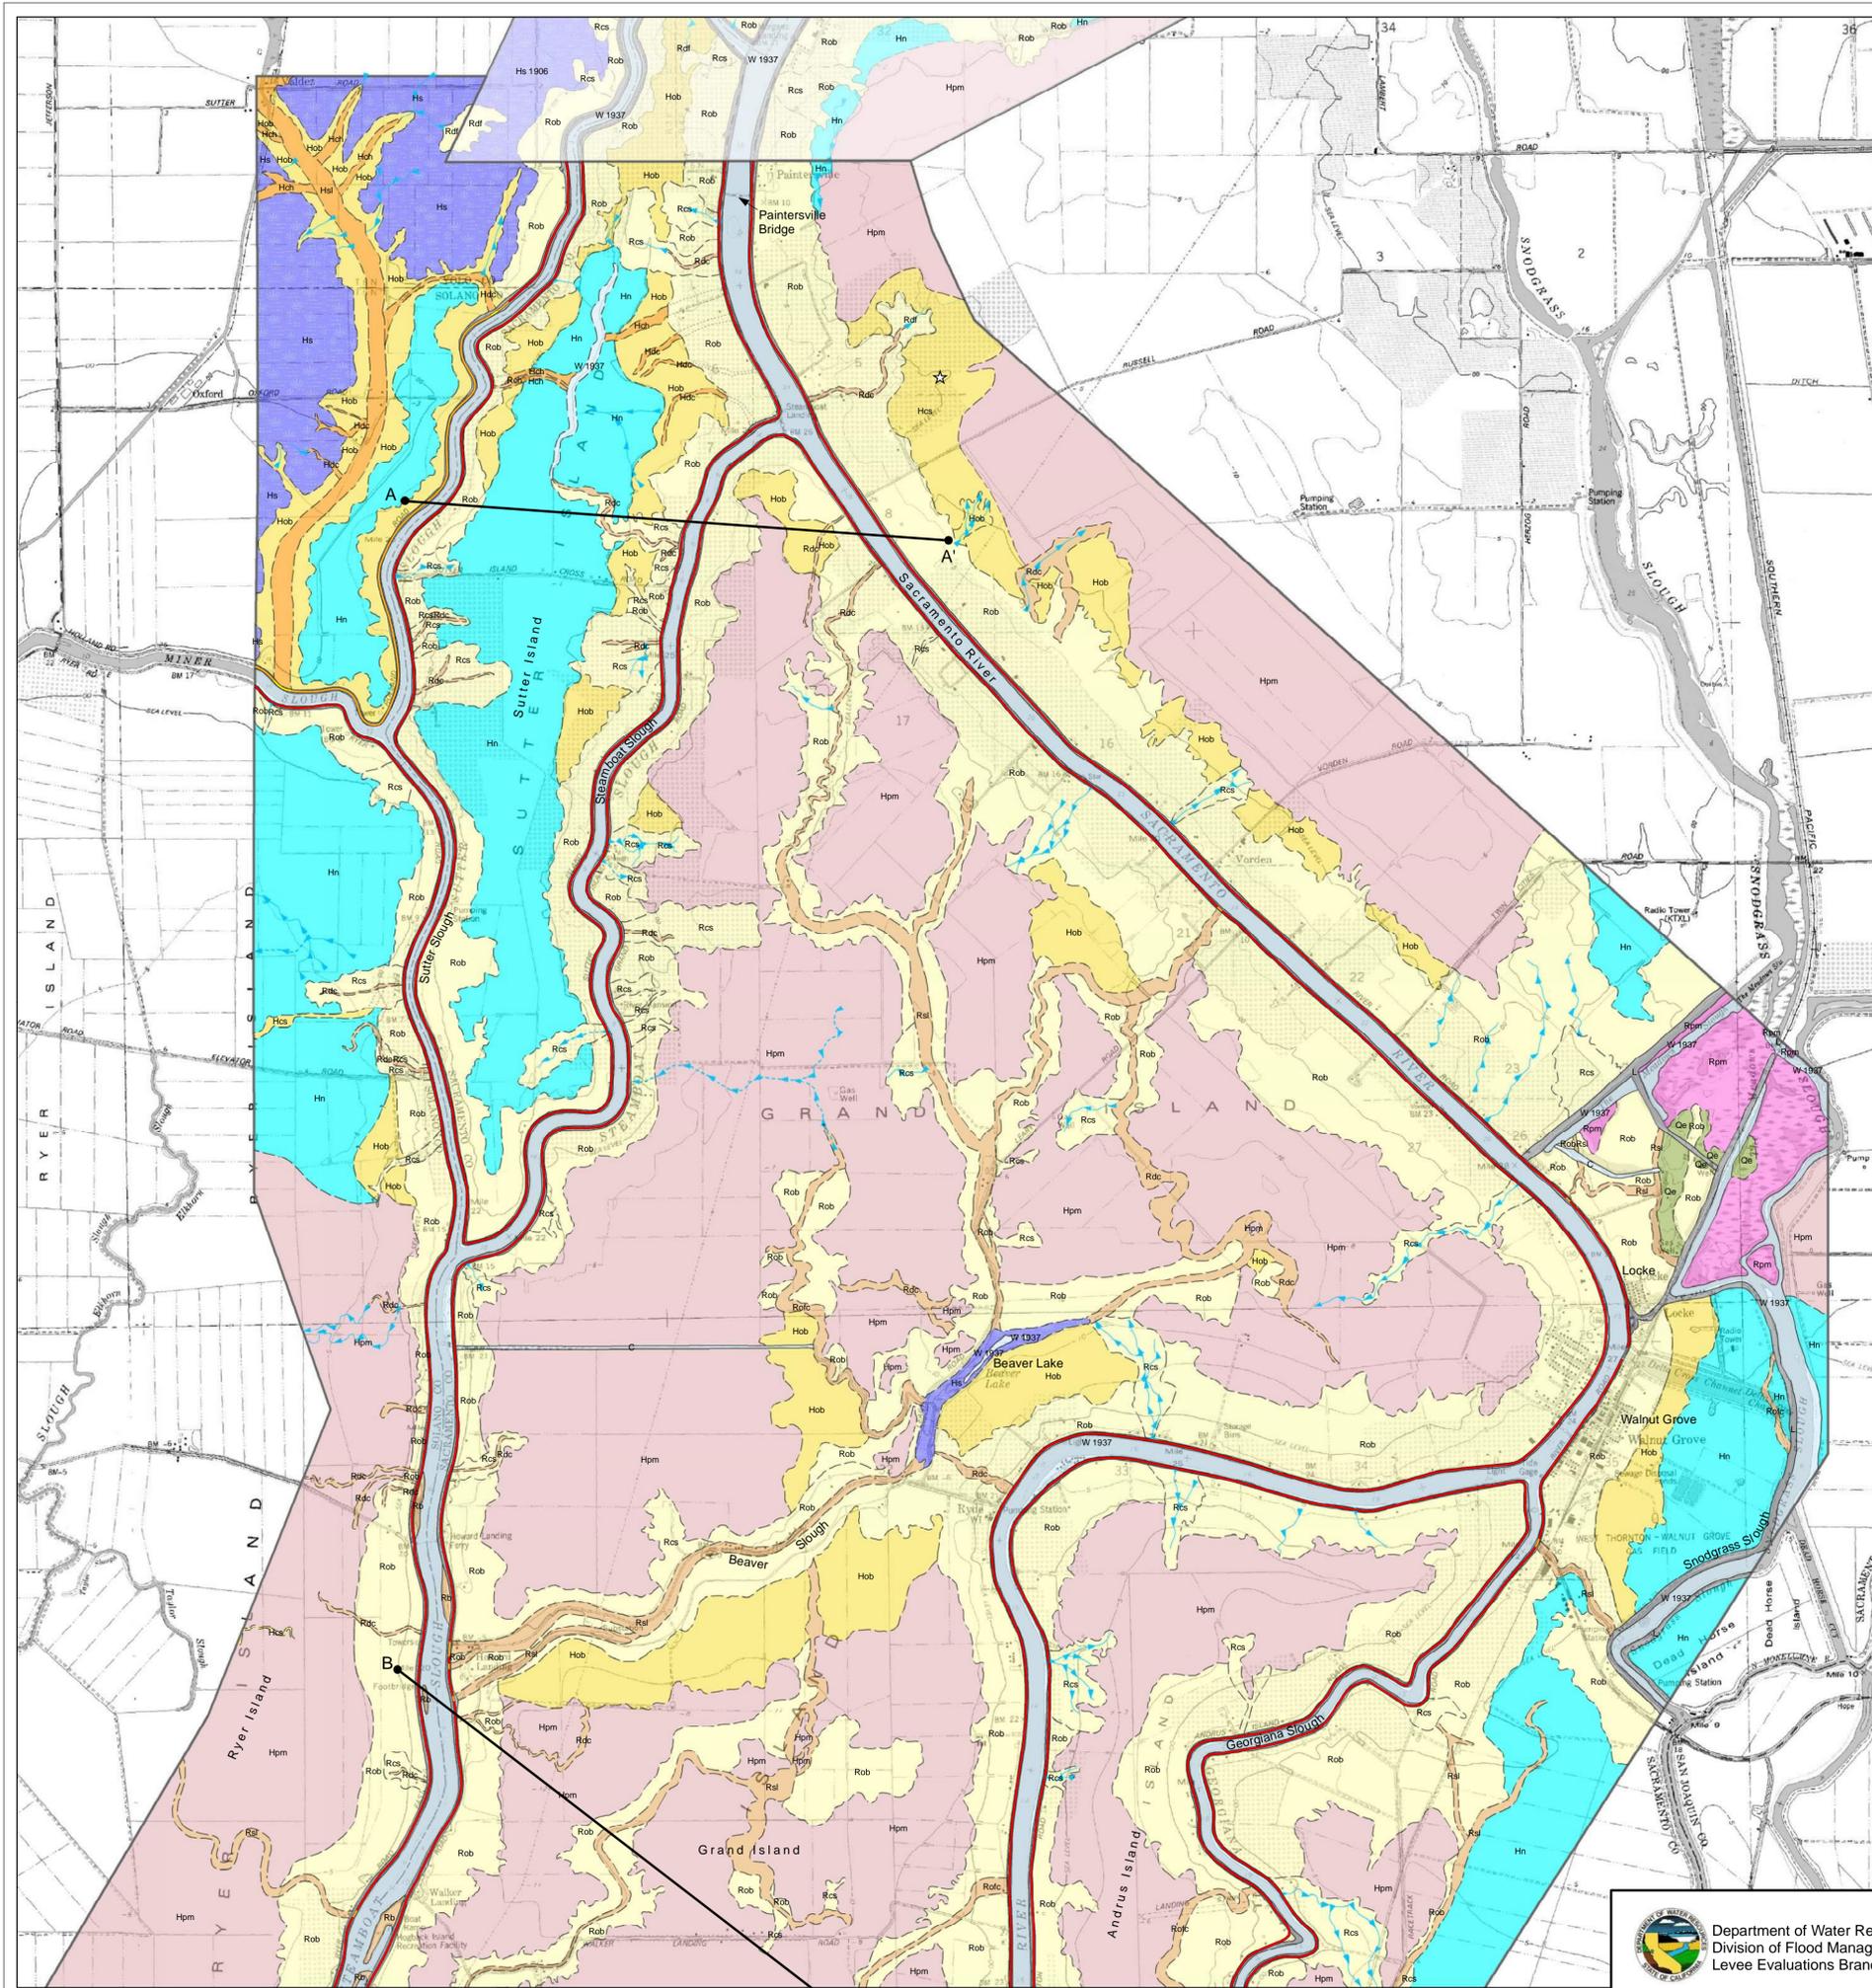
**Figure 6**

This map shows surficial geologic deposits and levees as they existed in 1937. Map units and boundaries are drawn by interpretation of historical aerial photography supplemented by data from historical maps and surveys. For reference, the mapping is superimposed on modern U.S. Geological Survey 7.5 topographic base maps (individual maps referenced below). See accompanying technical memorandum for complete descriptions of map units, process descriptions and methodology. Adjacent polygons that have identical map unit symbols are employed to delineate sequences of sedimentation and landscape evolution.

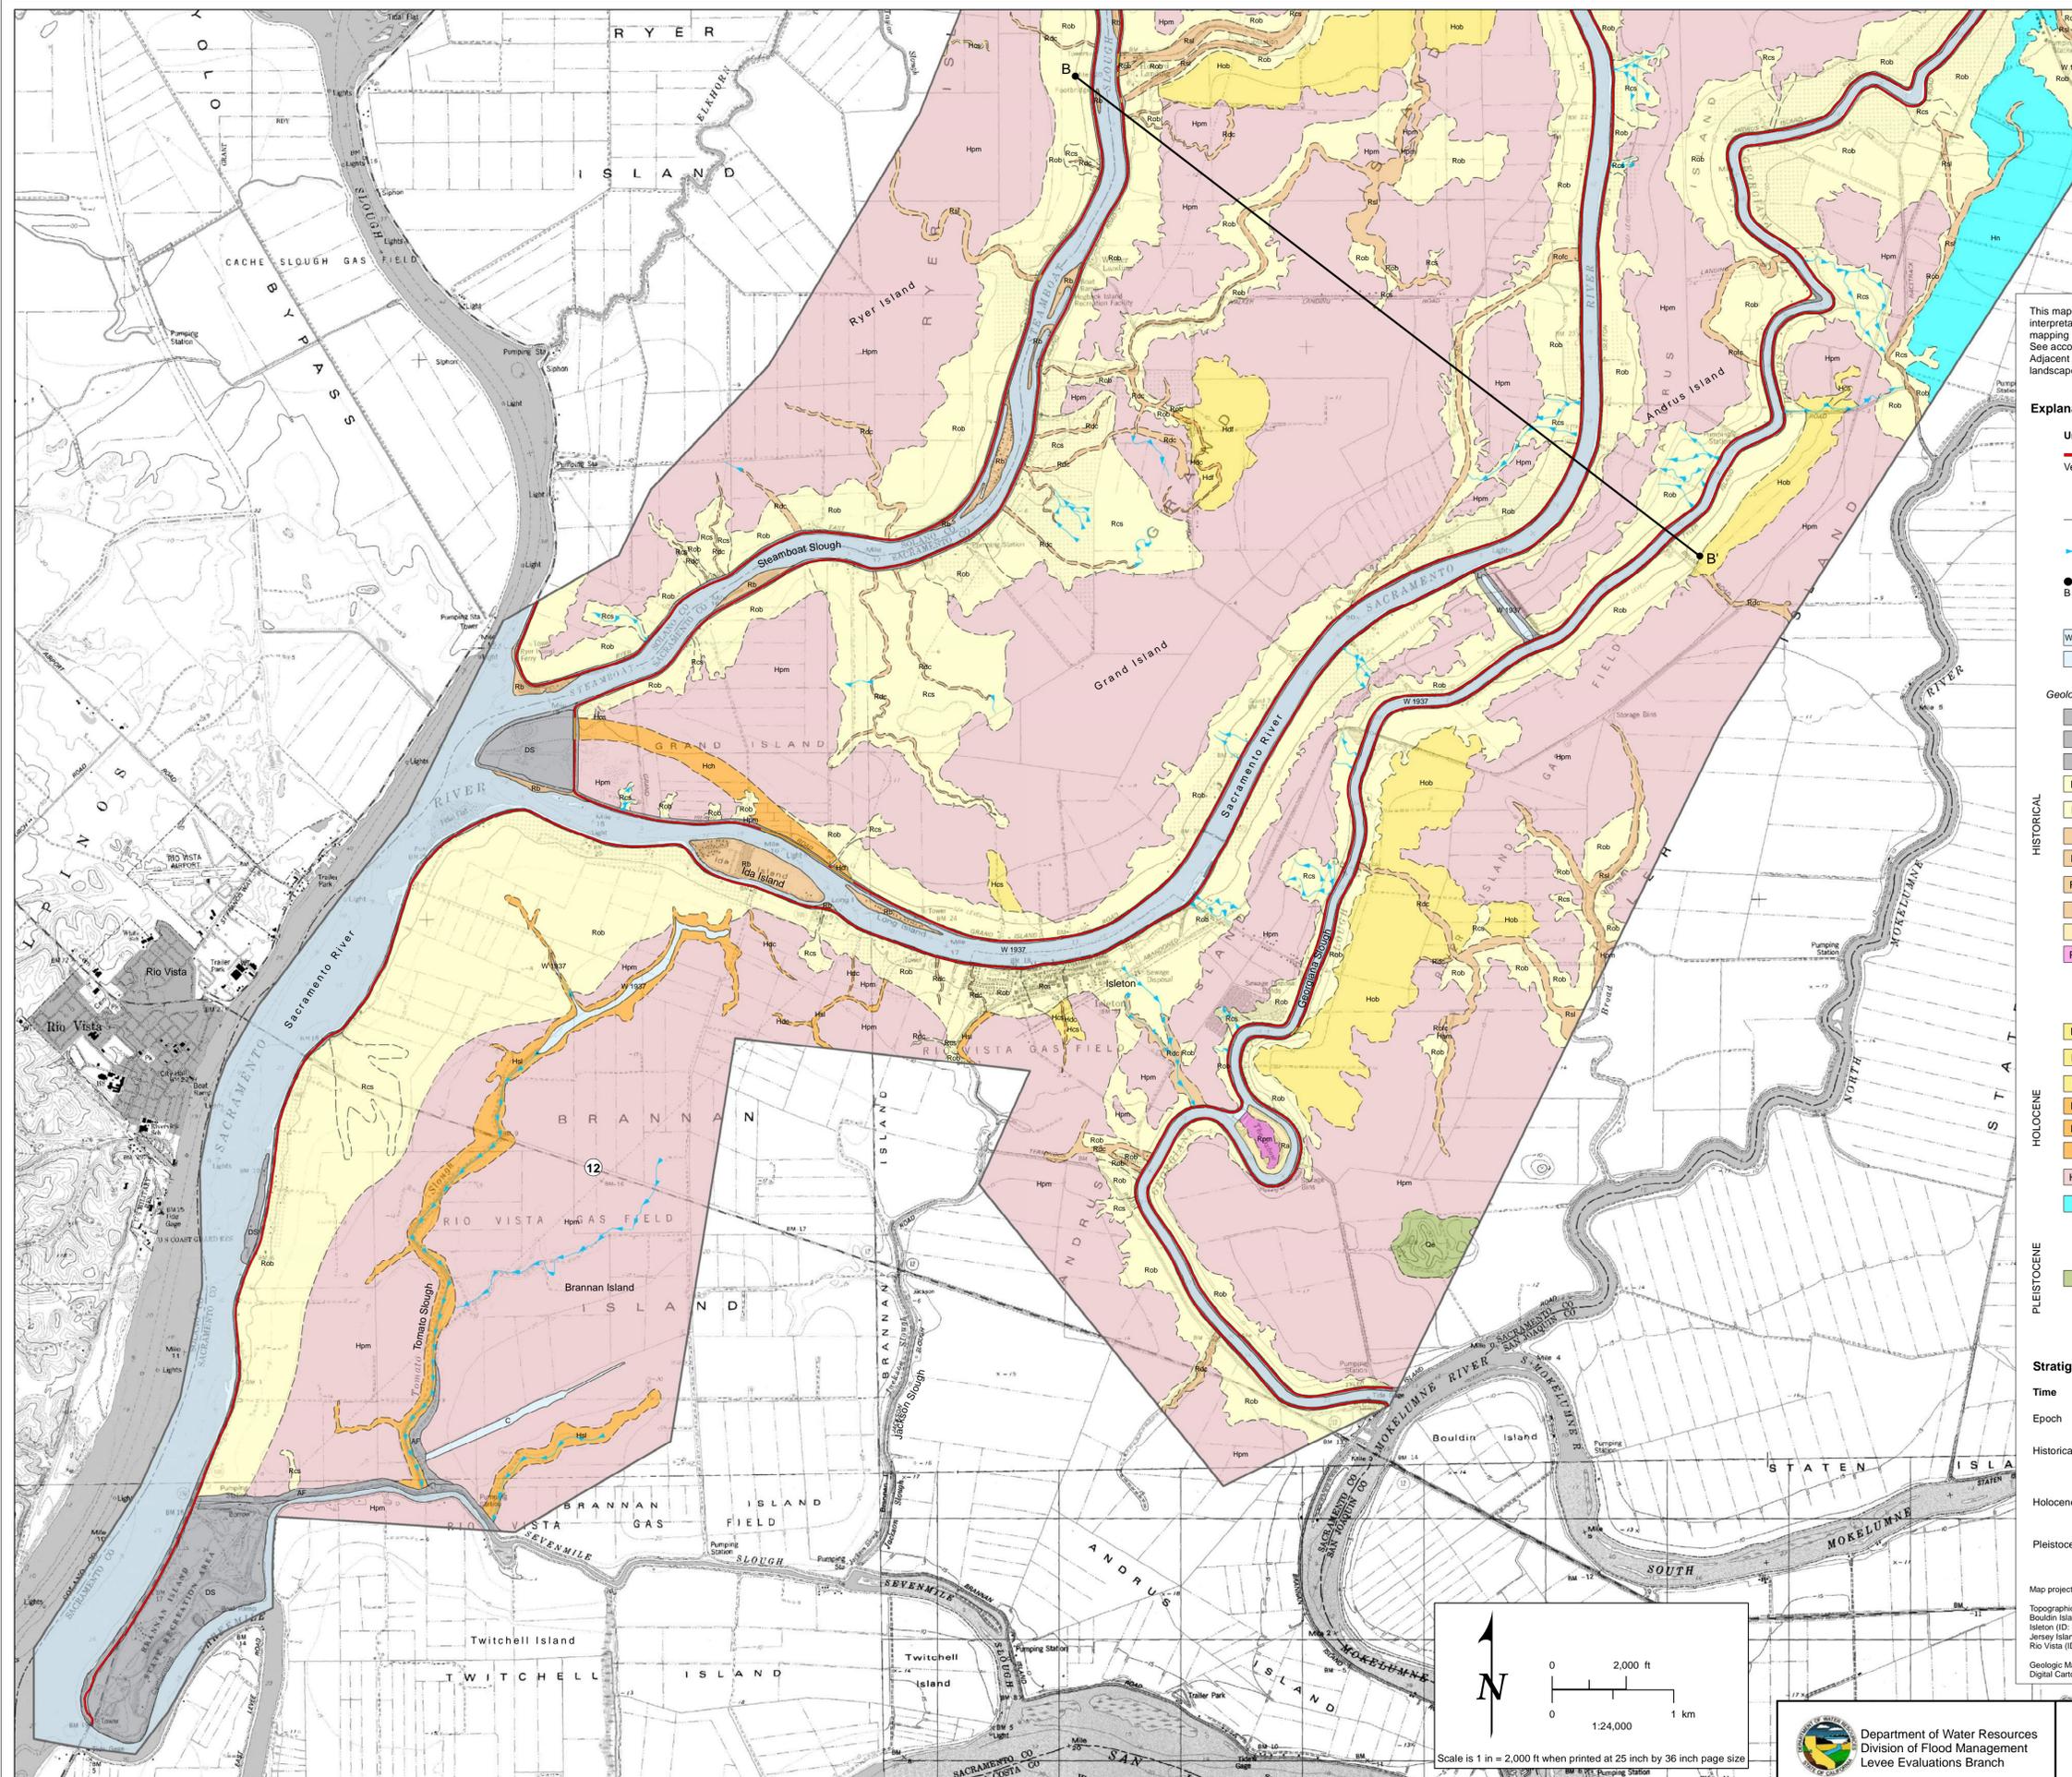
This map shows surficial geologic deposits and levees as they existed in 1937. Map units and boundaries are drawn by interpretation of historical aerial photography supplemented by data from historical maps and surveys. For reference, the mapping is superimposed on modern U.S. Geological Survey 7.5' topographic base maps (individual maps referenced below). See accompanying technical memorandum for complete descriptions of map units, process descriptions and methodology. Adjacent polygons that have identical map unit symbols are employed to delineate sequences of sedimentation and landscape evolution.

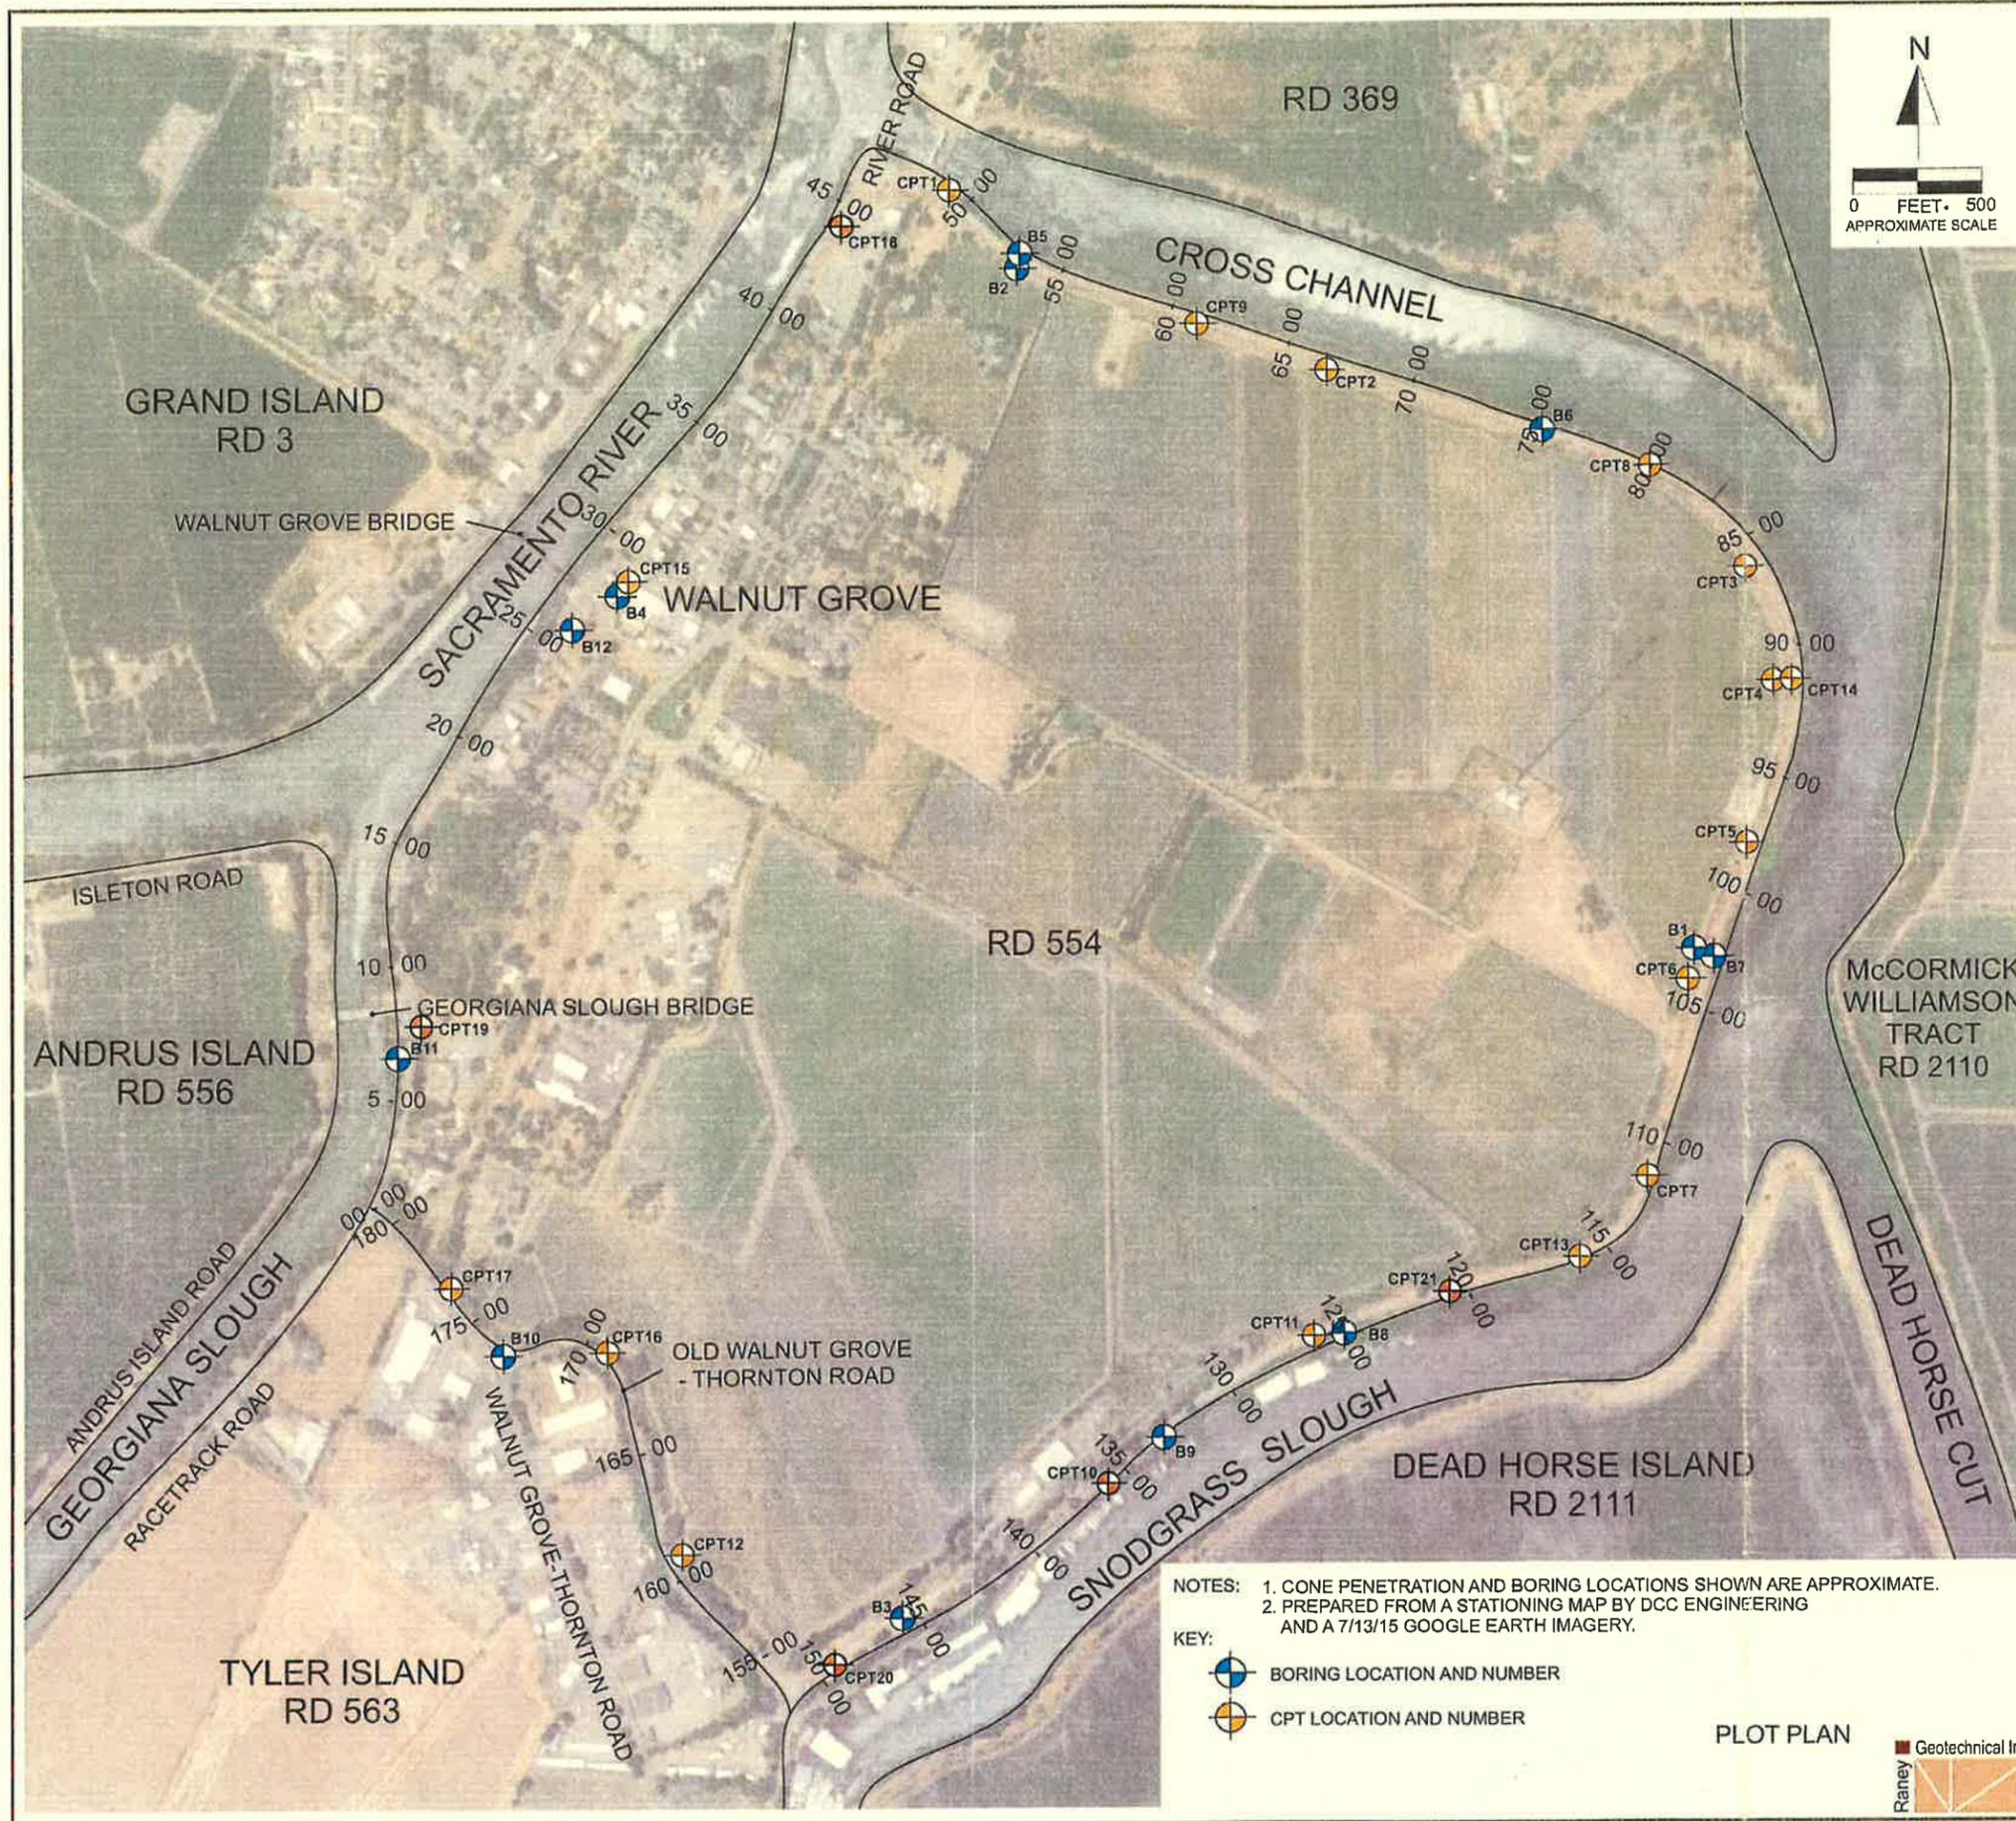
PROJECT NUMBER: 1135-021

NOTES: 1. CONE PENETRATION AND BORING LOCATIONS SHOWN ARE APPROXIMATE.  
 2. PREPARED FROM A STATIONING MAP BY DCC ENGINEERING AND A 7/13/15 GOOGLE EARTH IMAGERY.

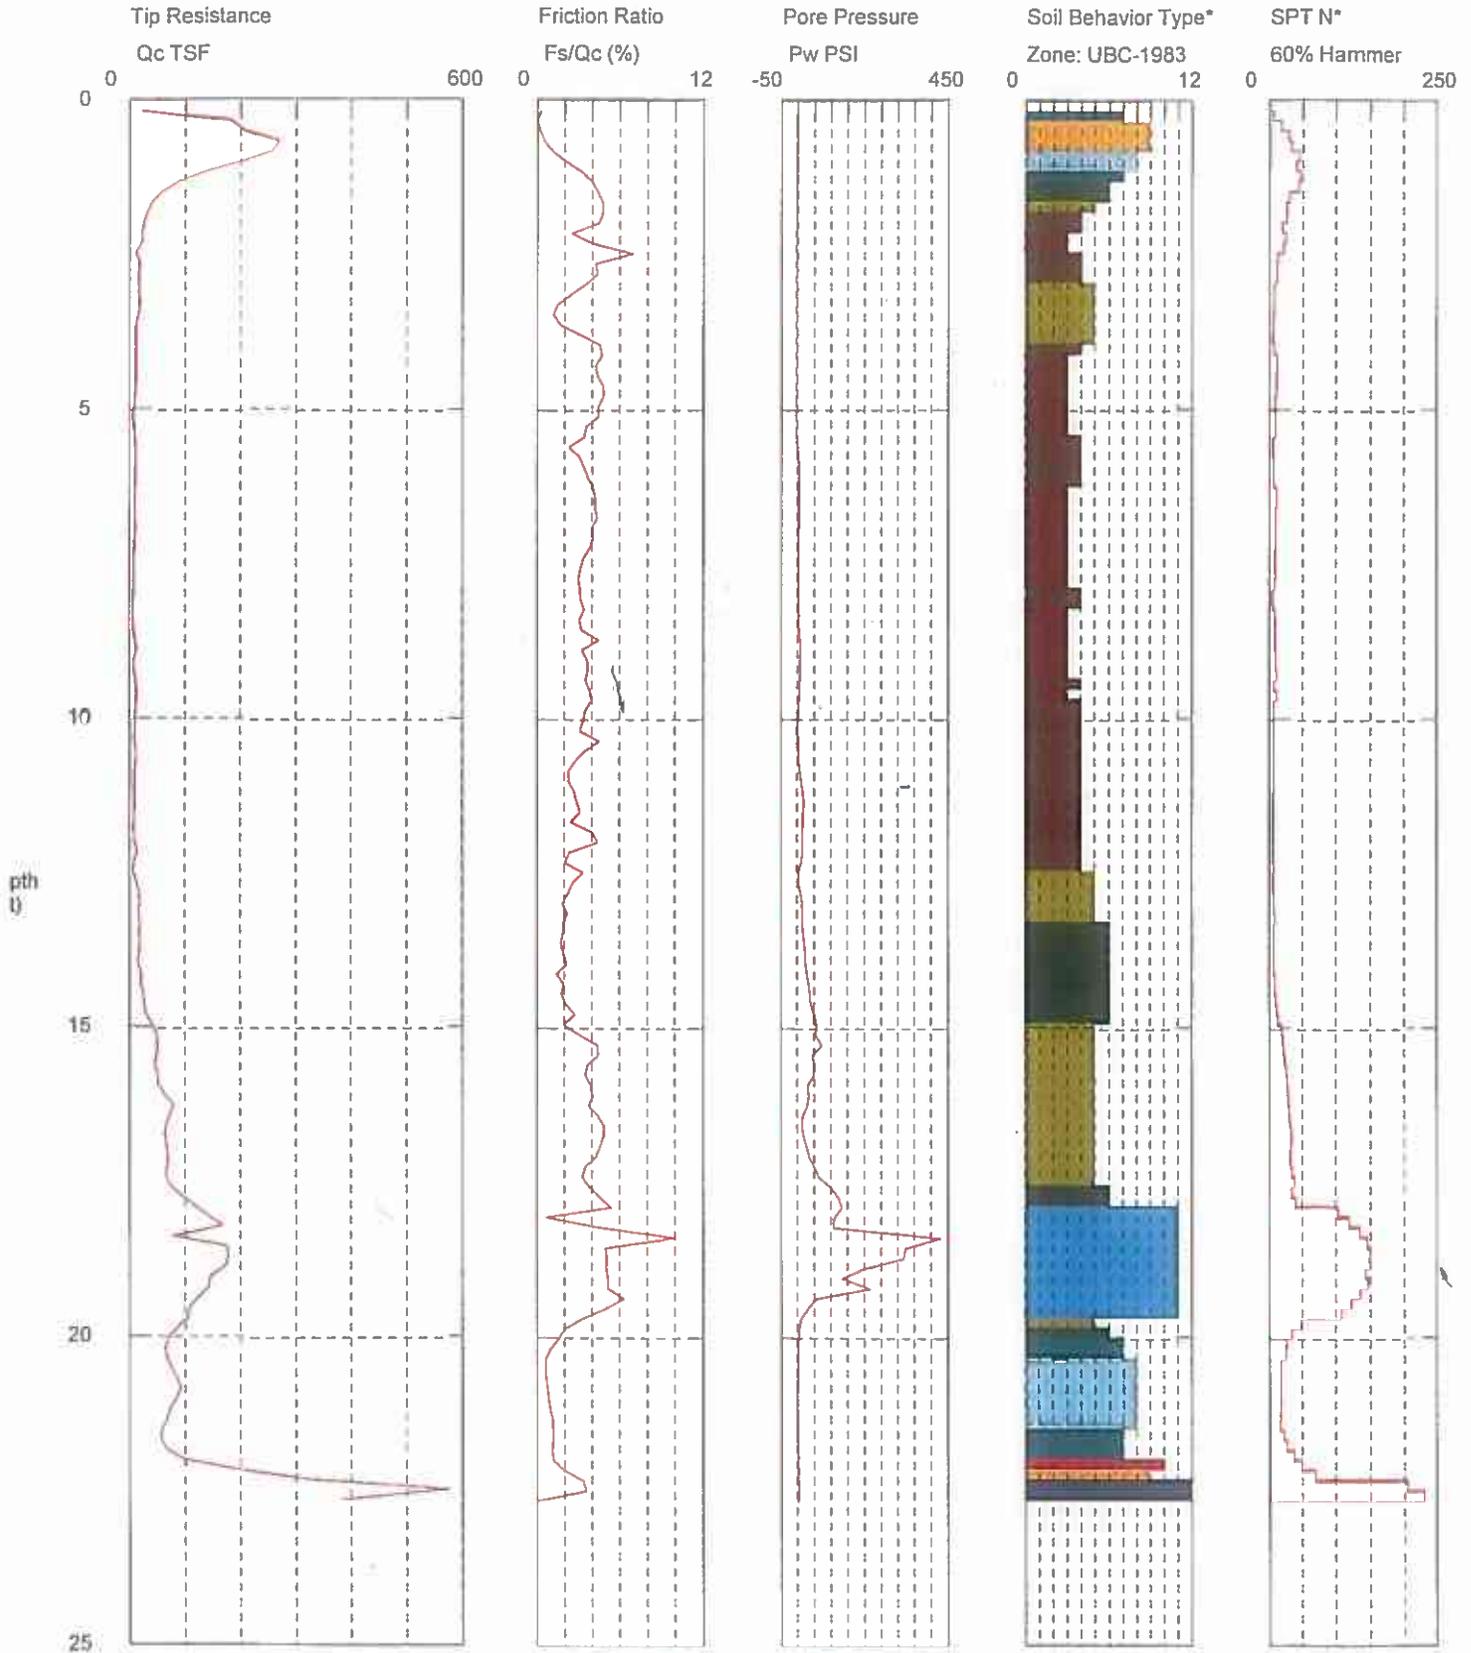
CPT Date/Time: 1/31/2014 12:29:29 PM  
 Location: Walnut Grove  
 Job Number: RNY-464-1135-021

Maximum Depth = 22.64 feet

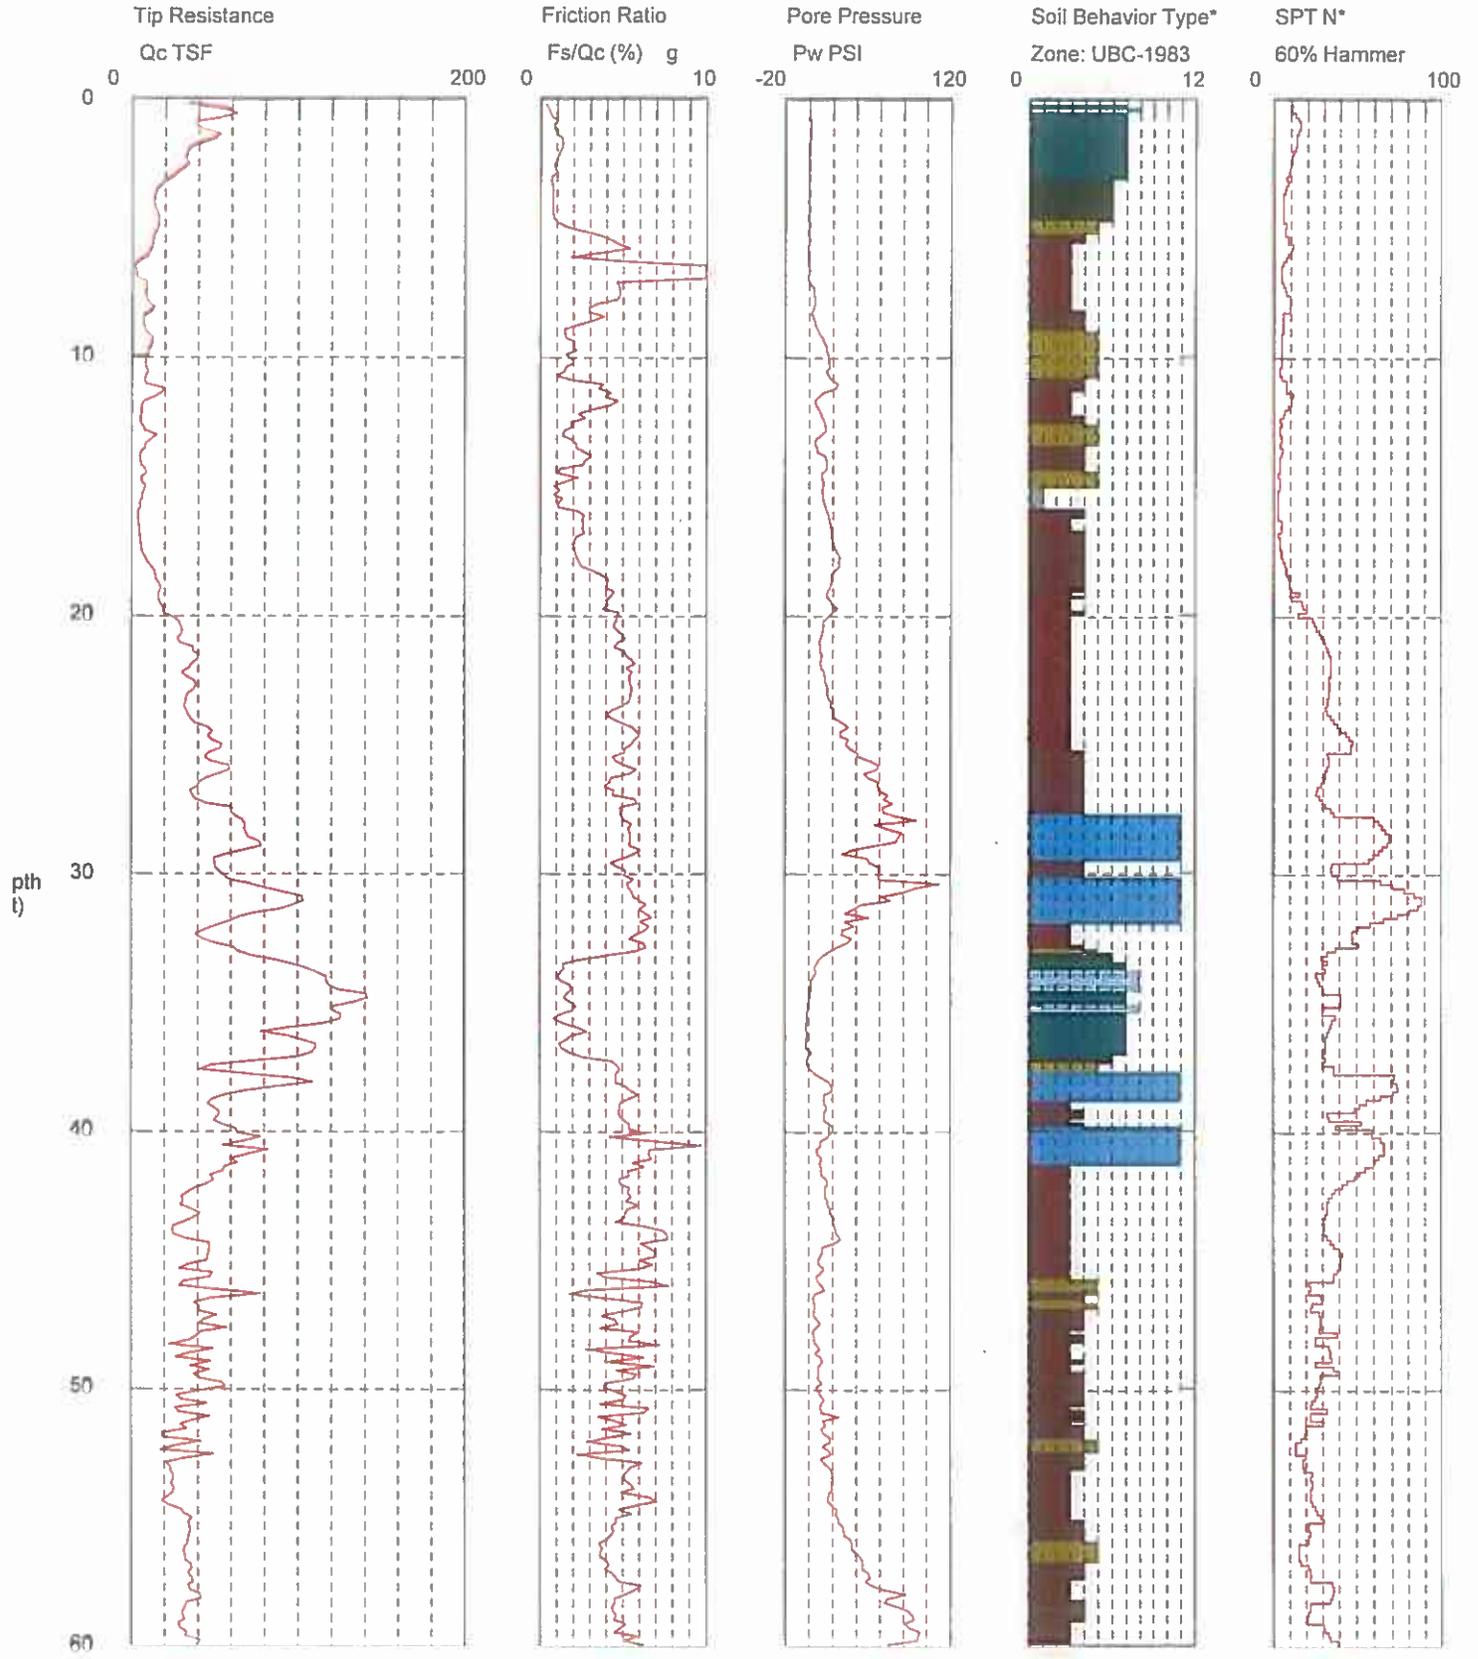
CPT Date/Time: 8/2/2016 3:21:12 PM  
 Location: Walnut Grove  
 Job Number: RNY-569

Maximum Depth = 60.37 feet

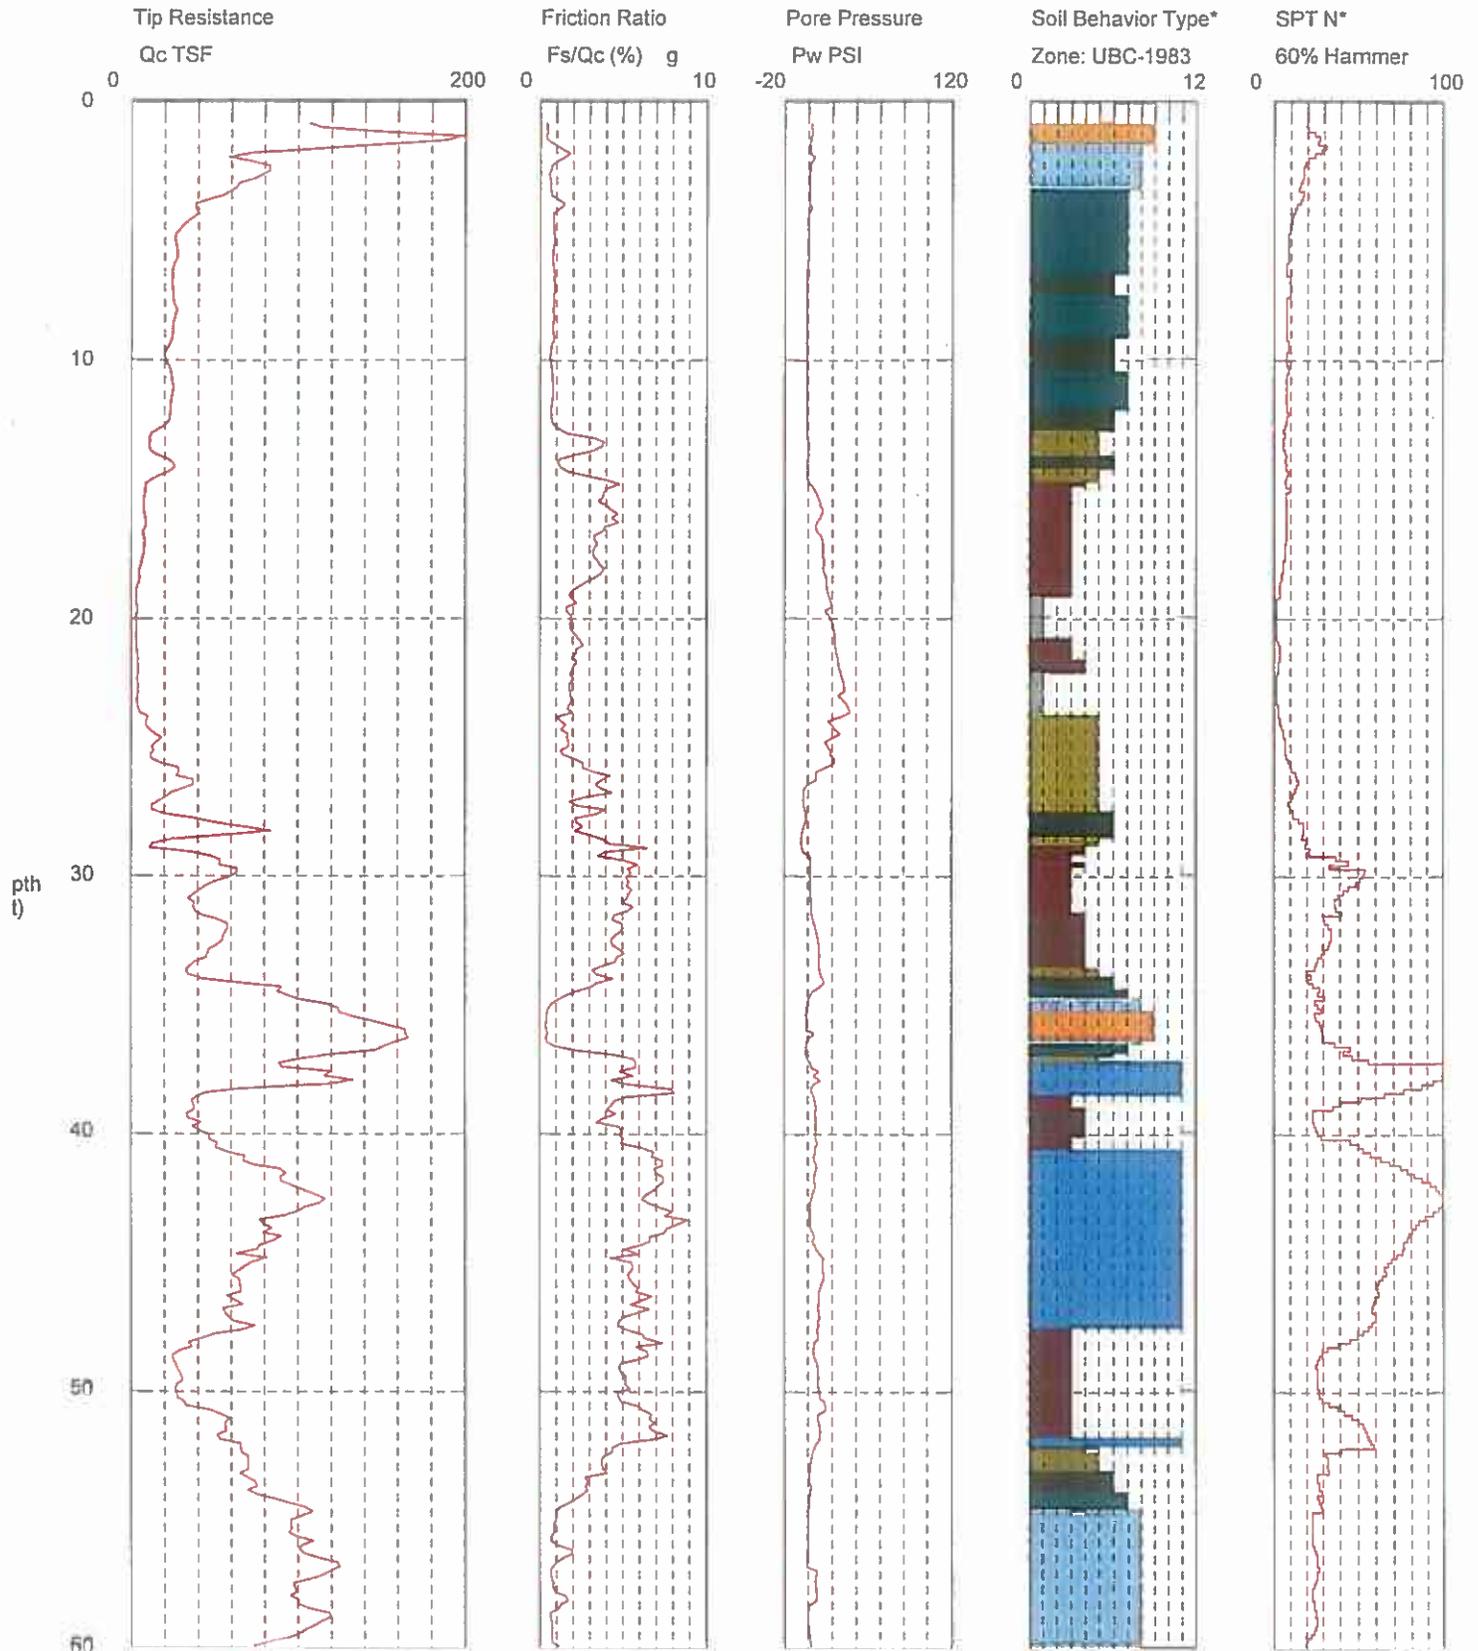
CPT Date/Time: 8/2/2016 11:07:40 AM  
 Location: Walnut Grove  
 Job Number: RNY-569

Maximum Depth = 60.20 feet
