# UPDATED EXISTING GEOTECHNICAL DATA

## TECHNICAL MEMORANDUM Community of East Walnut Grove, California

California Department of Water Resources  
Small Community Flood Risk Reduction  
Program

March 2020

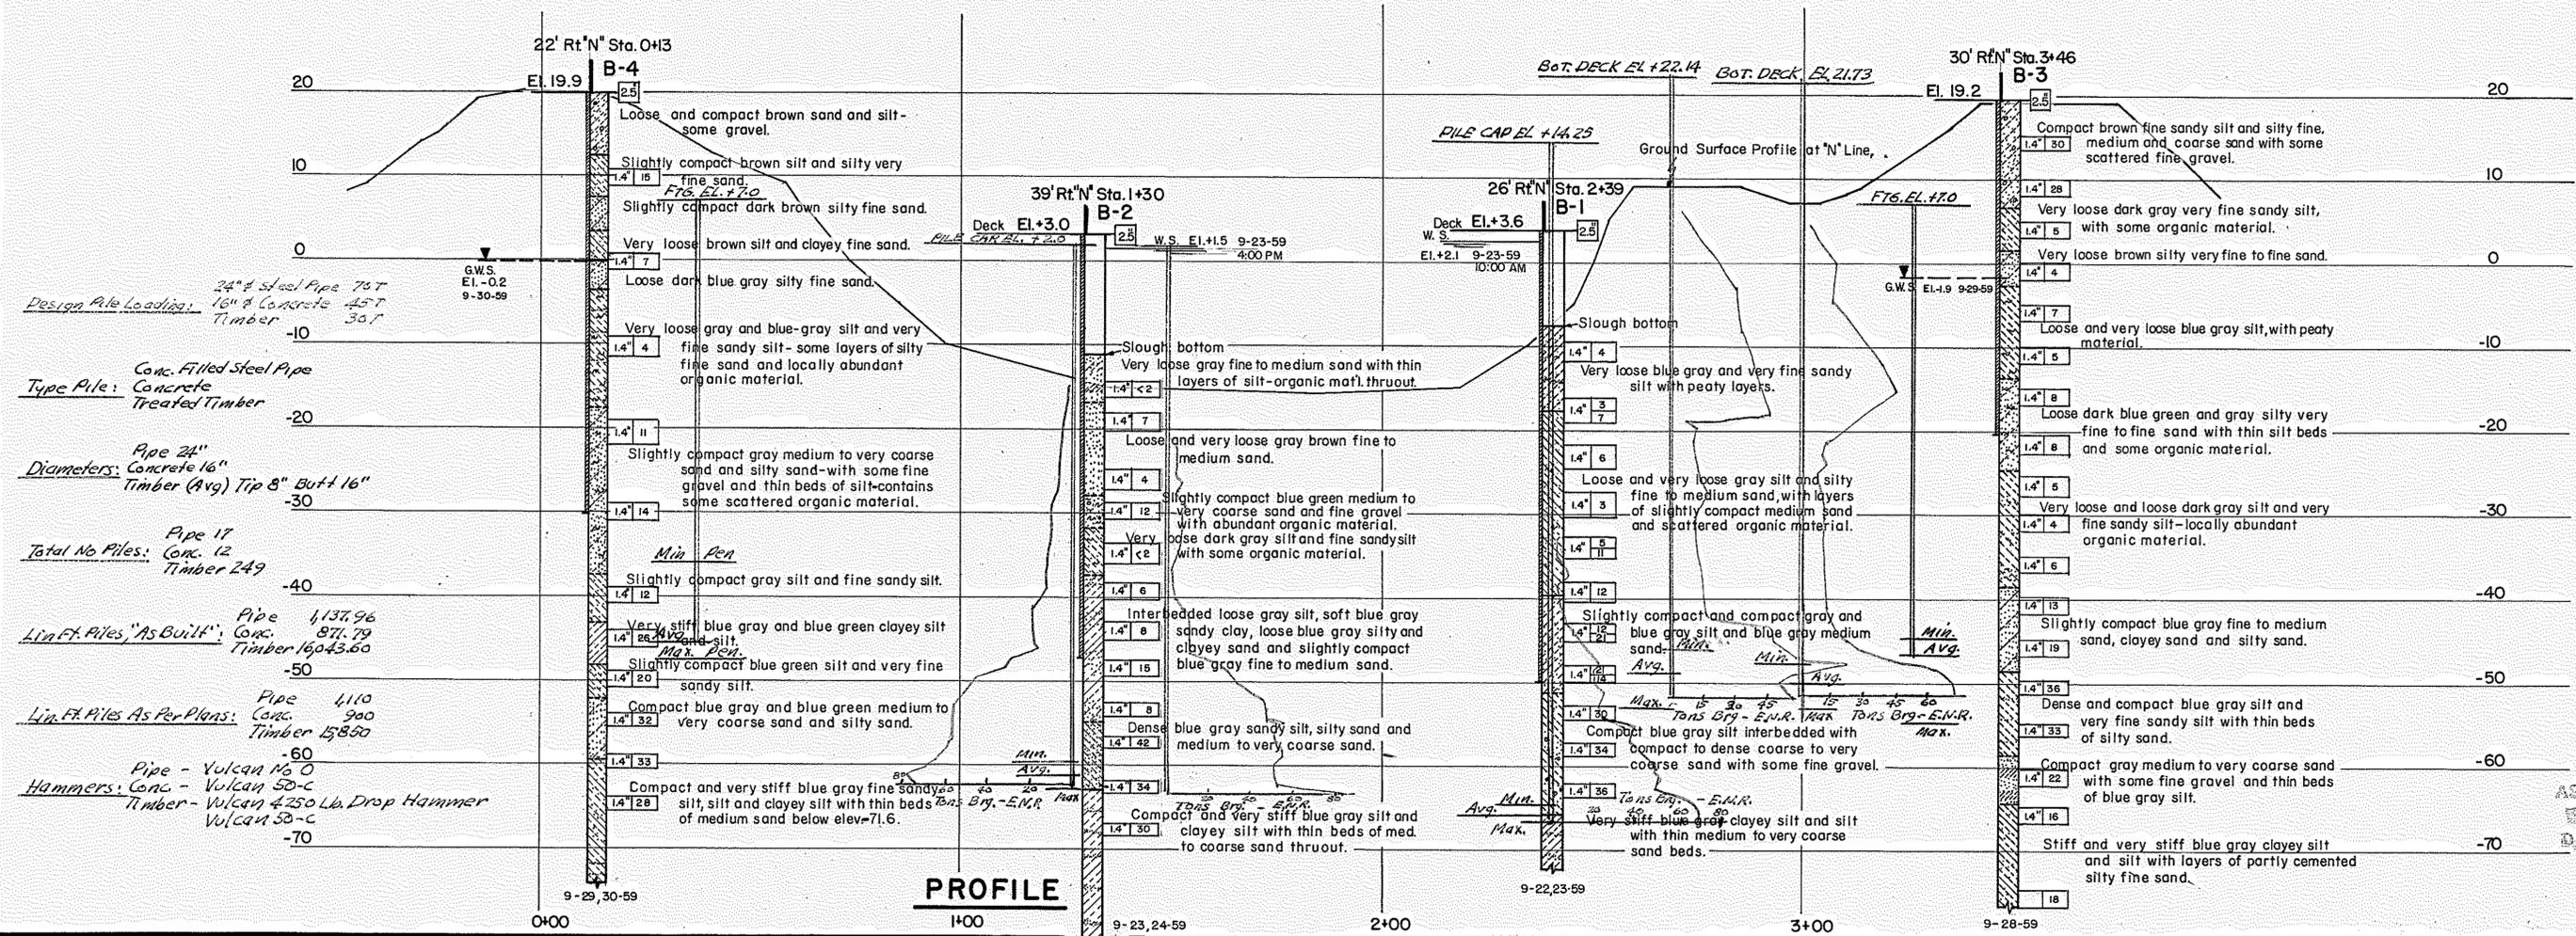
TBM - Bolt in pavement at 'N' Sta. 0+00  
 Elevation 20.18 USGS datum.

Design Pile Loading:  
 24" Steel Pipe 76T  
 16" Concrete 45T  
 Timber 30T

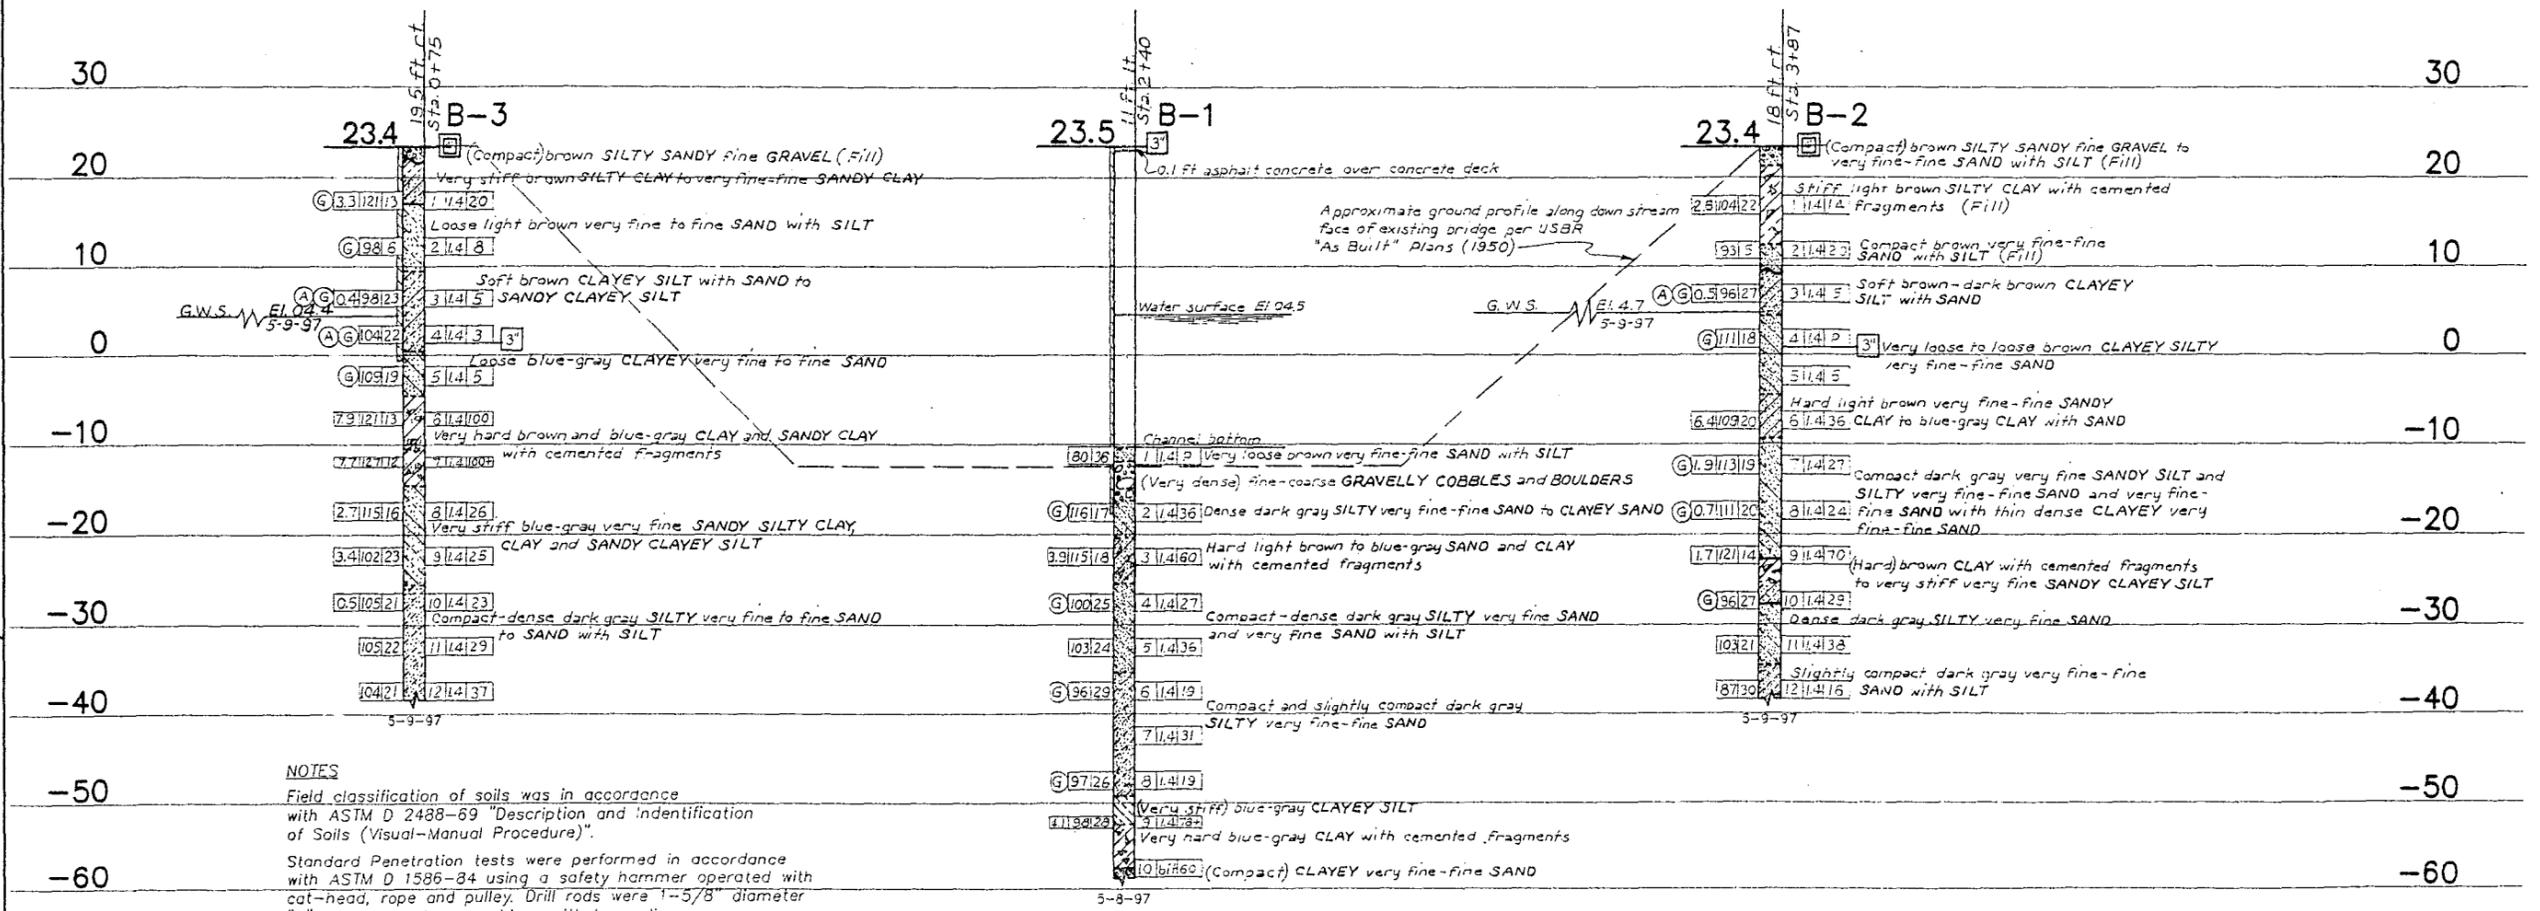
Elevation Reference  
Centerline North abutment at edge of deck - Elev. 23.50  
Per US Department of the Interior, Bureau of Reclamation "As Built" plans, 1950

**NOTES**  
Field classification of soils was in accordance with ASTM D 2488-69 "Description and Identification of Soils (Visual-Manual Procedure)".  
Standard Penetration tests were performed in accordance with ASTM D 1586-84 using a safety hammer operated with cat-head, rope and pulley. Drill rods were 1-5/8" diameter "A"-rods; sampler was driven with brass liners.
