# Preliminary Existing Condition Stability, Seepage and Settlement Evaluation

## Sacramento River and Georgiana Slough East Levees

Community of East Walnut Grove, California

Blackburn File No. 3139.x  
August 3, 2020

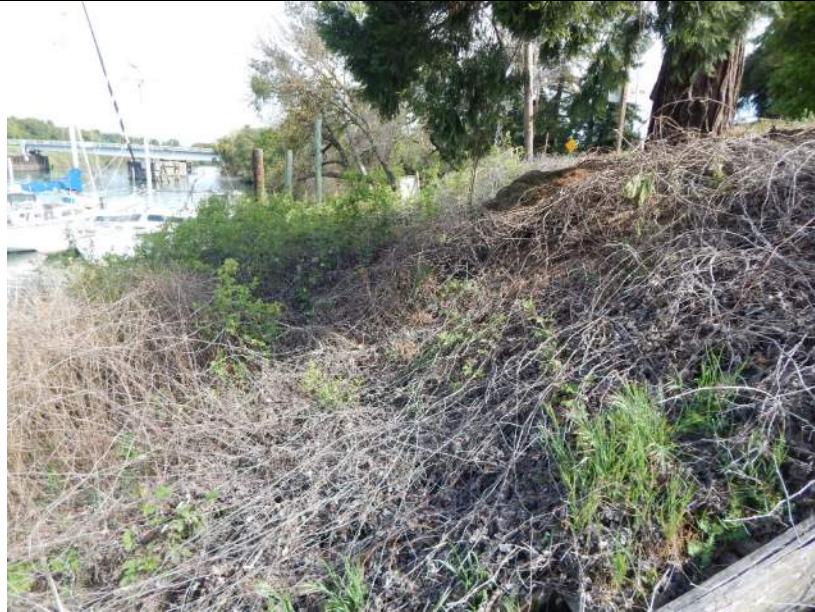
**Photo 1a: Waterside Slope**

Looking north along the waterside slope of Segment 128. The bridge over Georgiana Slough can be seen in the background.

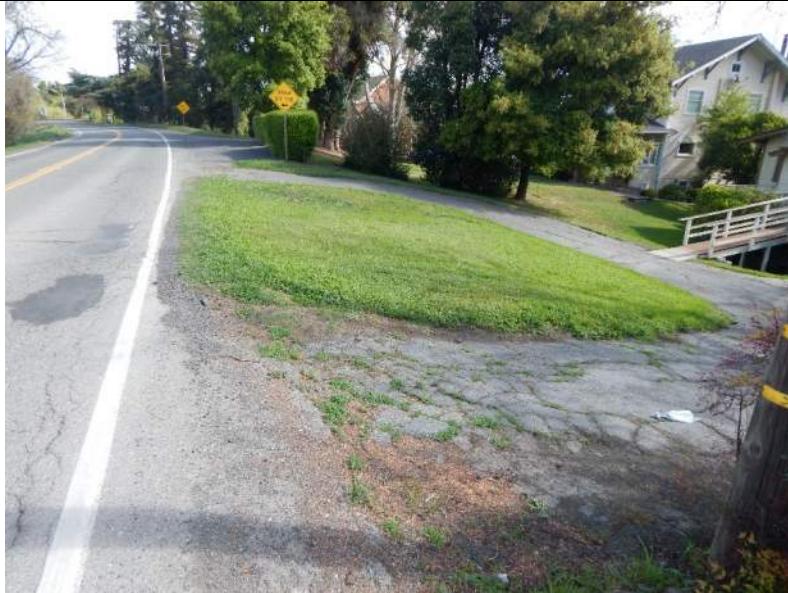
**Photo 2a: Landside Slope**

Looking north at residential lawns along the landside slope of Segment 128.

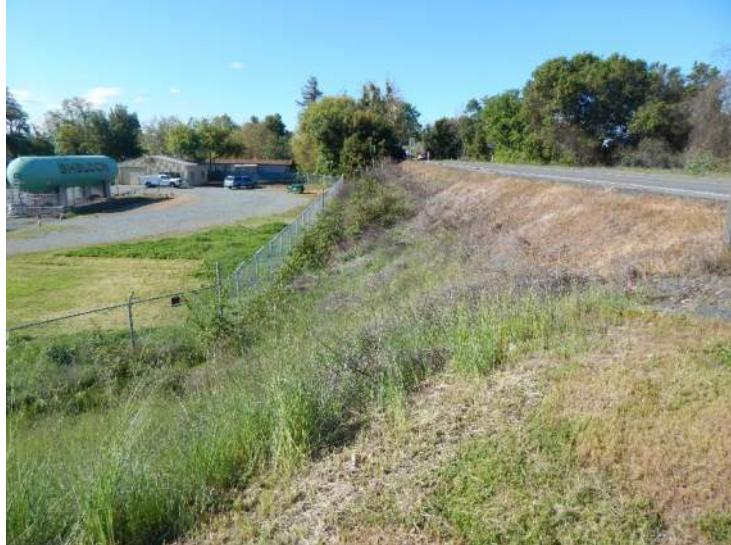
**Photo 2c: Landside Slope**

Looking south from Mealer Lane along the landside slope of Segment 128.

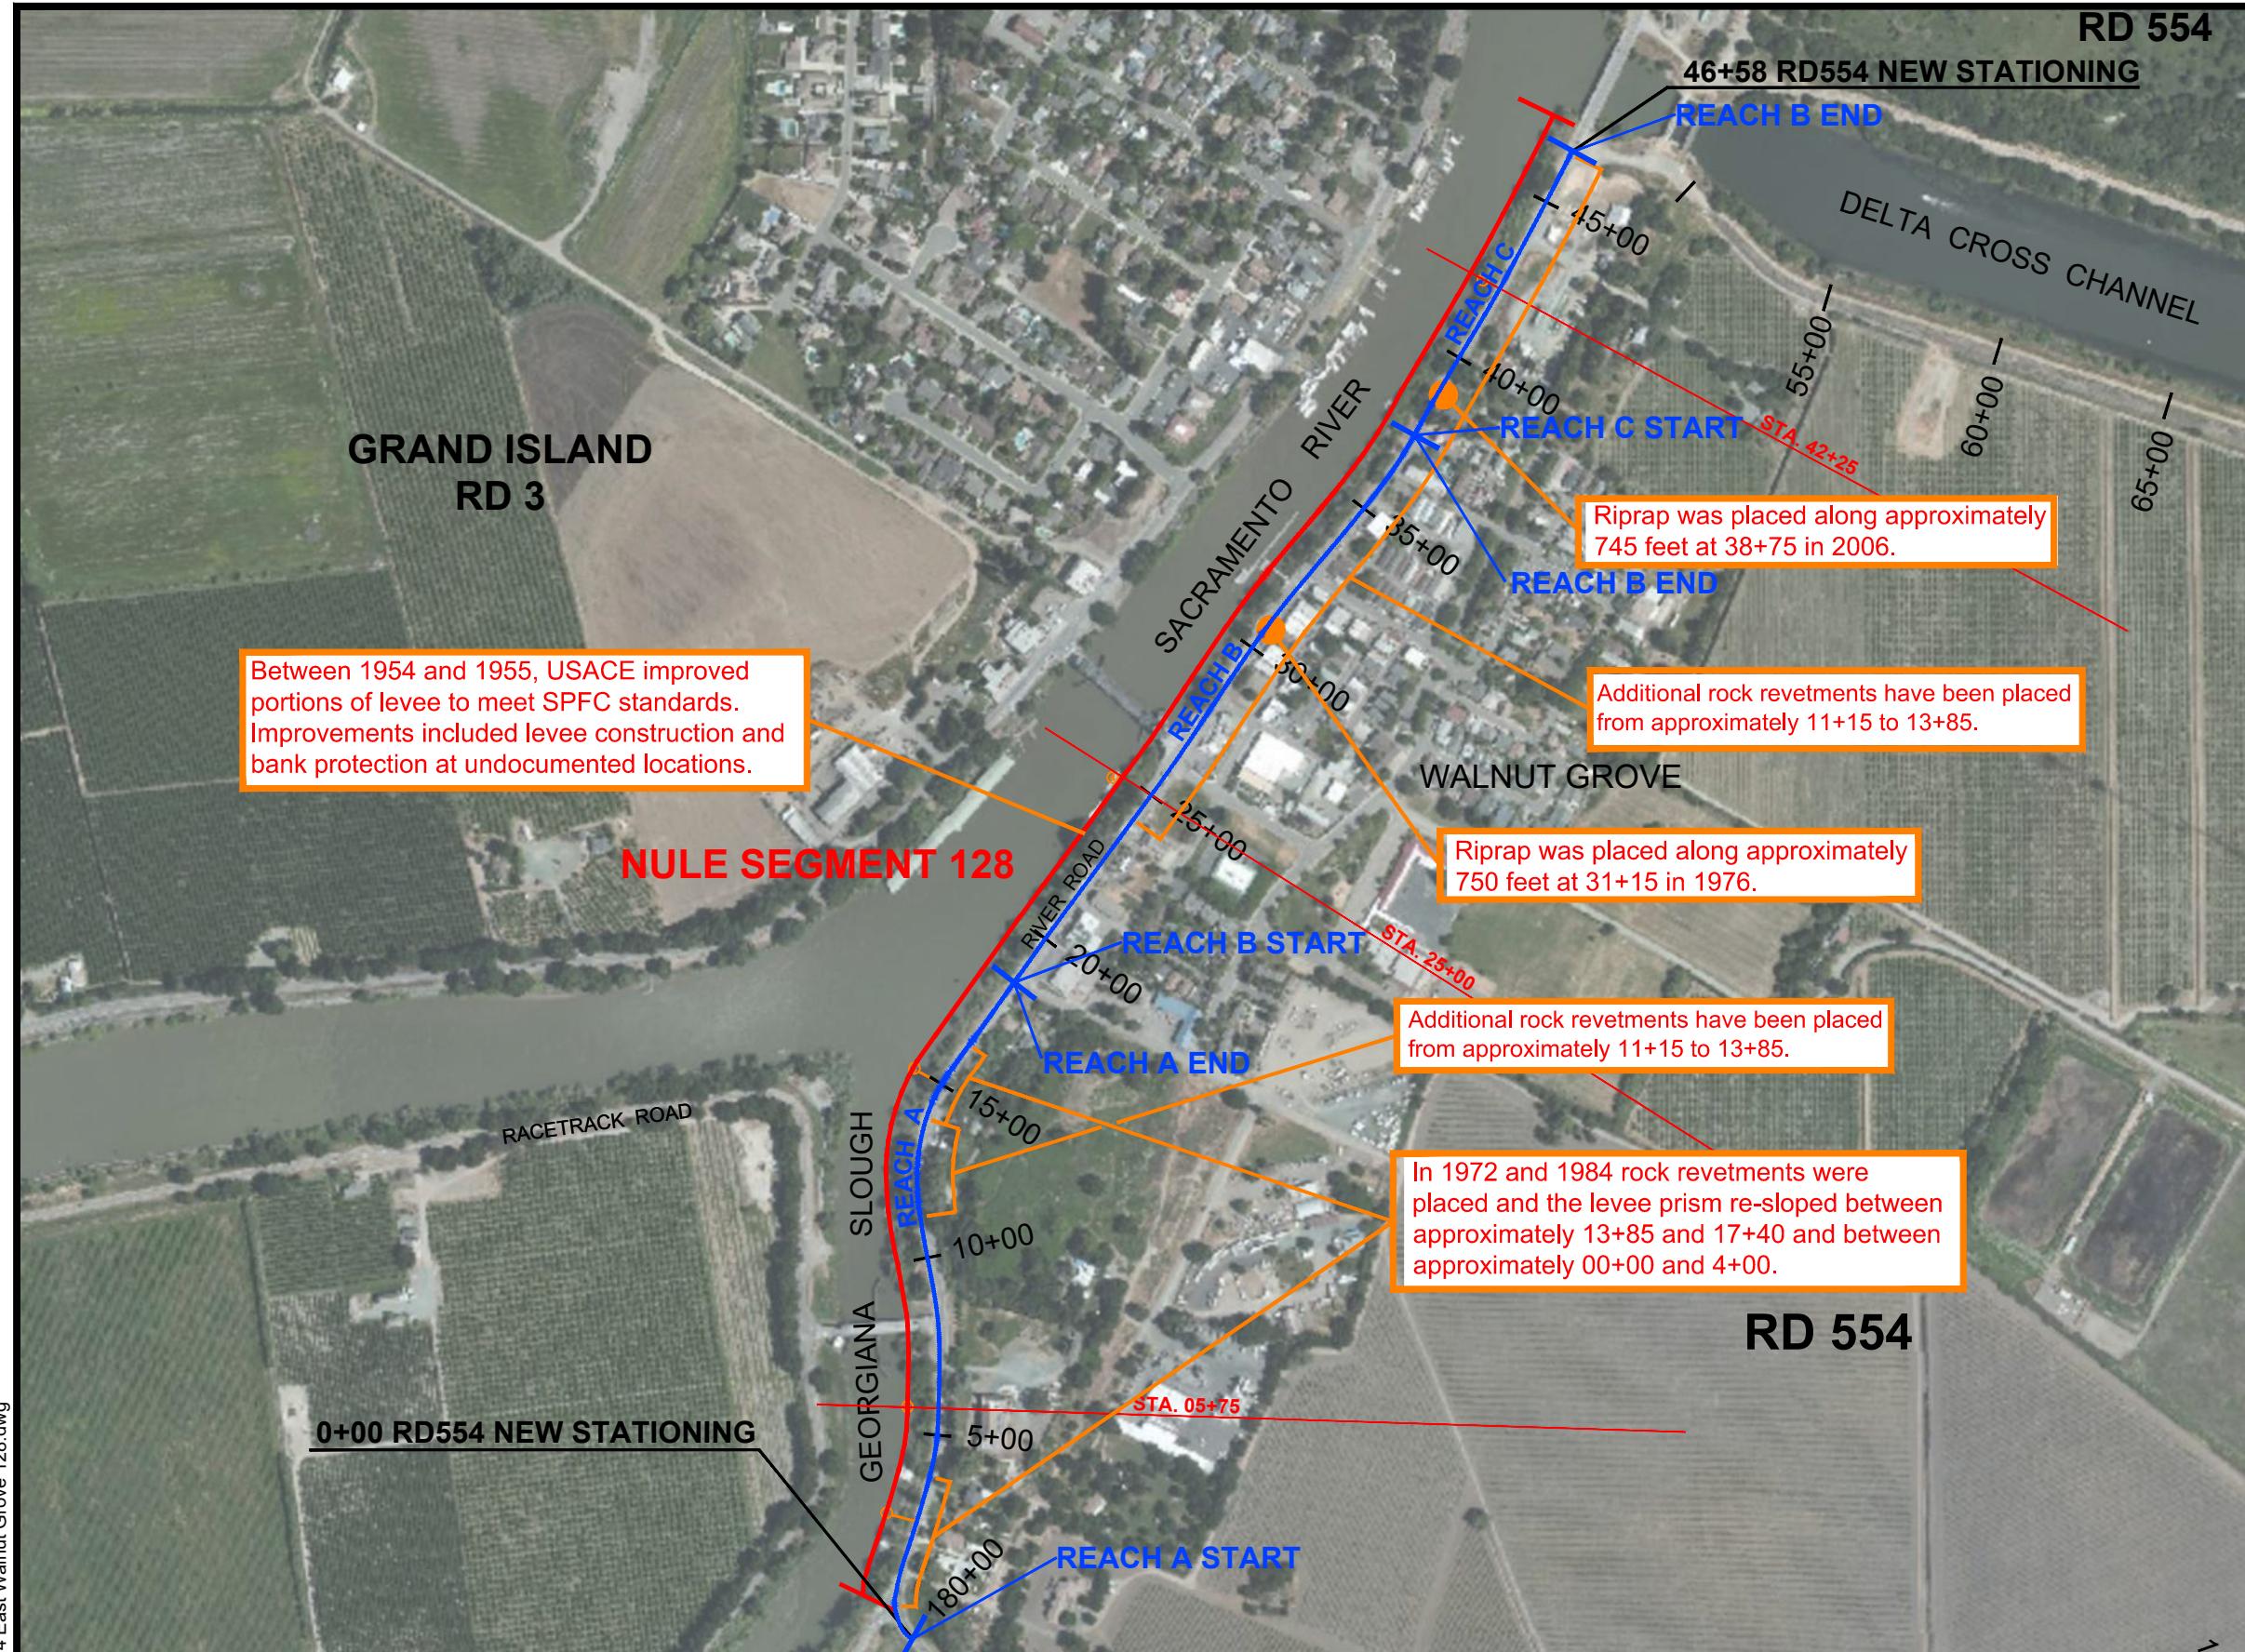
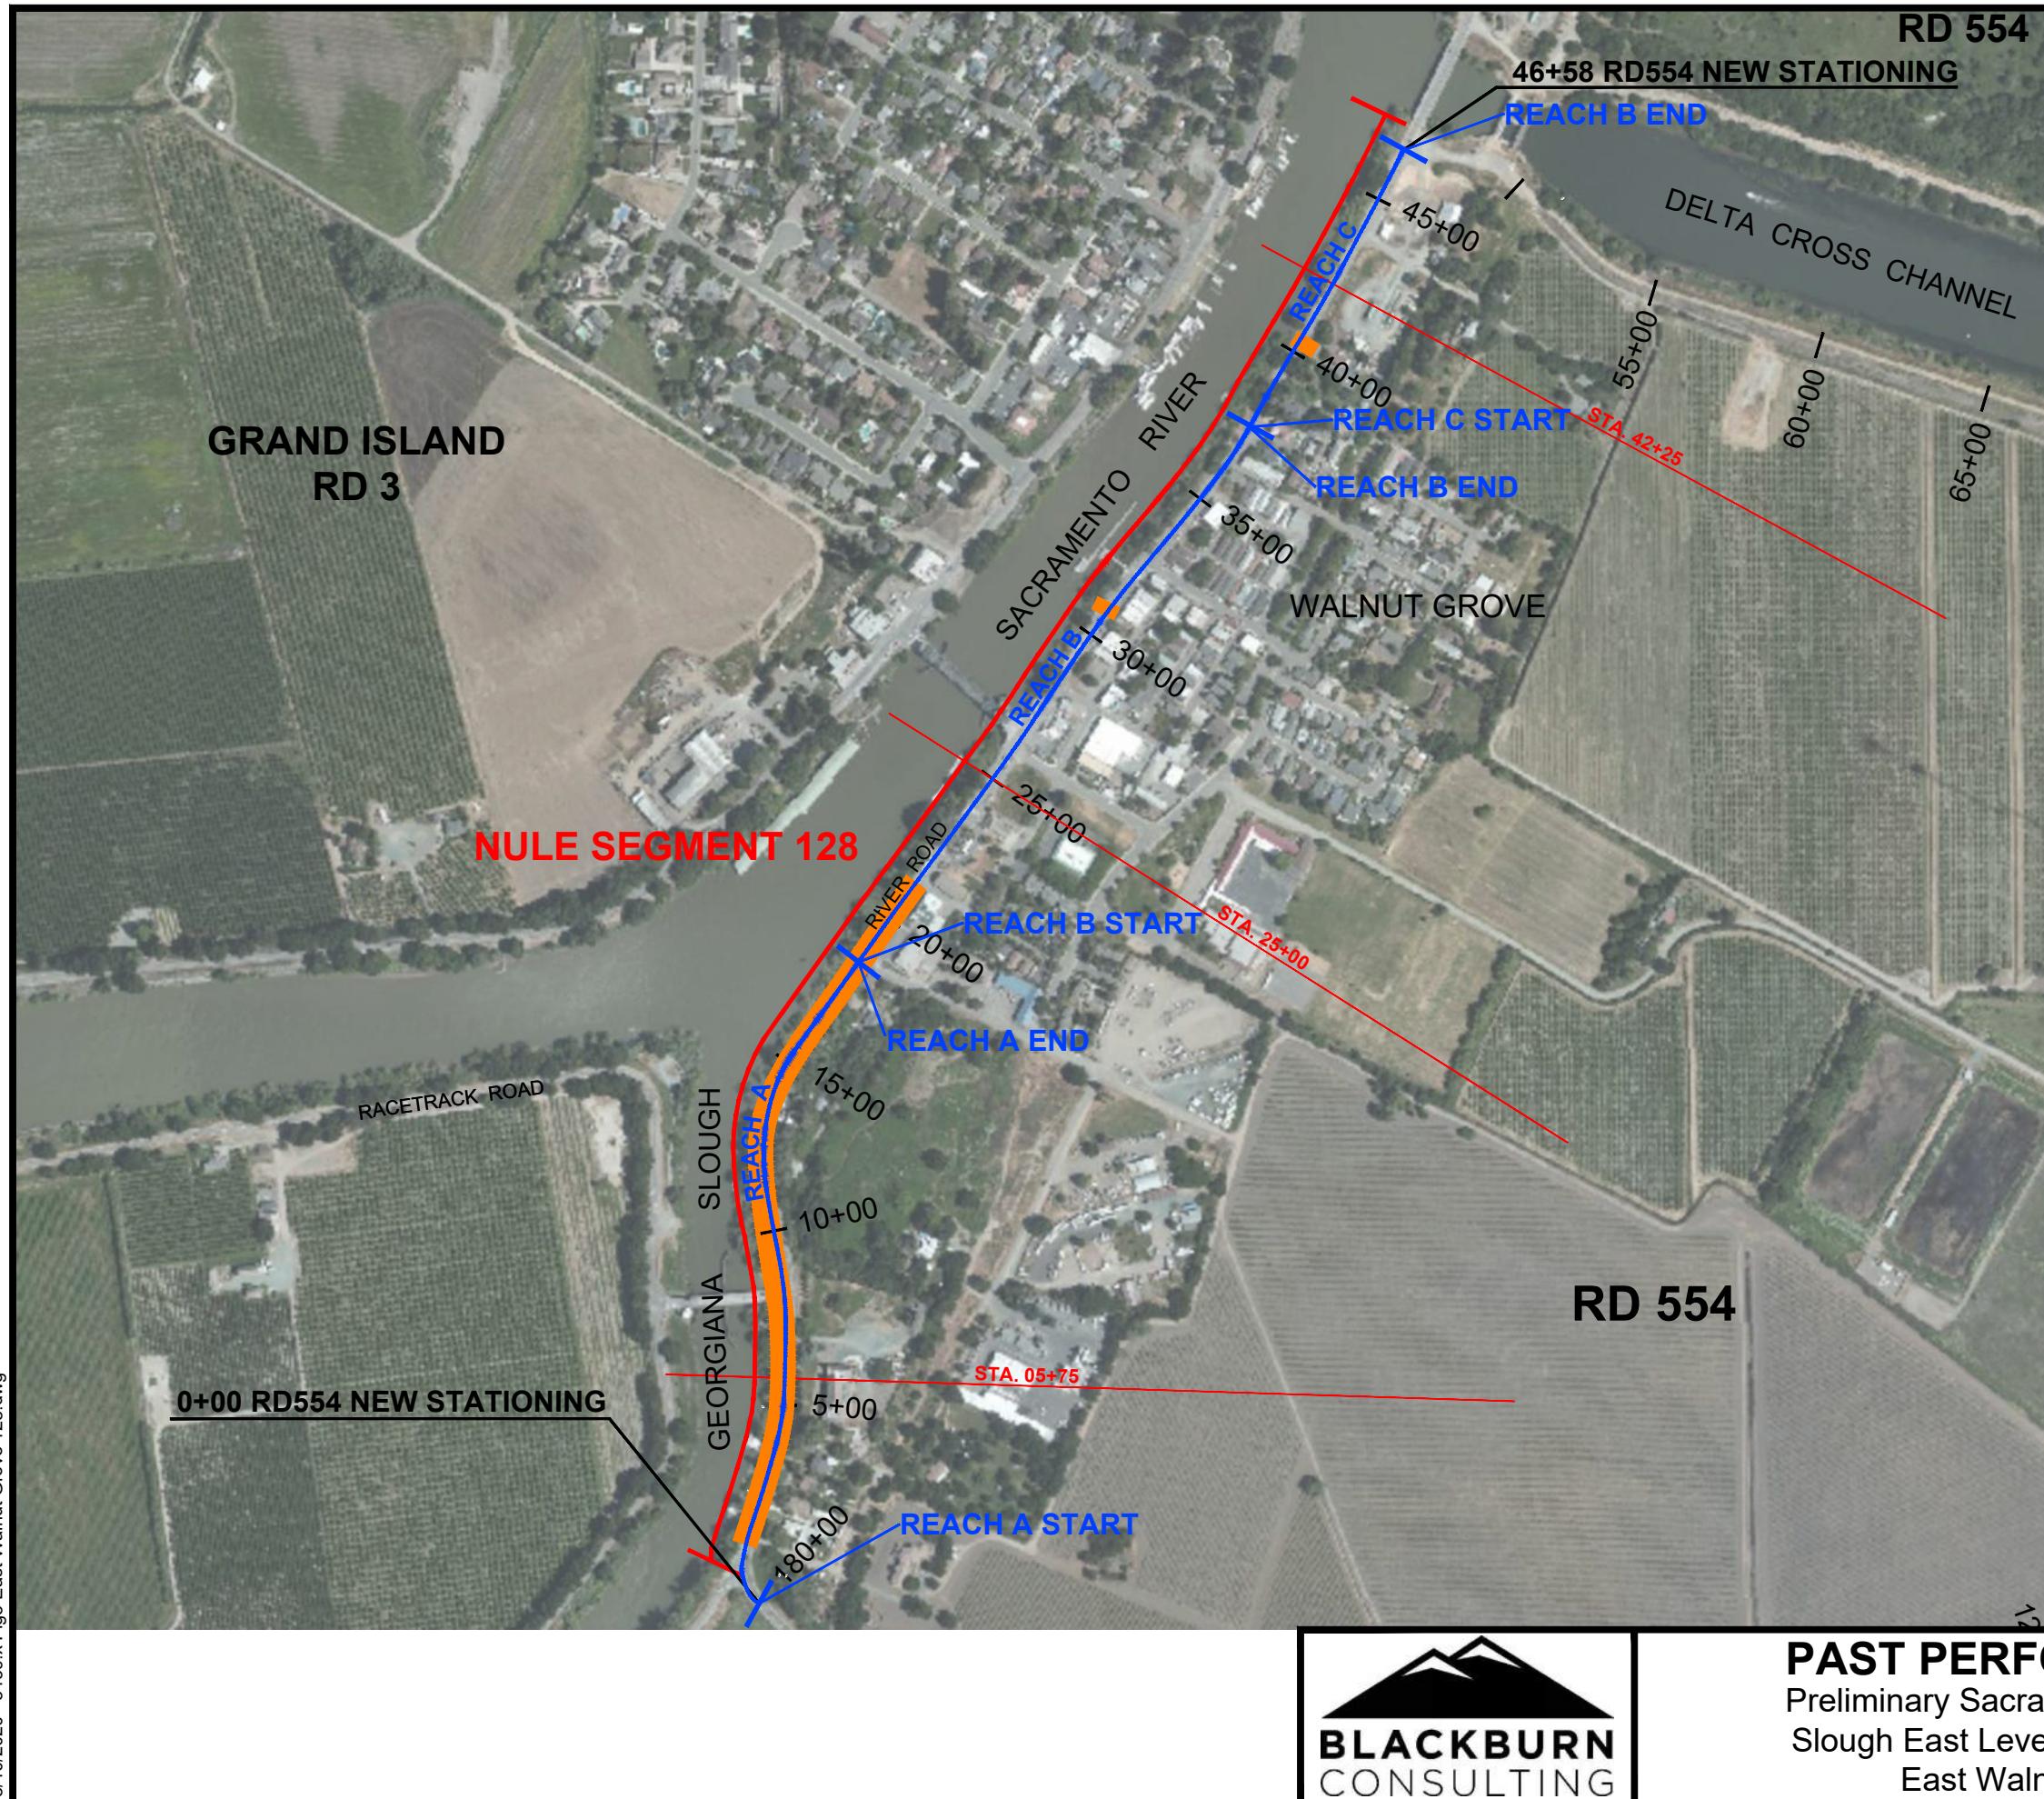
File No. 3139.x  
August 2020  
Figure 5

<b>Flood Season</b>	<b>Reported Event</b>	<b>Approximate Location (RD 554 Stationing)</b>	<b>Mitigation</b>
1957	Waterside erosion, slope caved	2+70 – 20+45	Not documented
1997	Erosion – Scouring, embankment slope failure	39+25	Not documented
1998	Toe failure of rock revetment	33+15 – 33+65	Repair recommended, not documented
2003	Erosion site	30+10	Upstream end (140') repaired

The locations of the above events are shown on Figure 5.

**PAST PERFORMANCE ISSUES**  
Preliminary Sacramento River and Georgiana  
Slough East Levee Evaluation, Segment 128  
East Walnut Grove, California

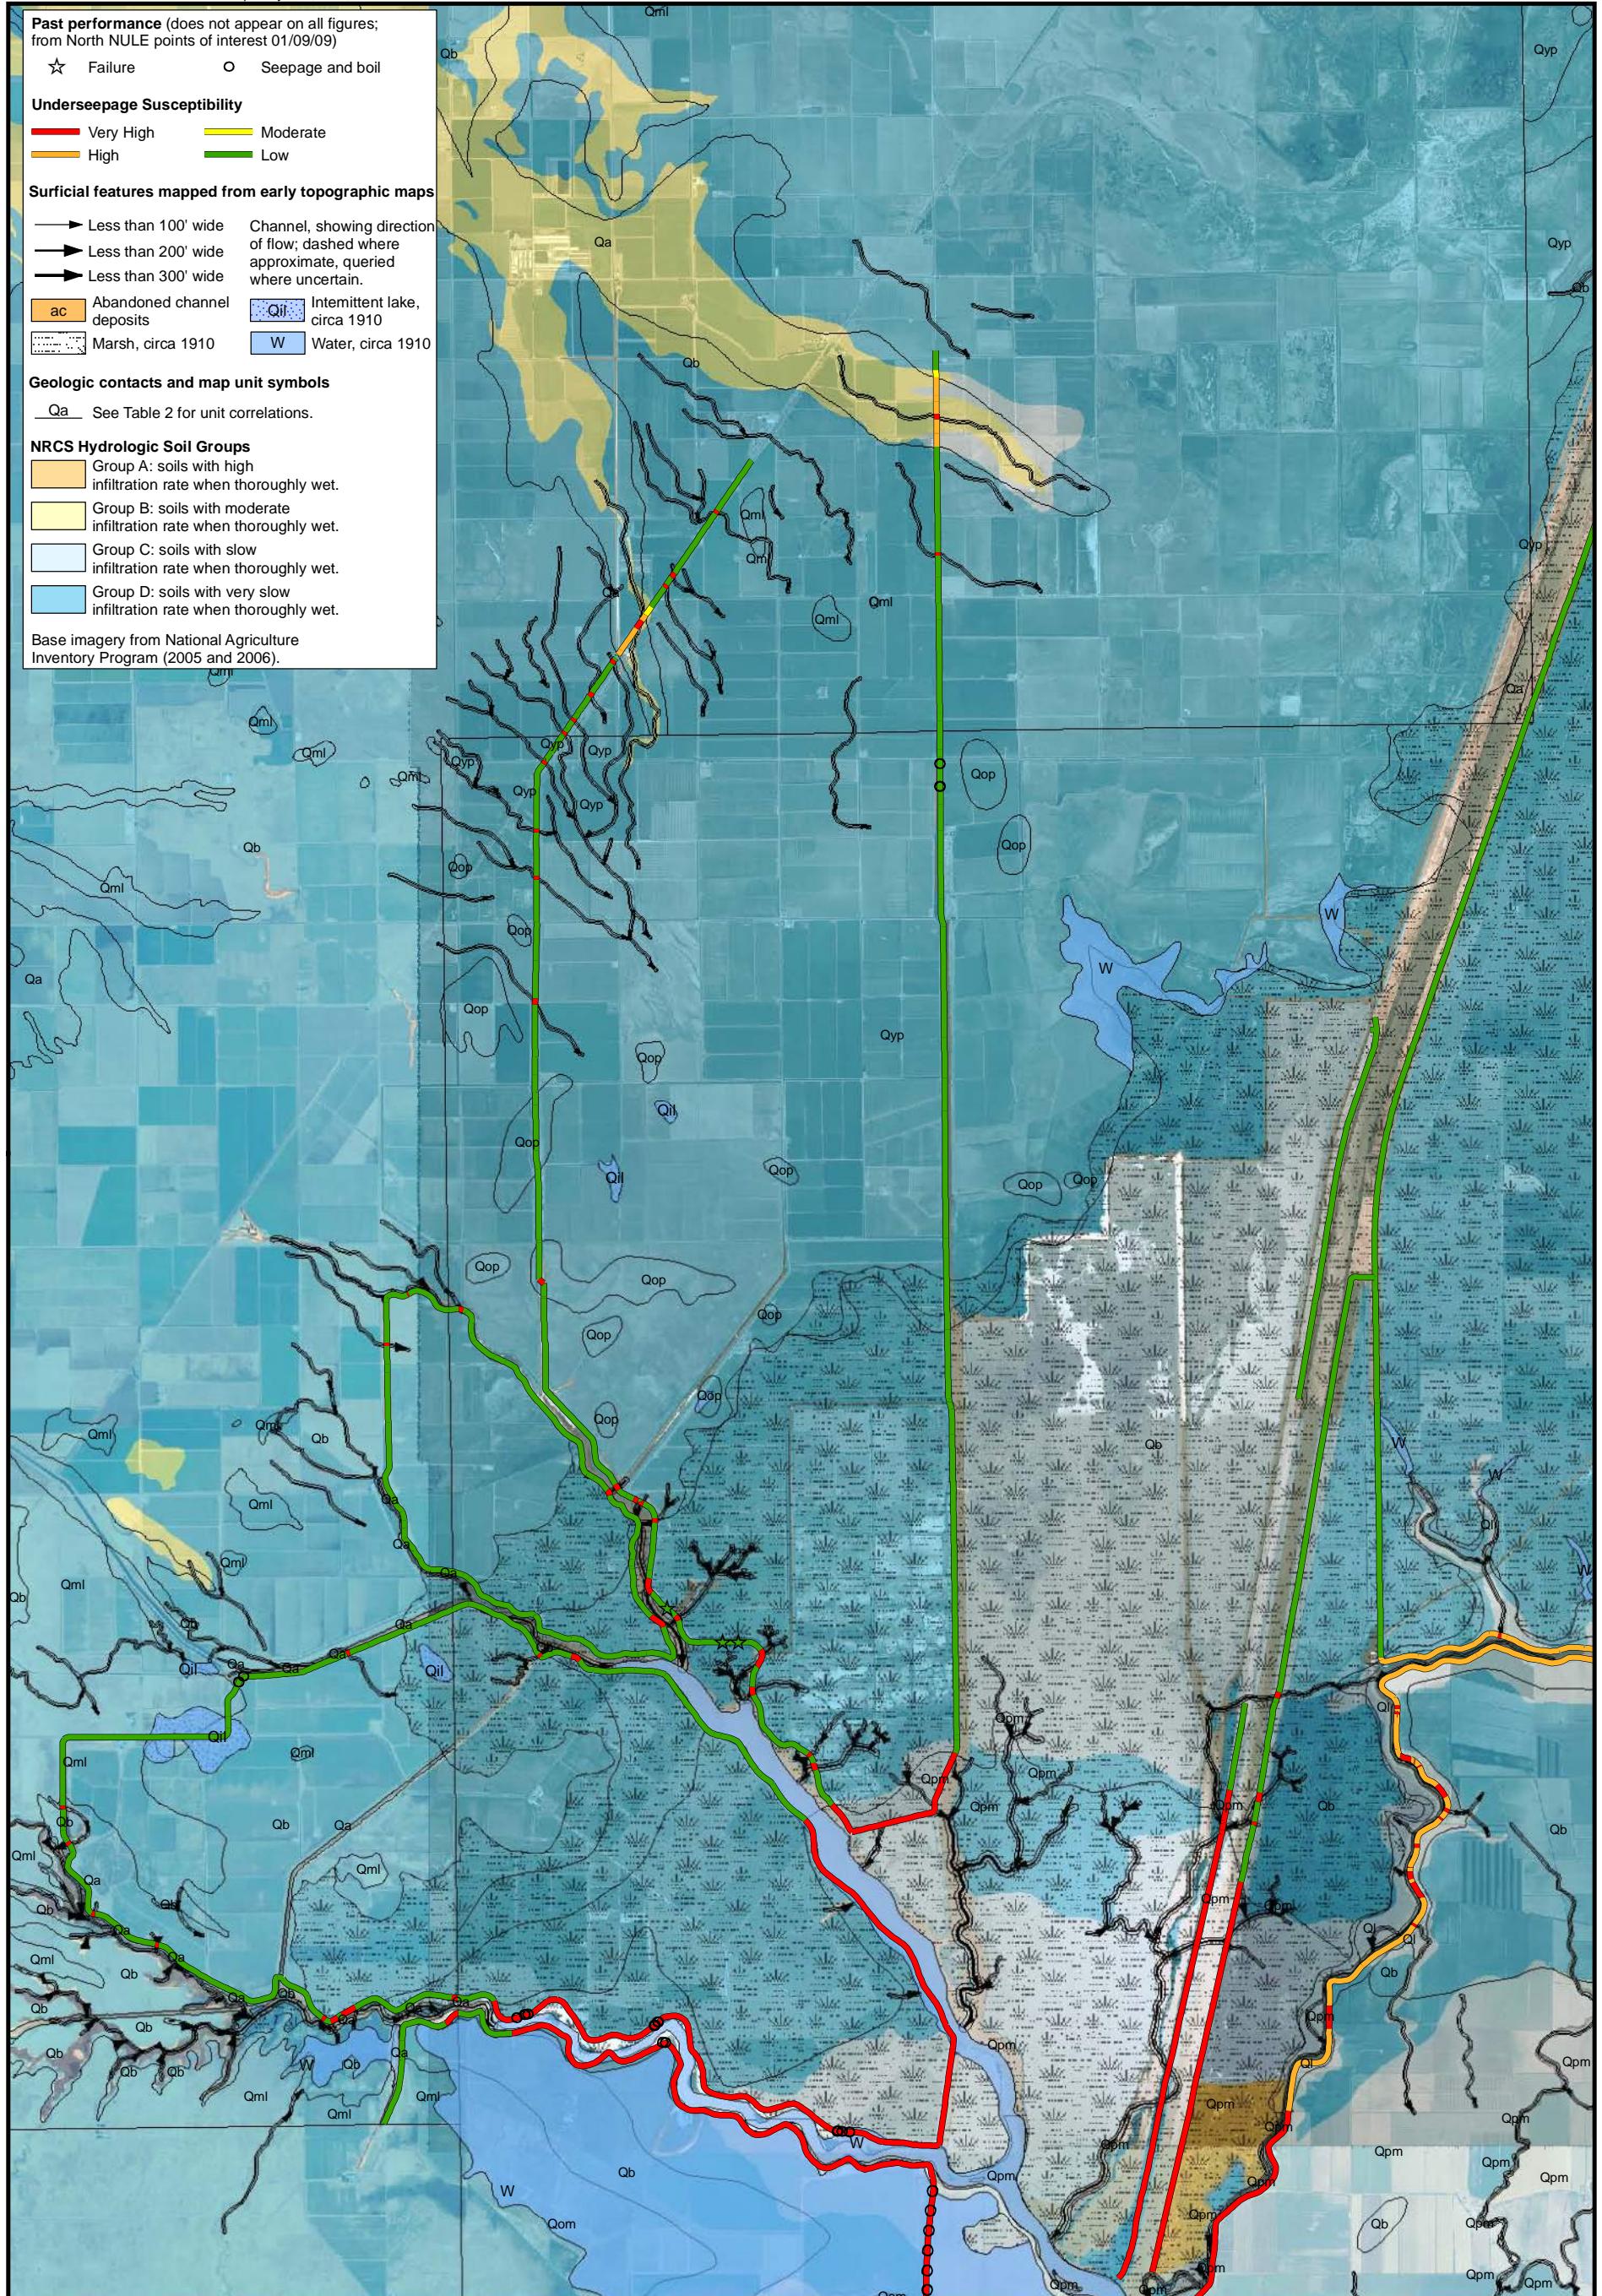
**Figure**  
**23**

This section describes NULE levees along the Sacramento River from directly south of the City of Sacramento downstream through the Delta to Sherman Island, the many sloughs within the Delta, and the Deep Water Ship Canal (Figures 23, 25, and 27). The levees along the lower Sacramento River overlie Holocene natural levee (Qa, Ql) and basin (Qb) deposits in the upstream areas, but these deposits transition to natural levee deposits that overlie organic-rich peat and mud deposits (Qpm) as the river approaches the Delta near Courtland and Paintersville (Figure 25). Non-urban non-Project levees are present directly east of Freeport around the Sacramento Regional Wastewater Treatment Plant, as well as along Snodgrass Slough (Figures 9 and 25). Non-urban non-Project levees east of Freeport principally overlie Pleistocene Riverbank Formation deposits that are assigned low susceptibility to underseepage. Along Snodgrass Slough, a former distributary channel of the Sacramento River, non-urban non-Project levees overlie a range of deposits and soil types, from sandy peat to fine-grained basin deposits, and the foundation underseepage susceptibility similarly ranges from very high to low (Figure 25). The non-urban Project levee along the Deep Water Ship Canal (Figure 25) traverses a flood basin that lies between the distal Putah Creek alluvial fan and the Sacramento River and related sloughs. Because the NULE levee along the Deep Water Ship Canal overlies thick flood basin materials, foundation underseepage susceptibility is low.

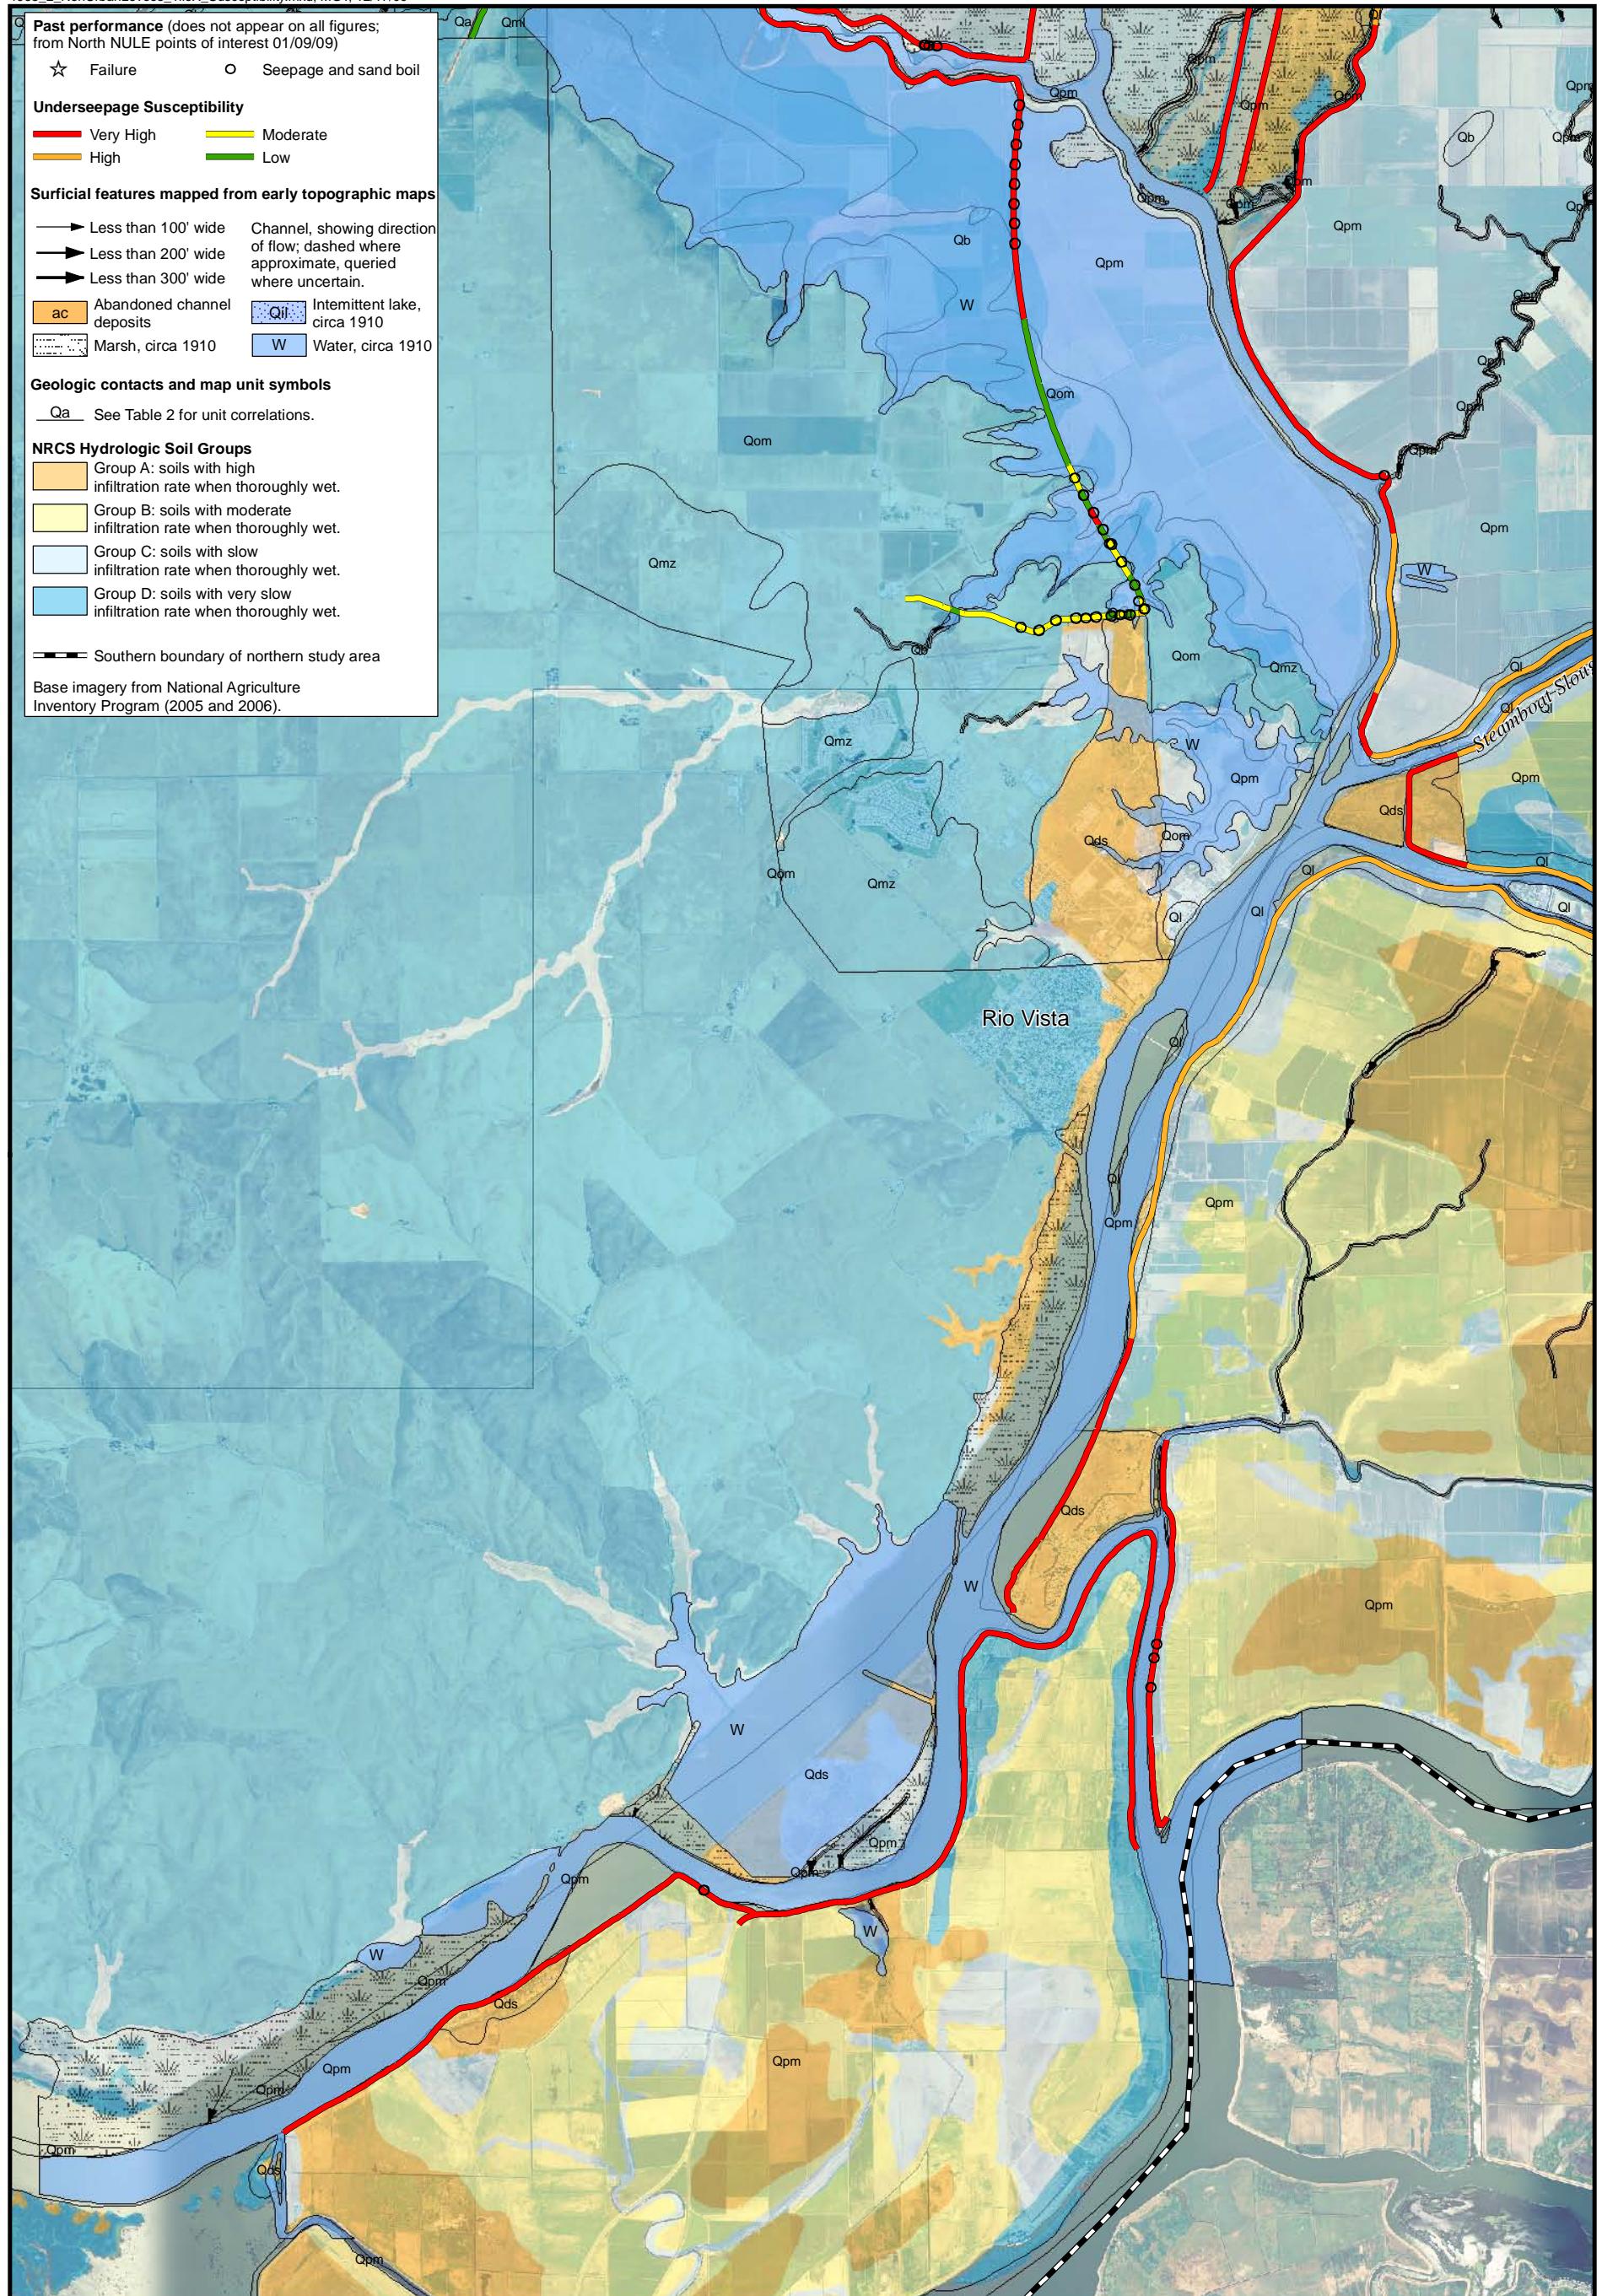
## Figure 25

Generally throughout the Delta region (e.g., Figures 25 to 27), silty-sandy natural levee deposits accumulate proximal to the active channels, forming rings of higher ground around lower elevation islands of organic-rich peaty material (Atwater, 1982). As deposition of natural levee material decreases away from the channels, the component of peat and mud material increases. The natural levees along sloughs such as Elk, Sutter, Steamboat, Miner, Georgina, and Threemile Sloughs generally are mapped as Qa or Ql. As a result, NULE levees along the Sacramento River and nearby sloughs are assigned high underseepage susceptibilities except in locations where underseepage susceptibilities are very high because levees overlie peat and mud materials (map unit Qpm) or spoils from the dredging of channels (map unit Qds; west side of Figure 27). At the southeastern extent of Figure 27, non-urban non-Project levee flanks the North Mokelumne River. Much of the levee overlies peat deposits that are Group A HSG types. This foundation condition is assigned very high susceptibility to underseepage.

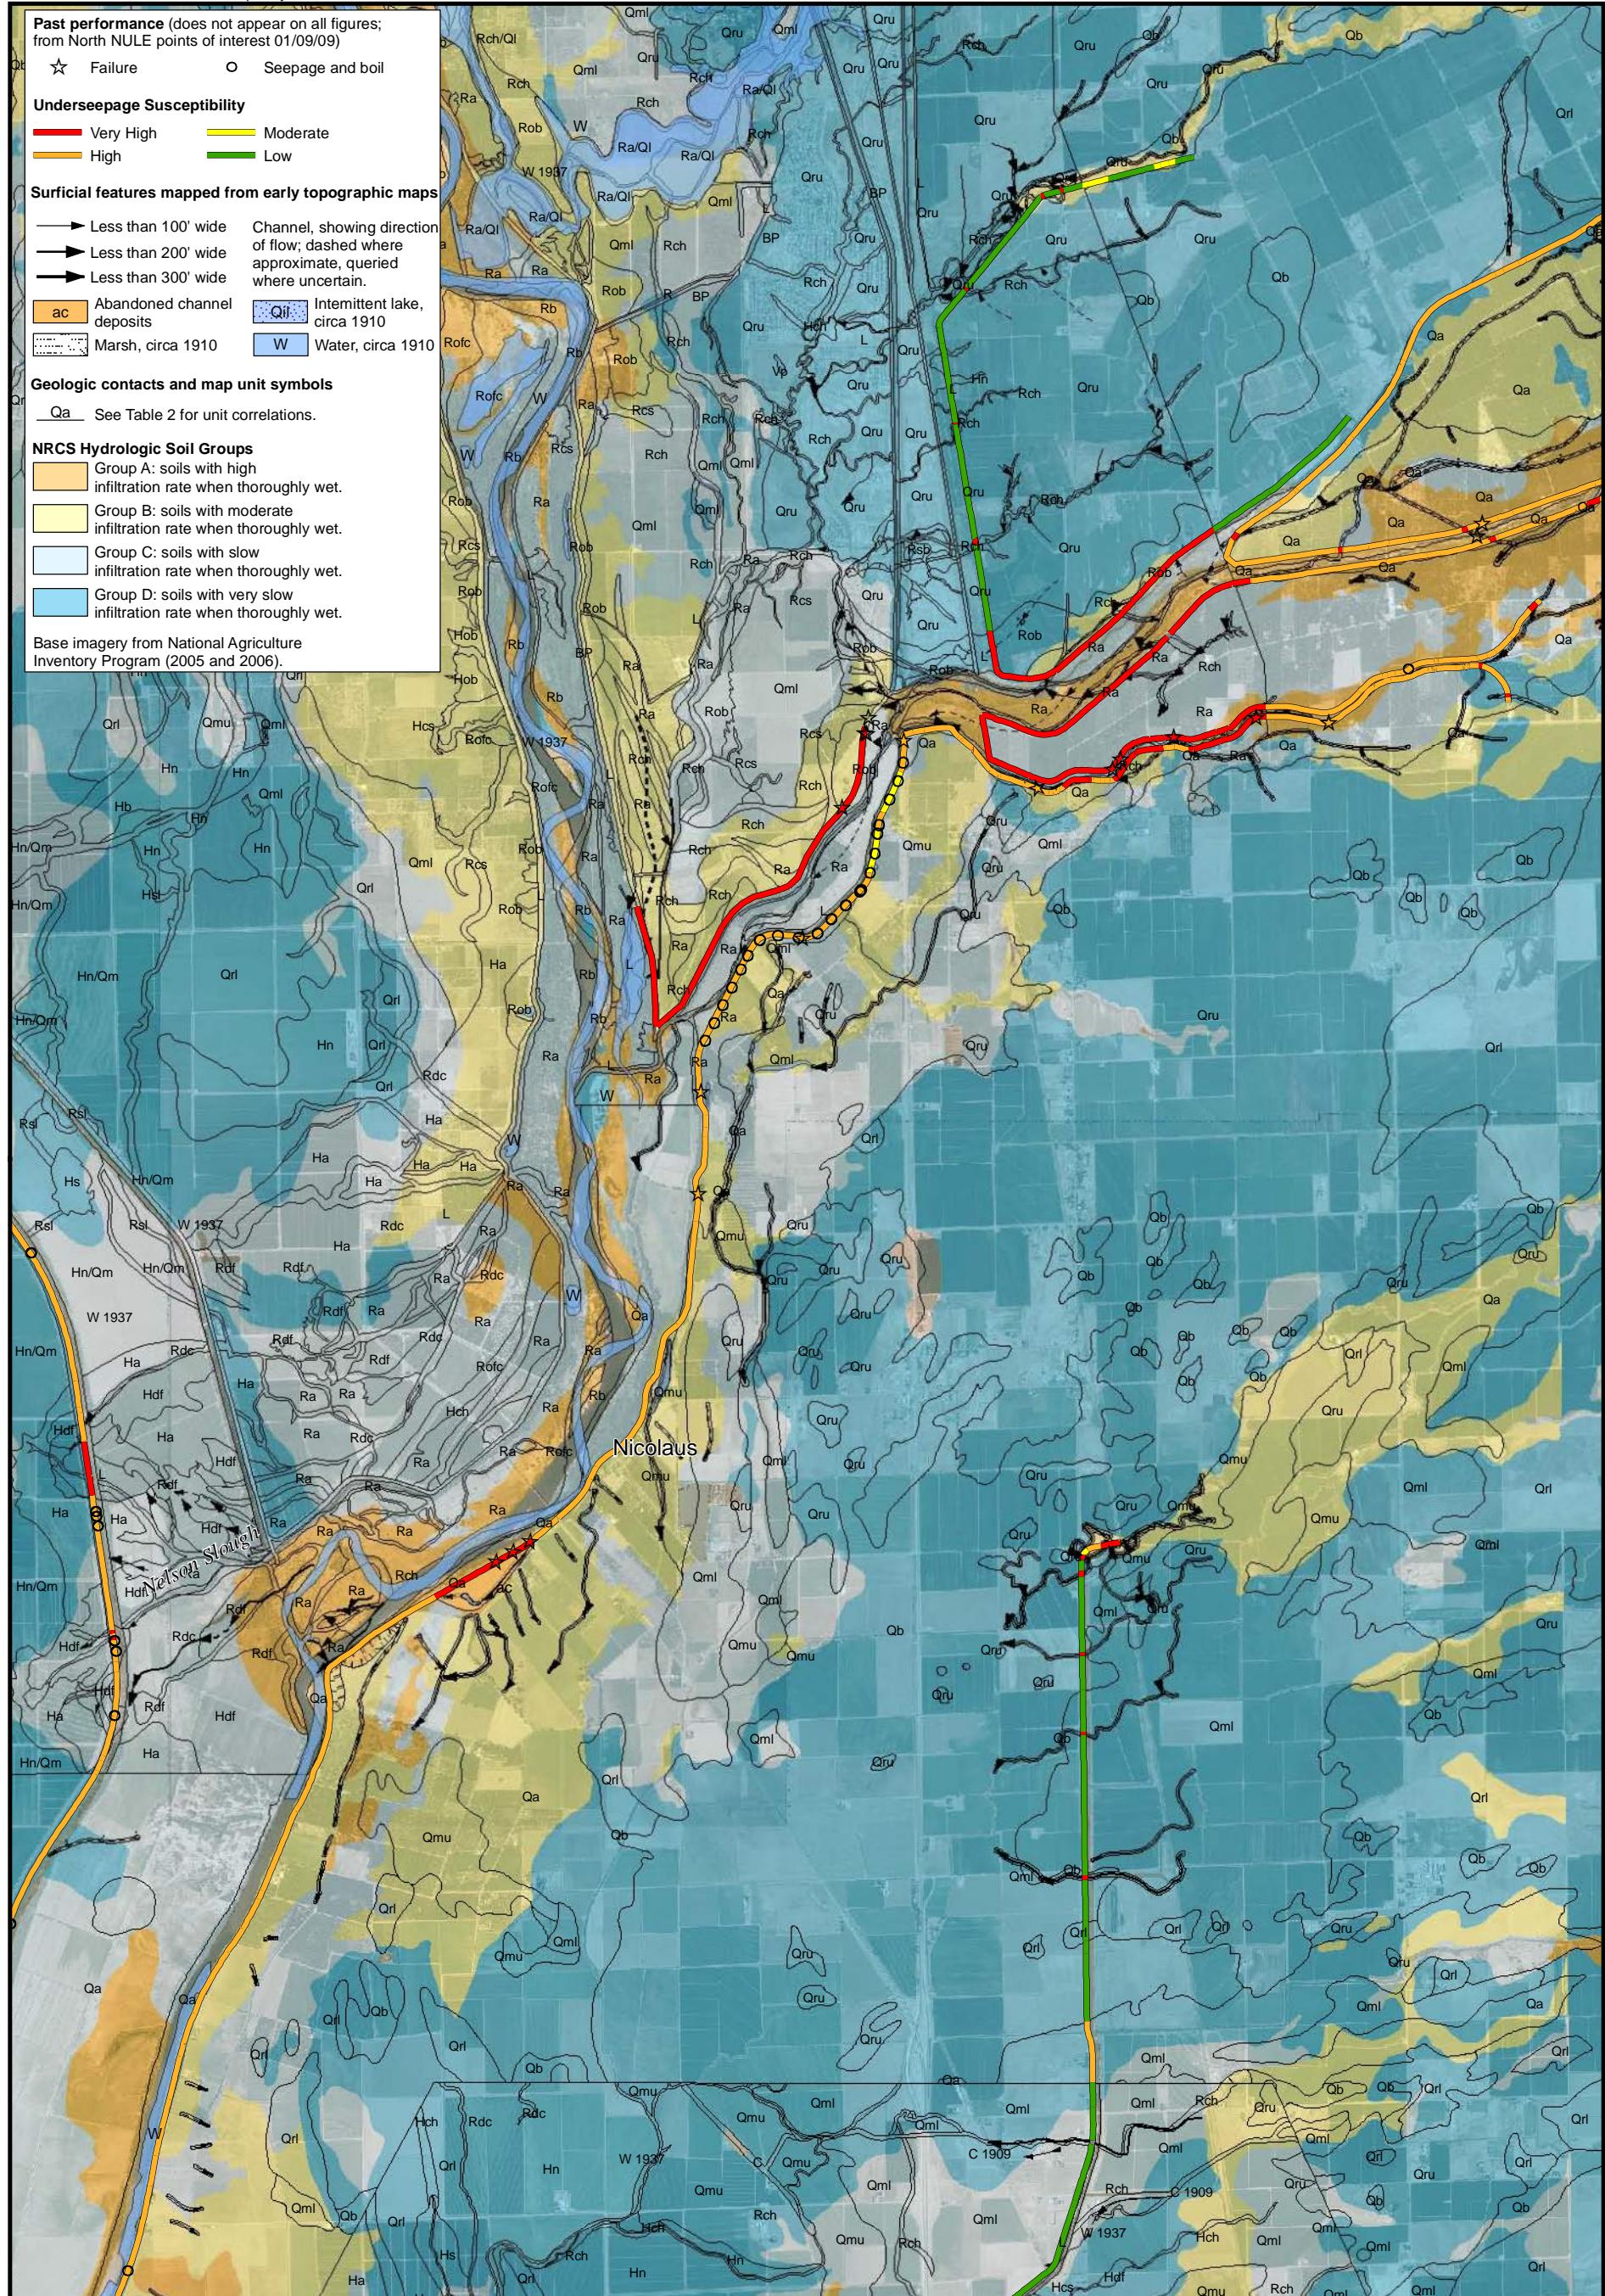
**Figure 33**

This group of levees includes levees along the Bear River and its tributaries (Dry Creek, Grasshopper Slough, and Yankee Slough), levees along Best Slough as well as a levee adjacent to the Western Pacific rail line (Figure 33), and the levee on the east bank of the

Feather River from the Feather's confluence with the Bear River south to the Feather's confluence with the Sutter Bypass (Figure 34). The levees of the Bear River and its tributaries generally constrain these watercourses to narrow and straight channels (Figure 33). These levees typically overlie extensive historical alluvium and stream channel deposits derived from upstream hydraulic mining debris, and therefore are interpreted as very high to high underseepage susceptibility (map units Rob, Qa, respectively). In contrast, the levees along nearby Best Slough and the Western Pacific rail line sit on older, consolidated alluvial fan deposits of the Riverbank Formation with low permeability soils and have low underseepage susceptibility. The levee along the east bank of the Feather River south of the Feather's confluence with the Bear River generally overlies historical alluvium of crevasse splay and overbank deposition (Rcs, Rob; Table 5-2), which is assessed as having high susceptibility to underseepage. Underseepage has been recorded in the performance databases along the levees assessed as having high and very high susceptibility in this area.

Changes in assigned susceptibility can occur at boundaries between map data sources (e.g., between geologic authors, or counties of soil surveys). Changes in assigned susceptibility (e.g., from low to high) at map boundaries should be treated carefully. For example, Figure 33 shows a NULE levee on the north side of Dry Creek abruptly changing from green (low susceptibility) to red (very high susceptibility). This change occurs at the border between 1:20,000-scale mapping and 1:62,500-scale mapping. A concerted effort was made to minimize border effects but because of the regional scale of analysis, some discrepancies remain.
