# Preliminary Existing Condition Stability, Seepage and Settlement Evaluation

## Sacramento River and Georgiana Slough East Levees

Community of East Walnut Grove, California

Blackburn File No. 3139.x  
August 3, 2020

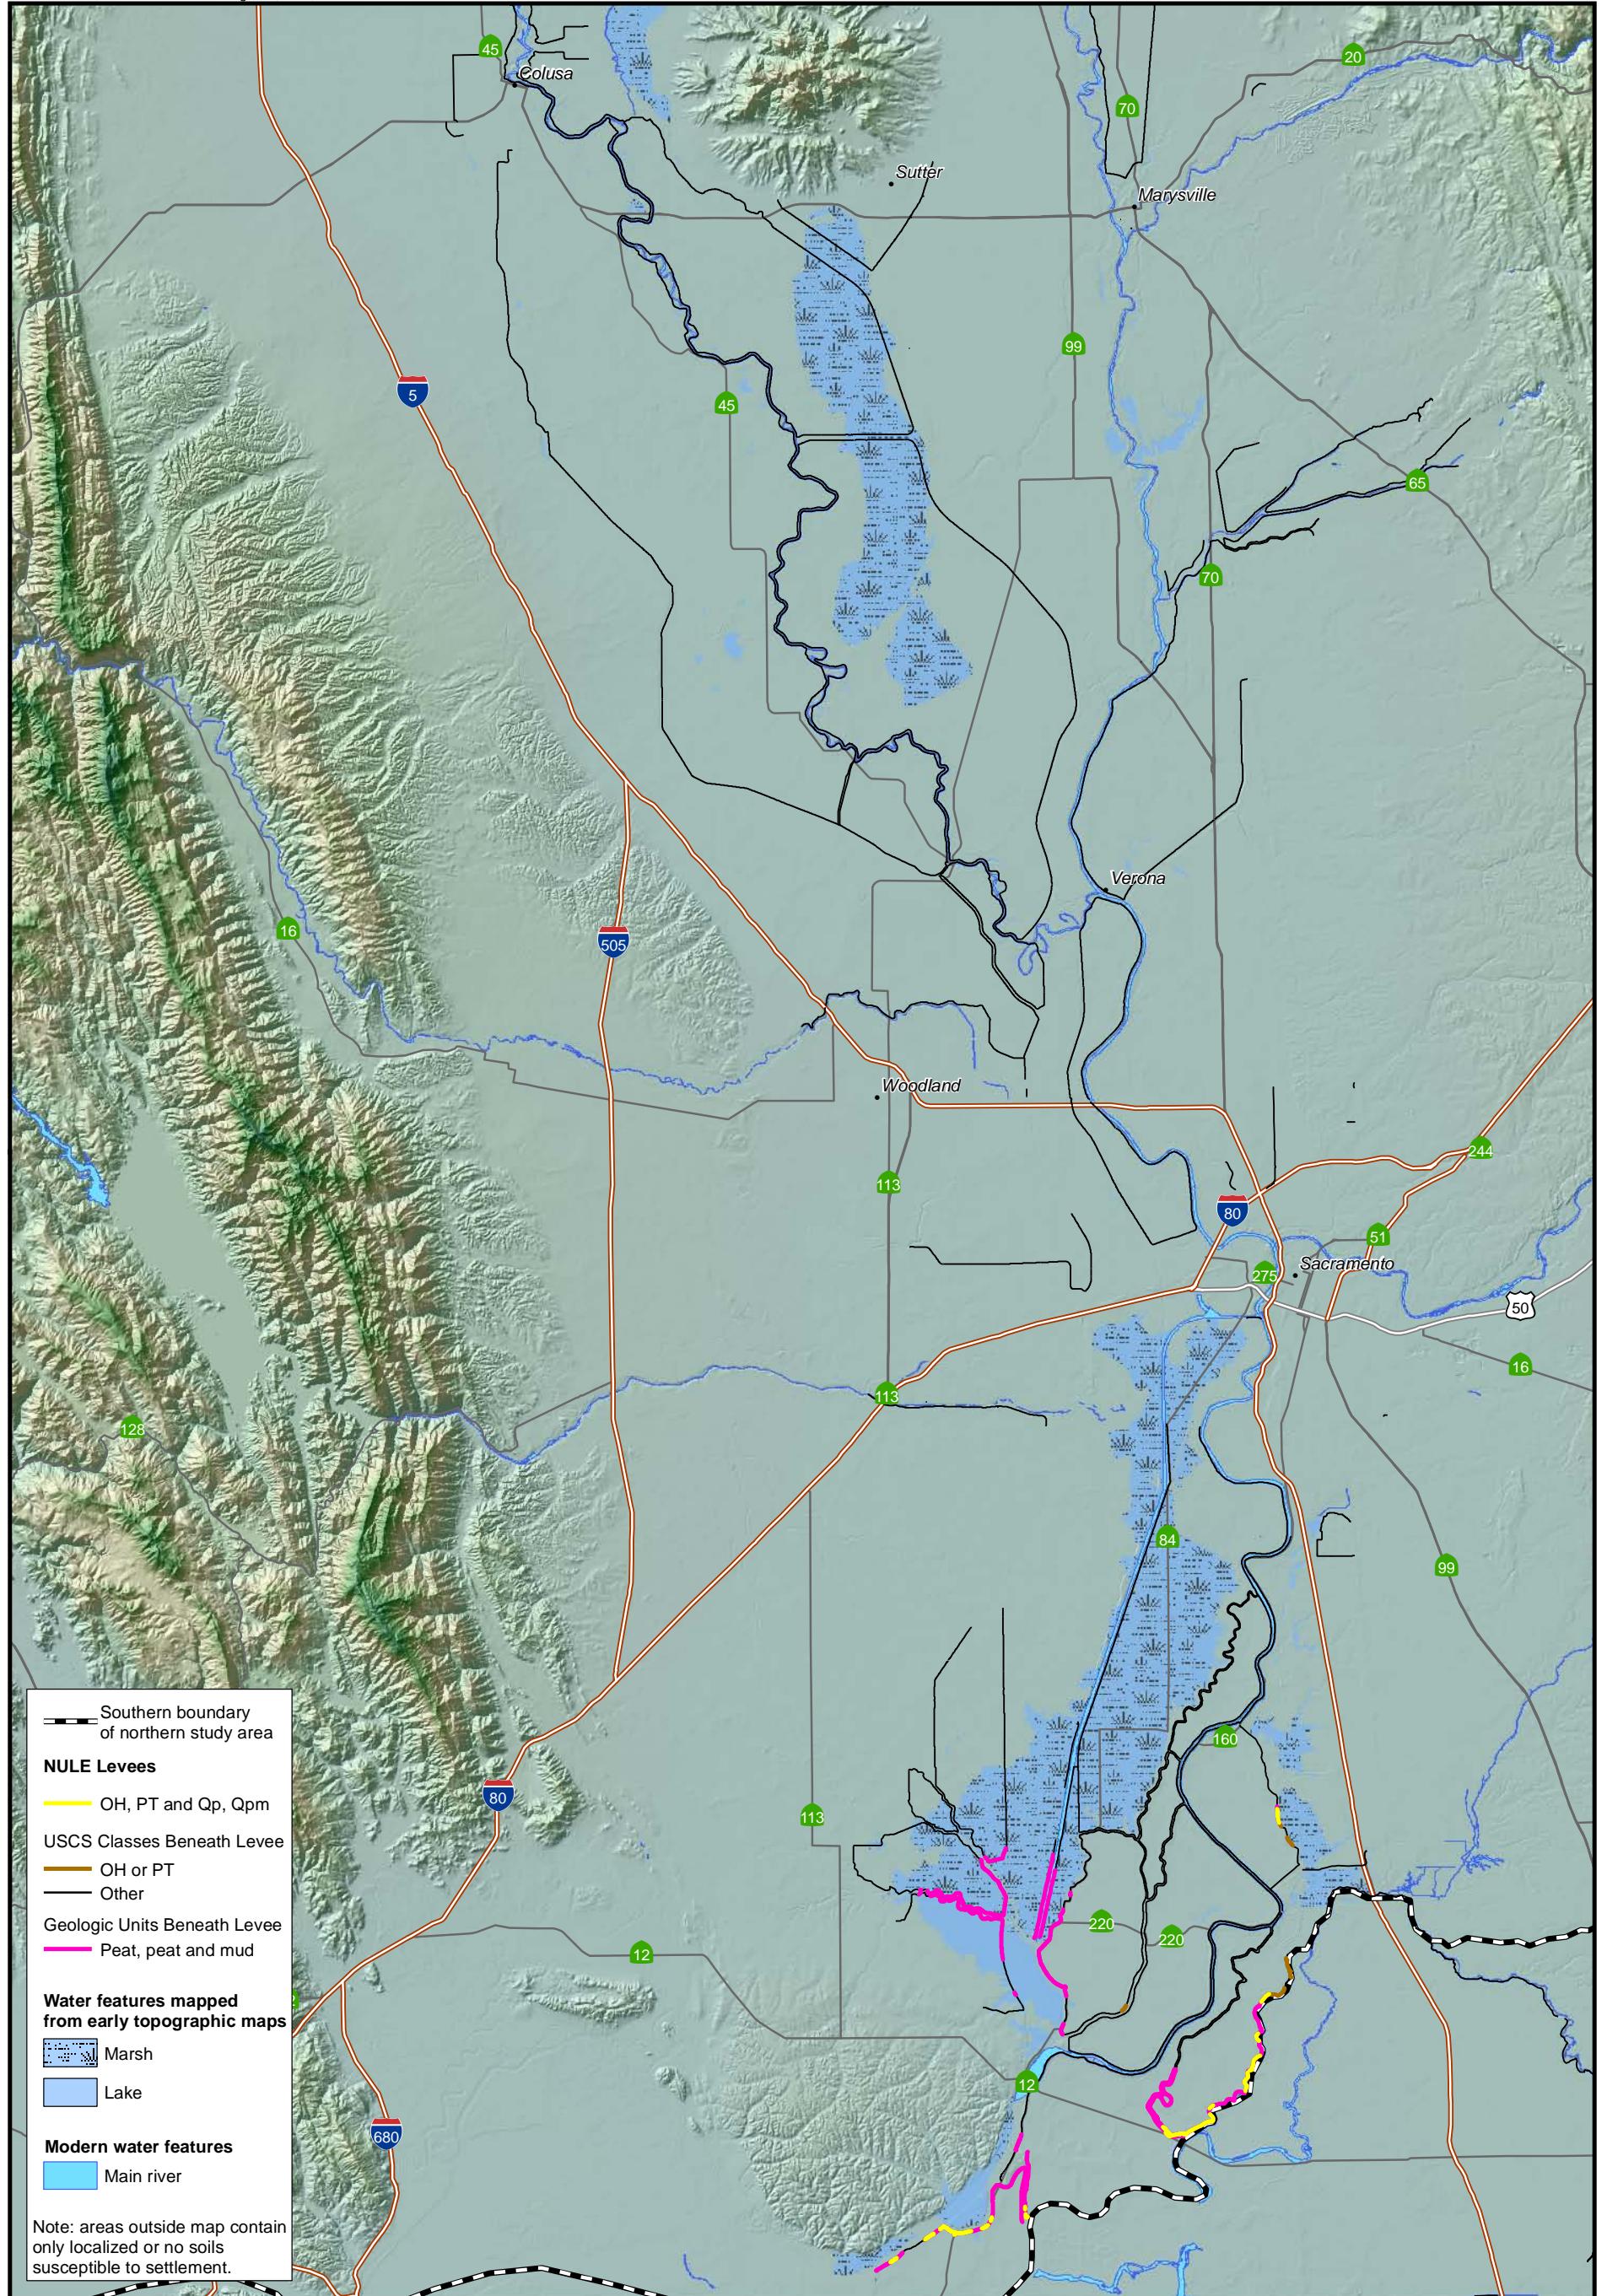
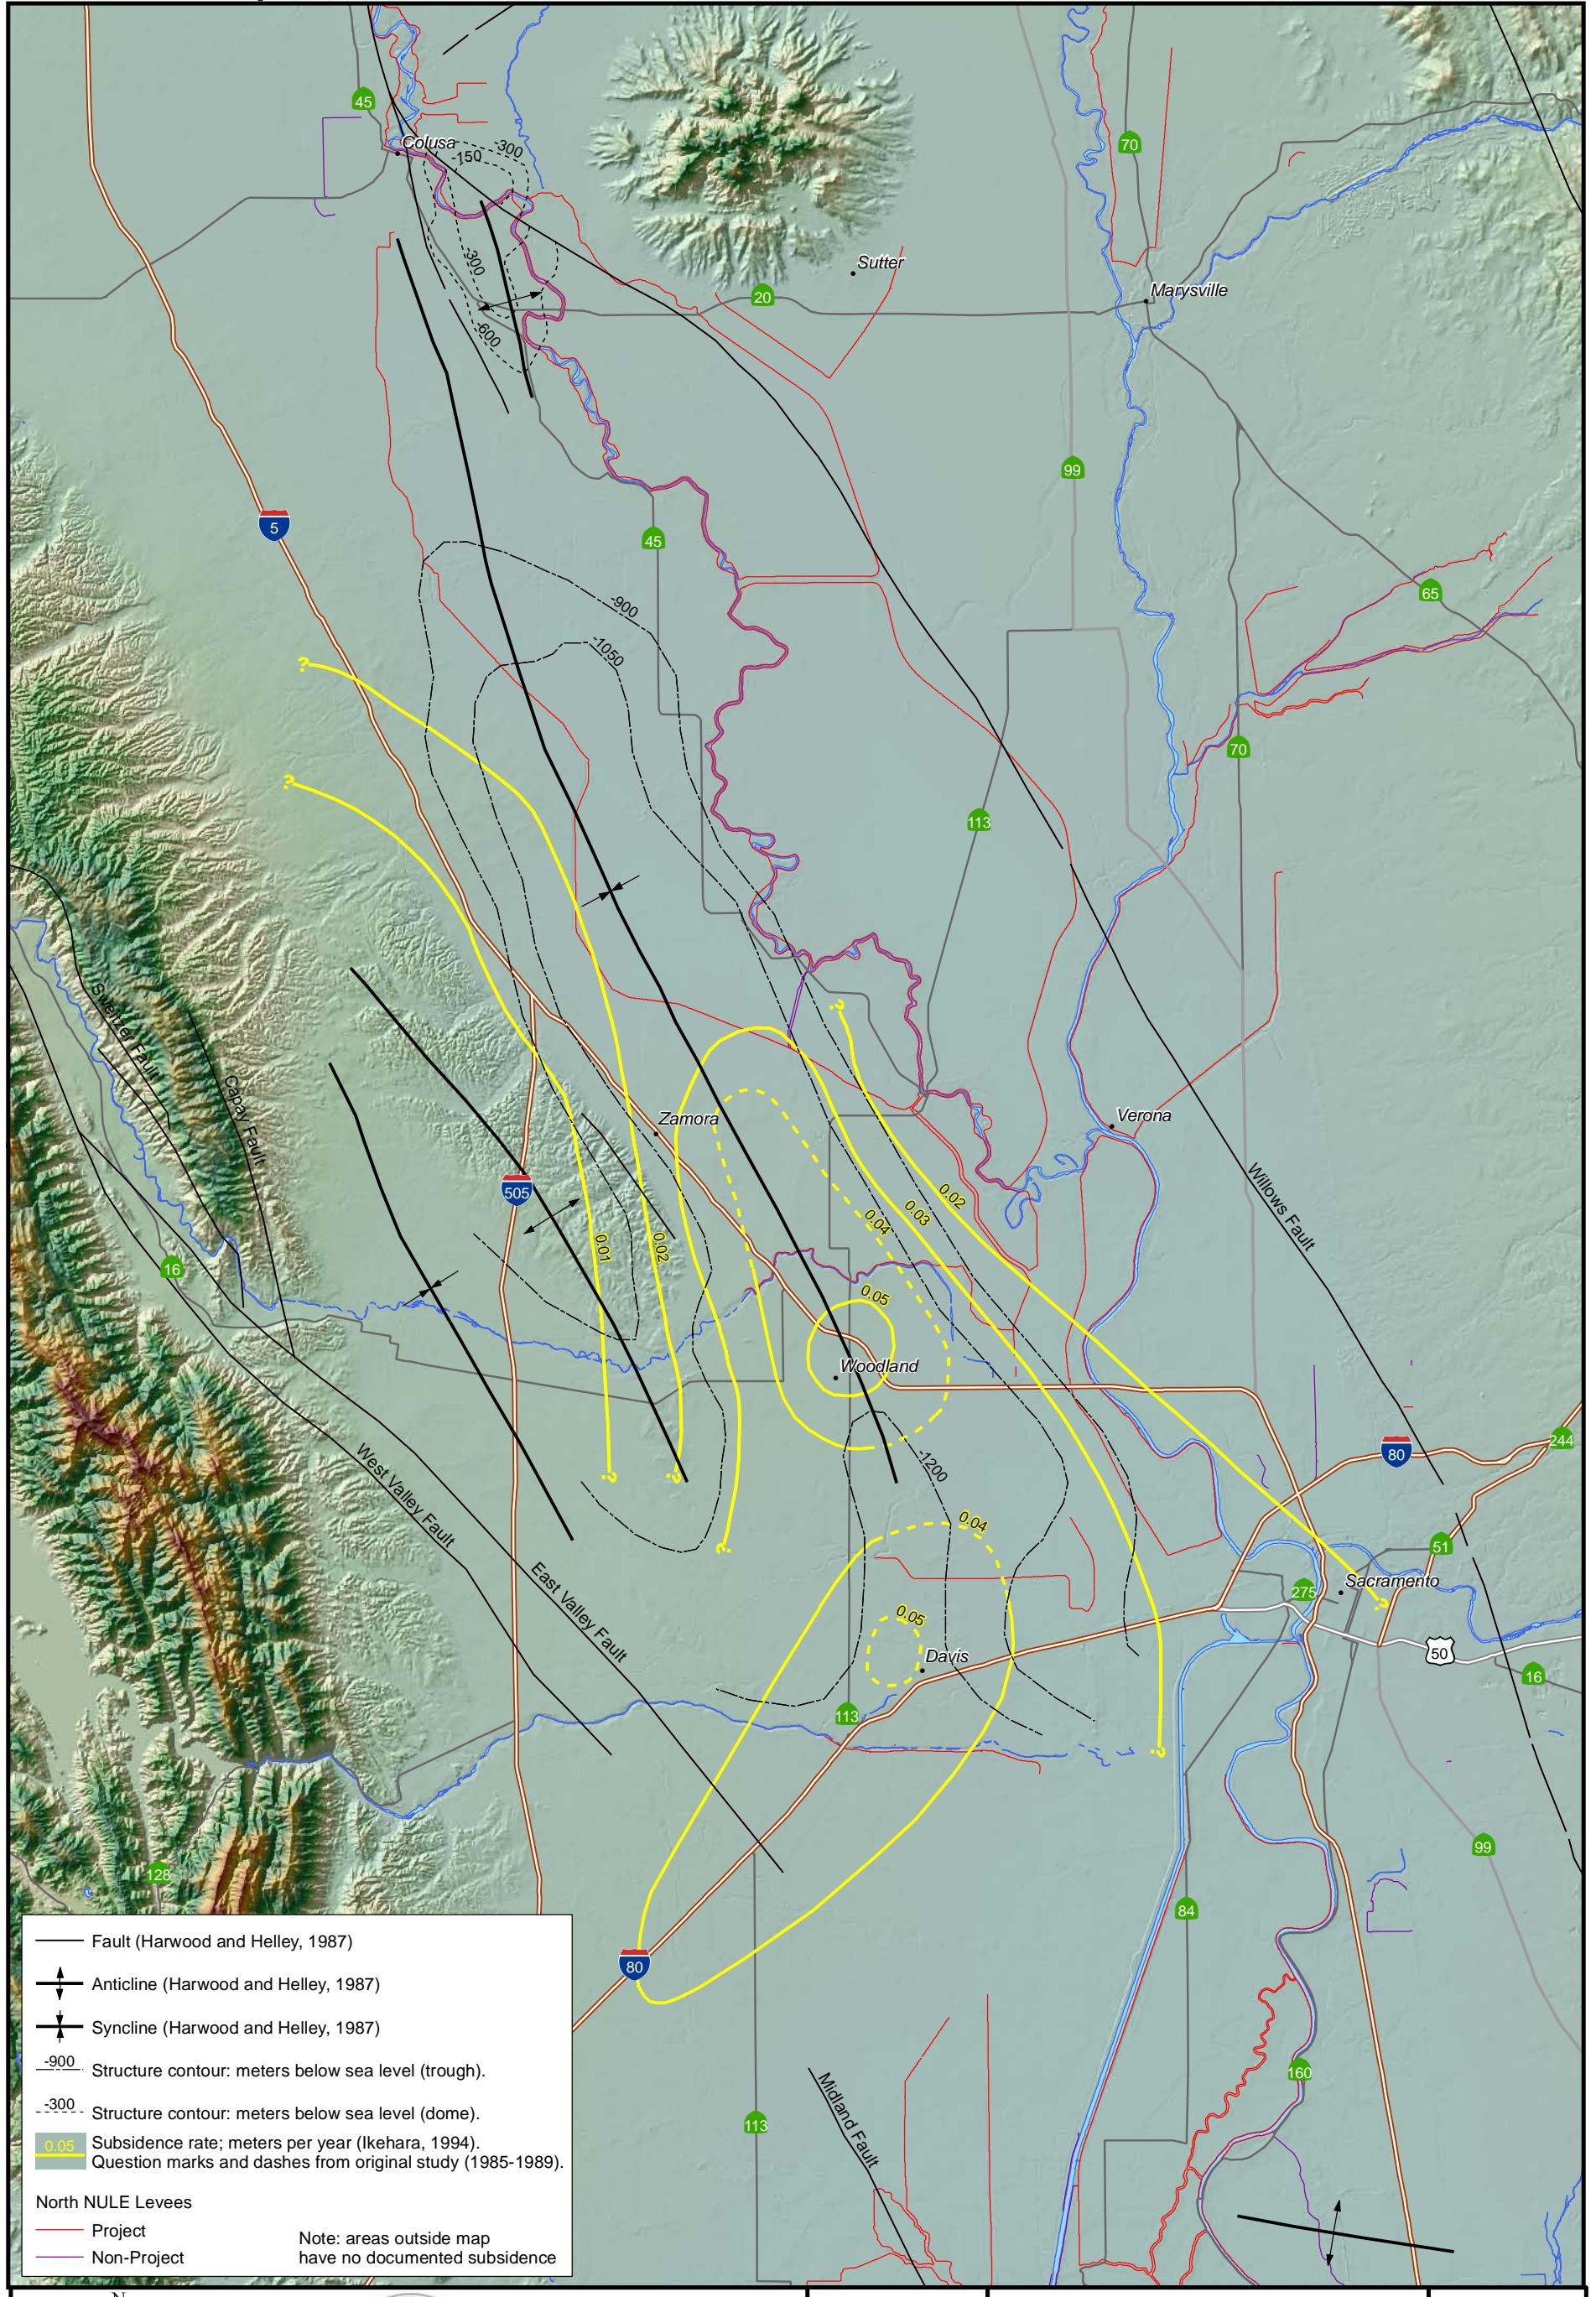
The Level 2-I analysis provides a regional assessment of potential soft soil levee foundations based on available data (Figures 37a and 37b). For this analysis, areas of marshes, former marshes and water bodies, organic (soft) soils, and peat deposits are mapped, and it is inferred that these areas are more likely to contribute to levee instability (e.g., circular failure planes beneath levees) compared to other North NULE foundations. Marshes, former marshes and water bodies are identified by mapping from early topographic maps. Organic-rich soft soils are identified from NRCS soil maps. Peat deposits are identified from geologic maps of Helle and Harwood (1985) and Atwater (1982).

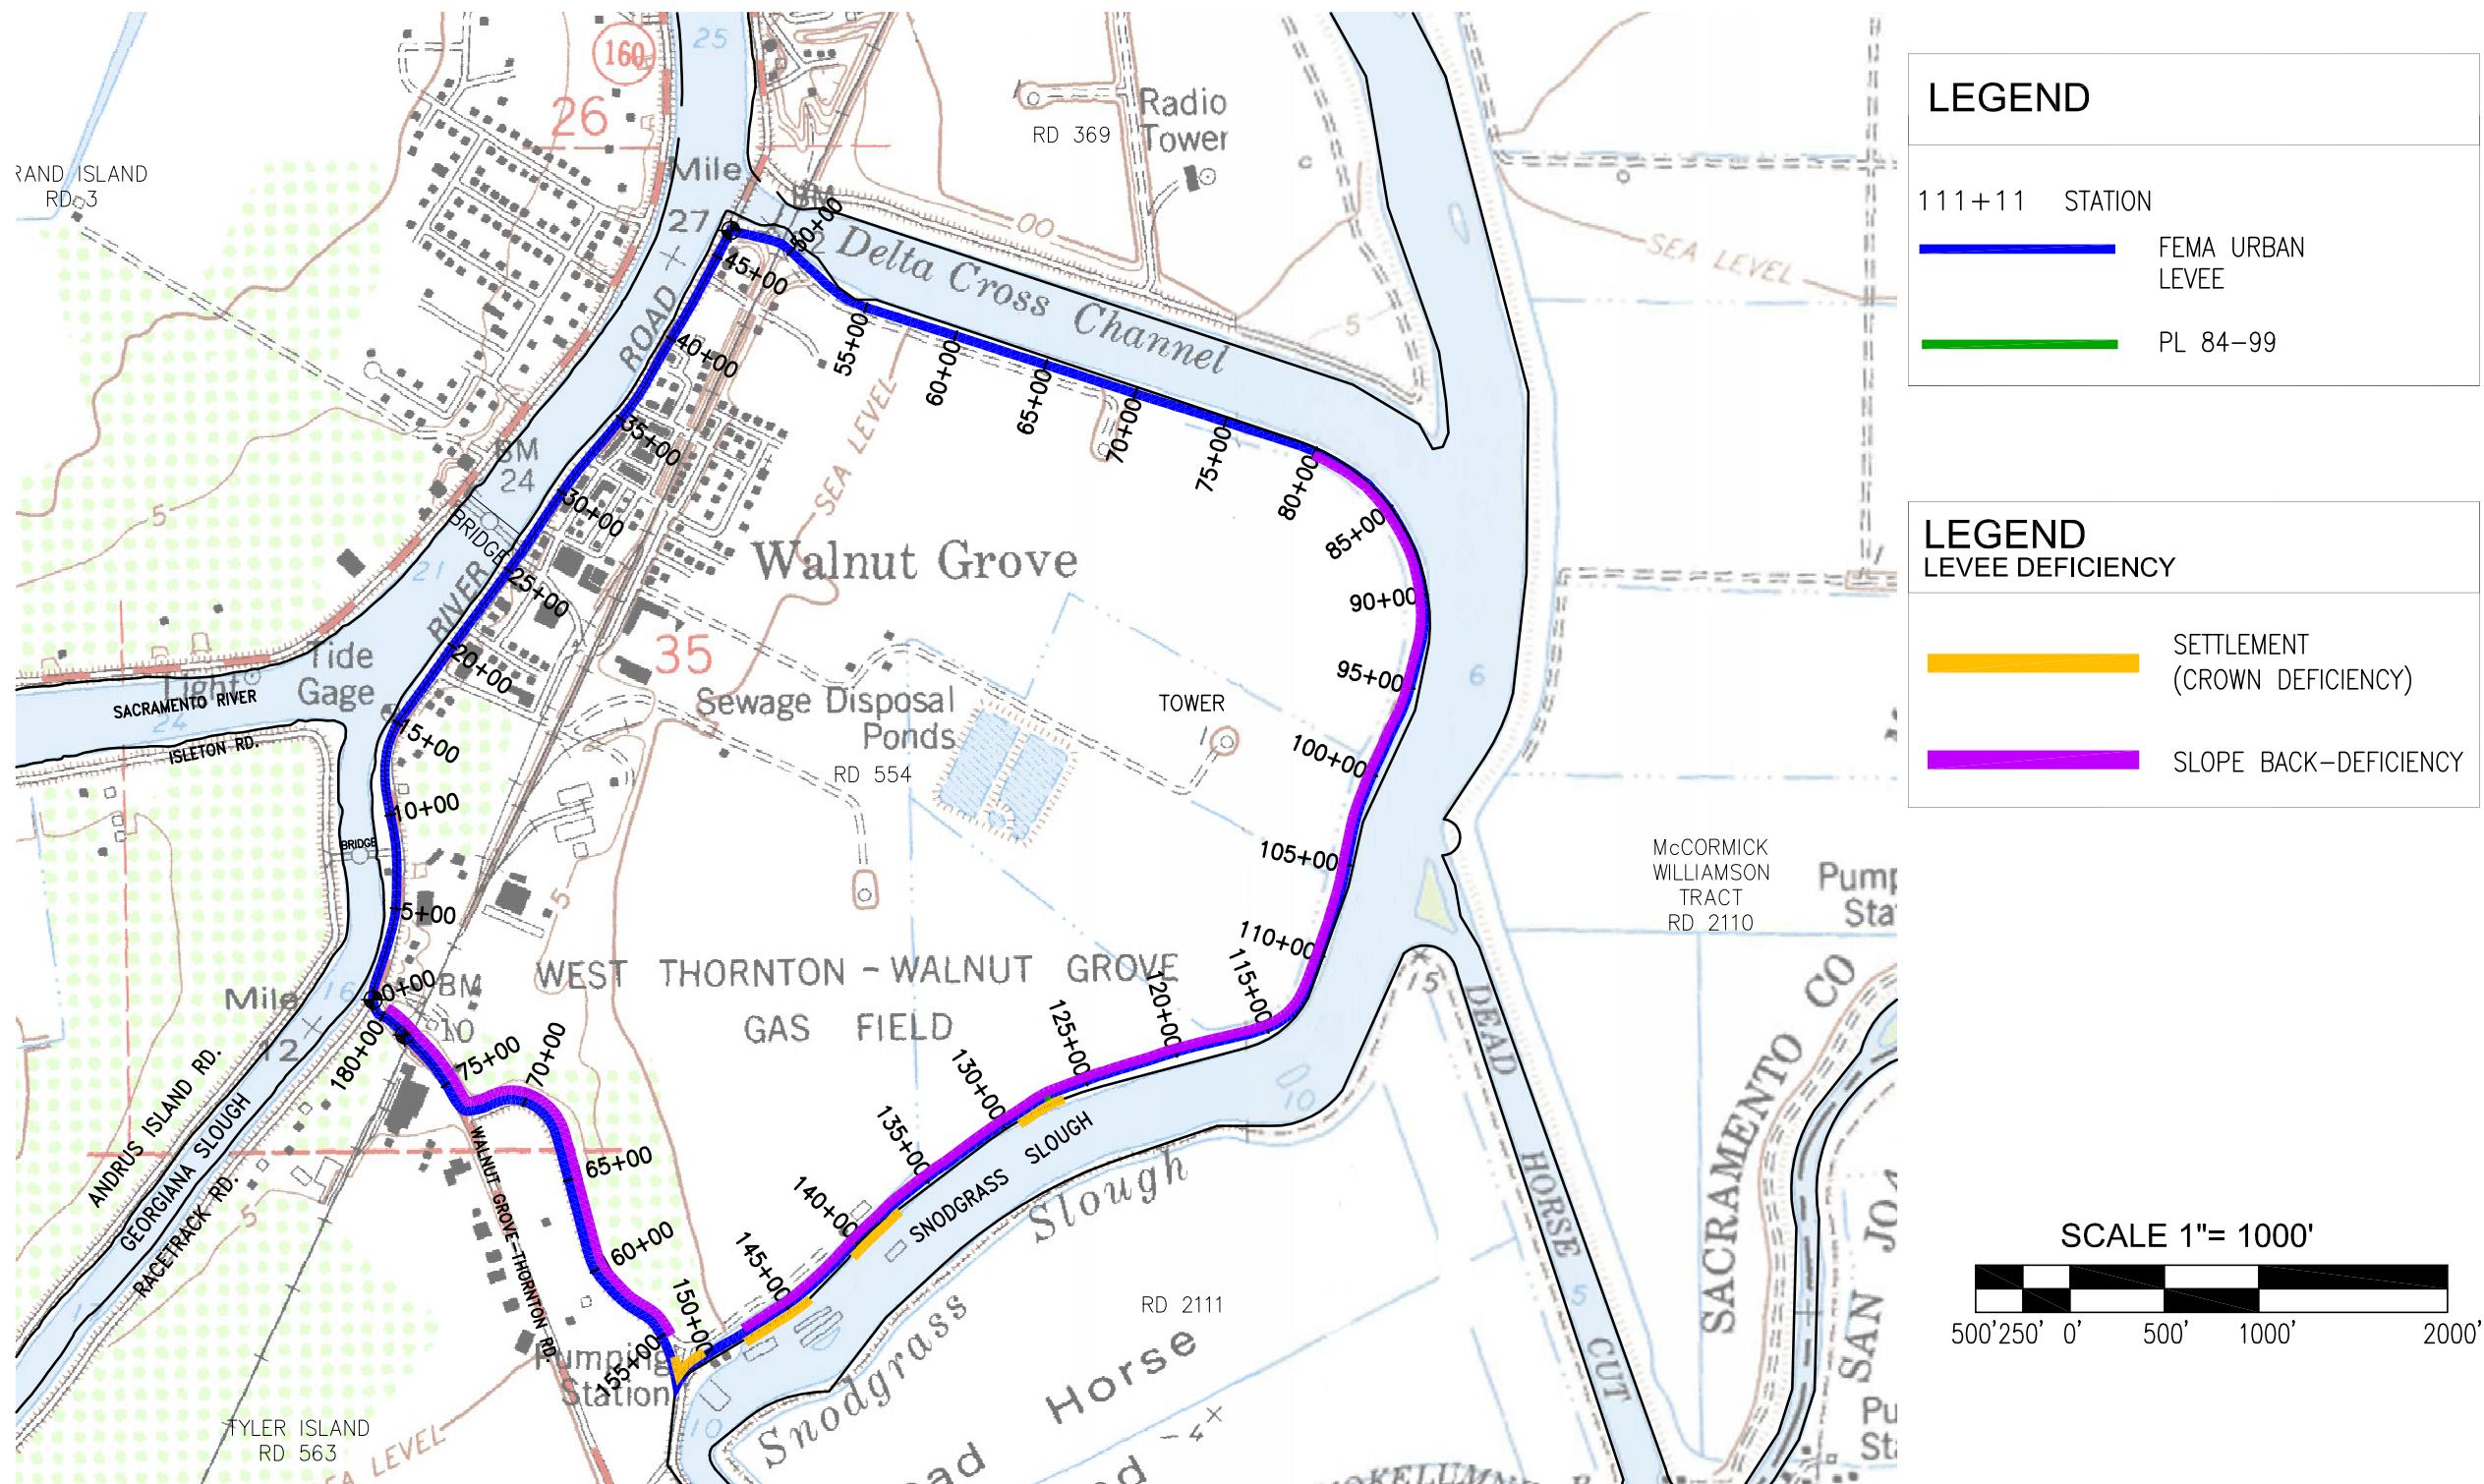
# RECLAMATION DISTRICT 554 LEVEE ASSESSMENT

In general, comparing the most recent profile survey with one performed by DWR in 1999, indicated no signs of levee settlement.

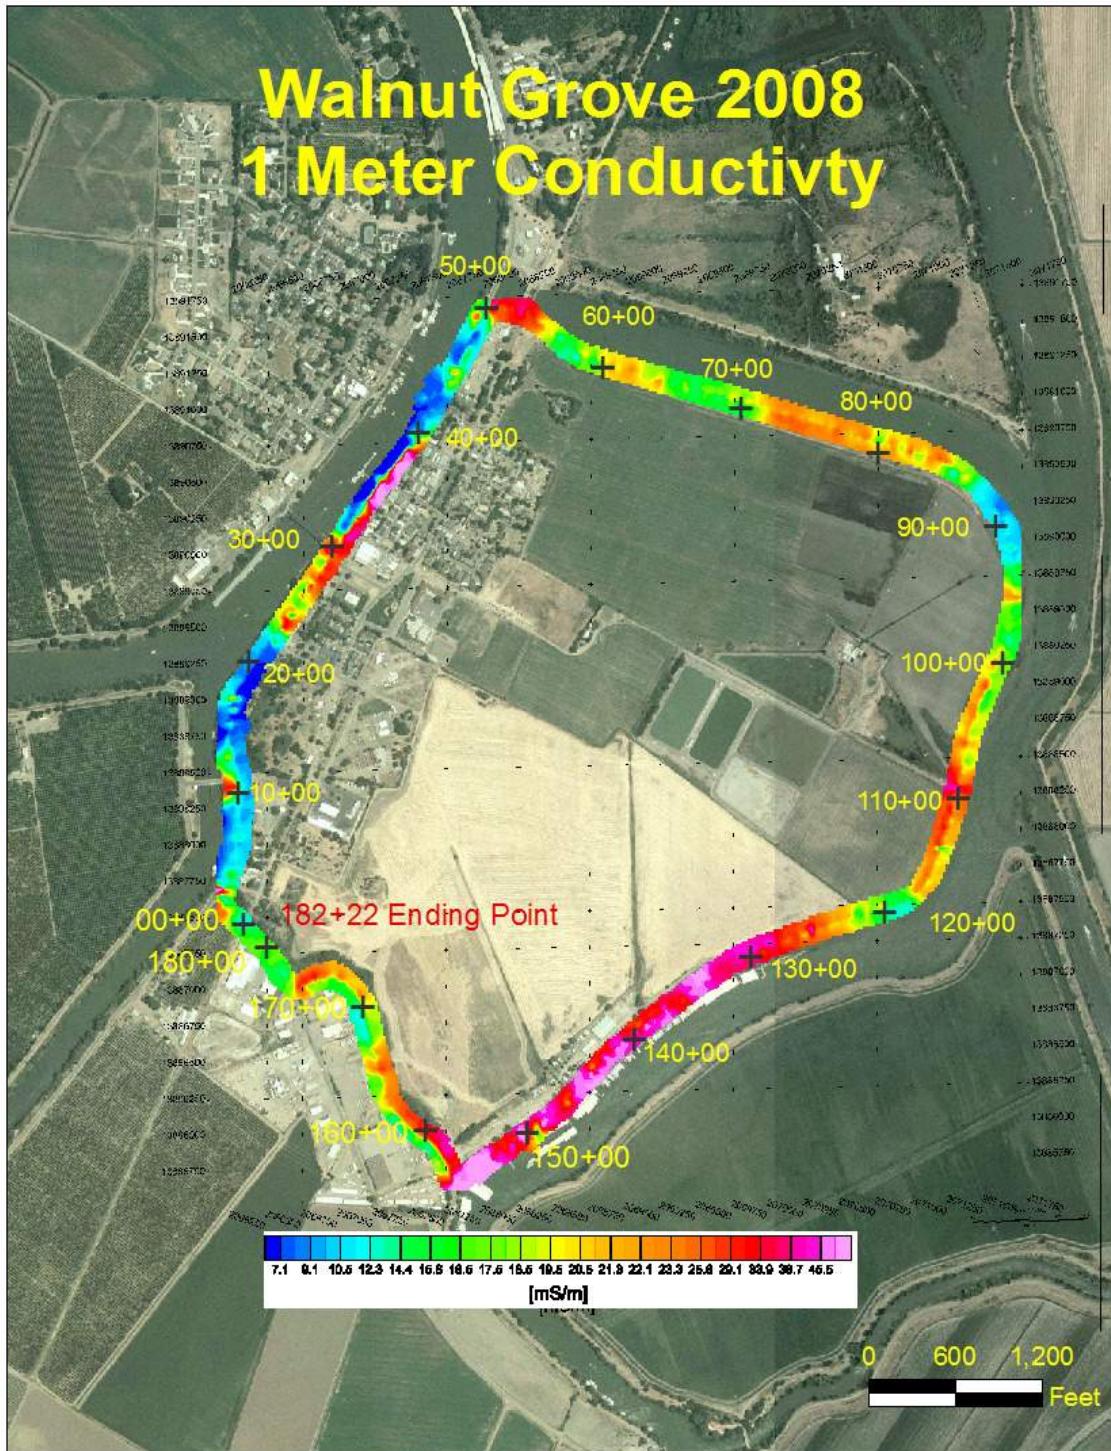
## Walnut Grove 1 Meter Conductivity

still present. The effect of these parked vehicles is obvious on the conductivity profiles. There were several unknown signal observed. Because of the number of parked vehicles it is very difficult to determine if the signals are vehicles or actually pipes. The whole area on the west side needs to be checked in the phase two portion of the study.

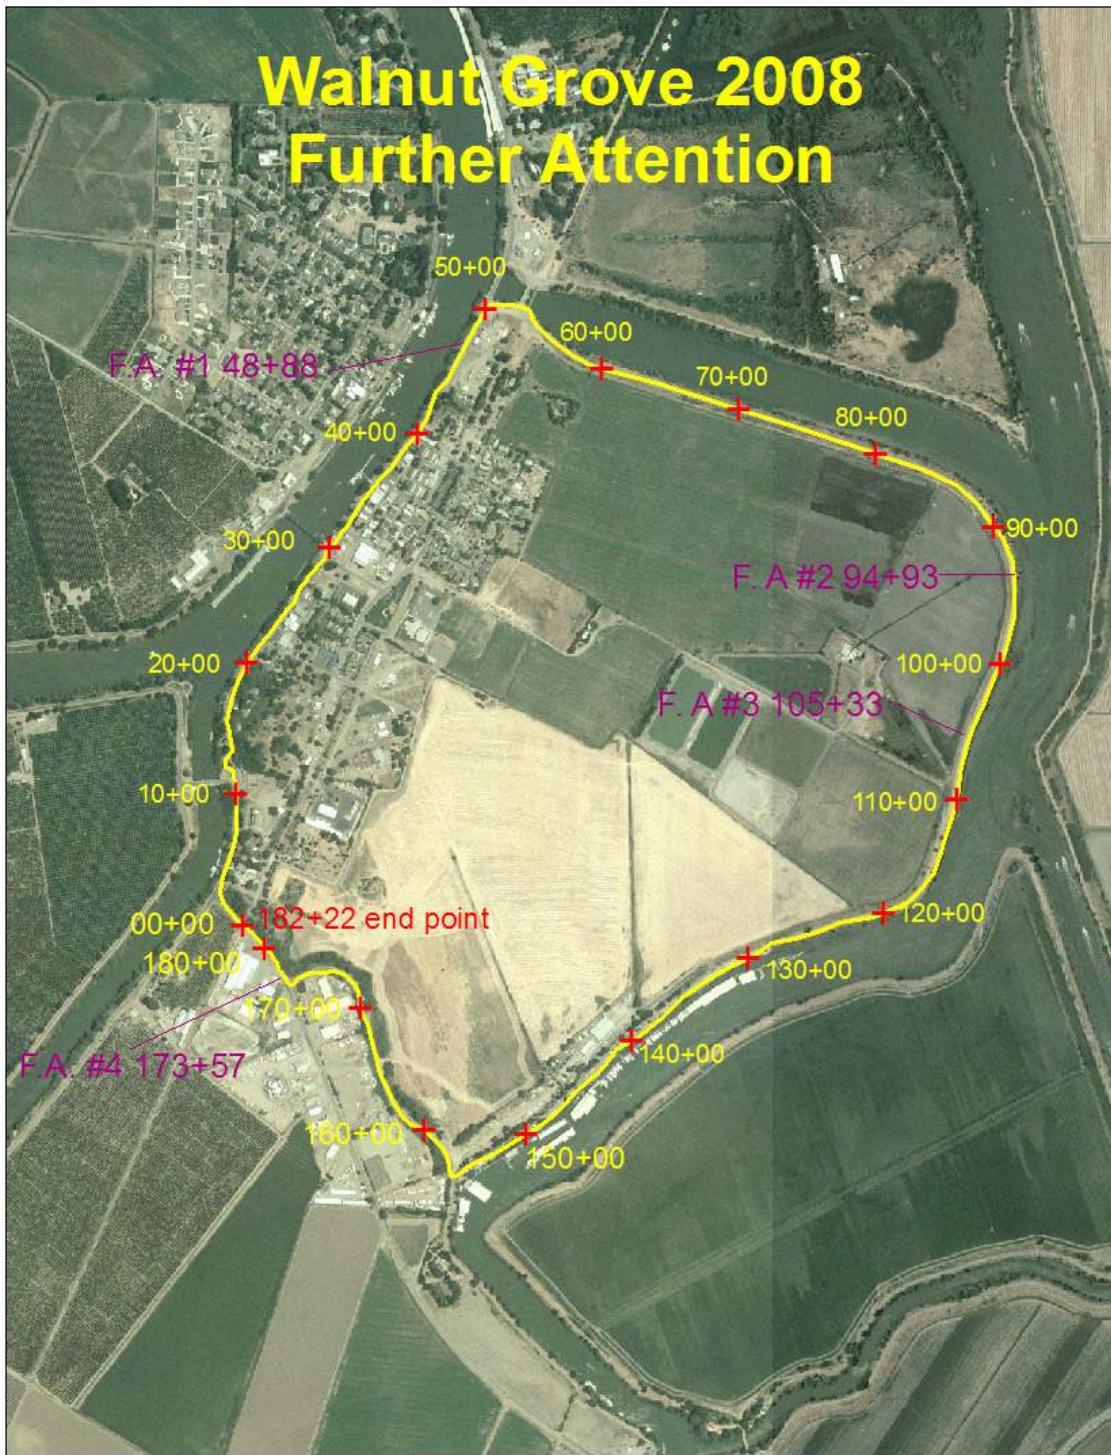
## Walnut Grove Further Attention Maps

2nd Name	Em Station	Station	Event	Event #	Latitude	Longitude	Discussion	Possible Depth (feet)
Walnut Grove	5983	0048+88	Further Attention	1	3814.78199013,N	12130.62287793,W		
Walnut Grove	10426	0094+93	Further Attention	2	3814.42440987,N	12129.86833409,W		
Walnut Grove	11550	0105+33	Further Attention	3	3814.26104362,N	12129.94440022,W		
Walnut Grove	18729	0173+57	Further Attention	4	3814.02223867,N	12130.89733954,W

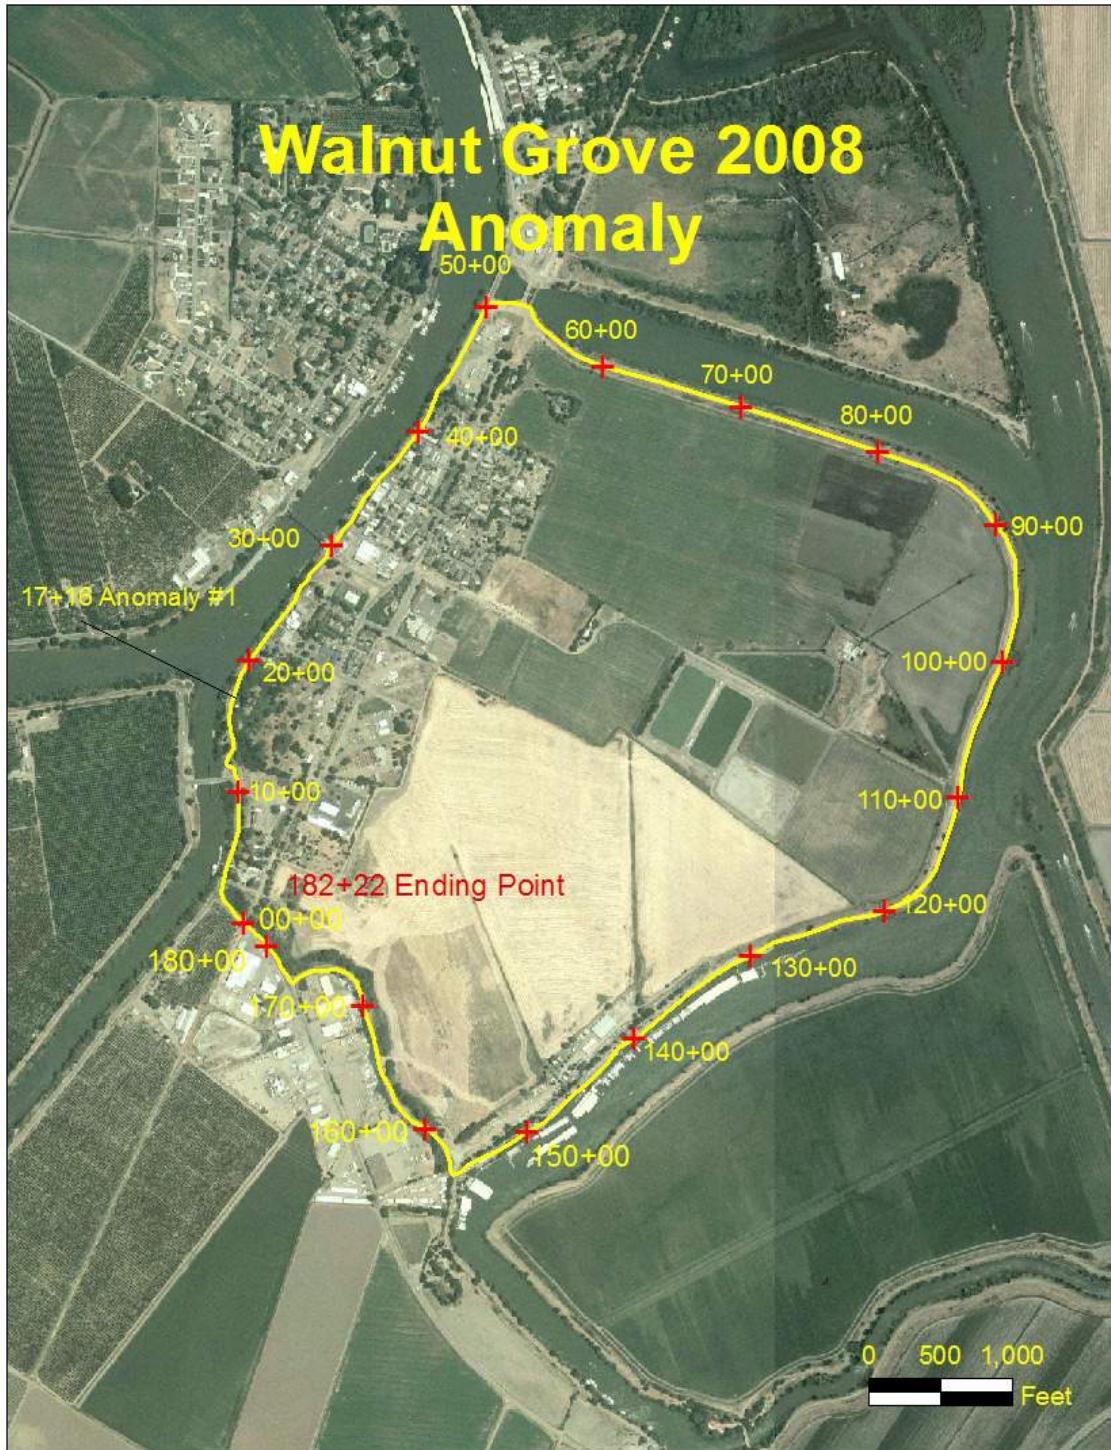
## Walnut Grove Anomaly Map

1 total

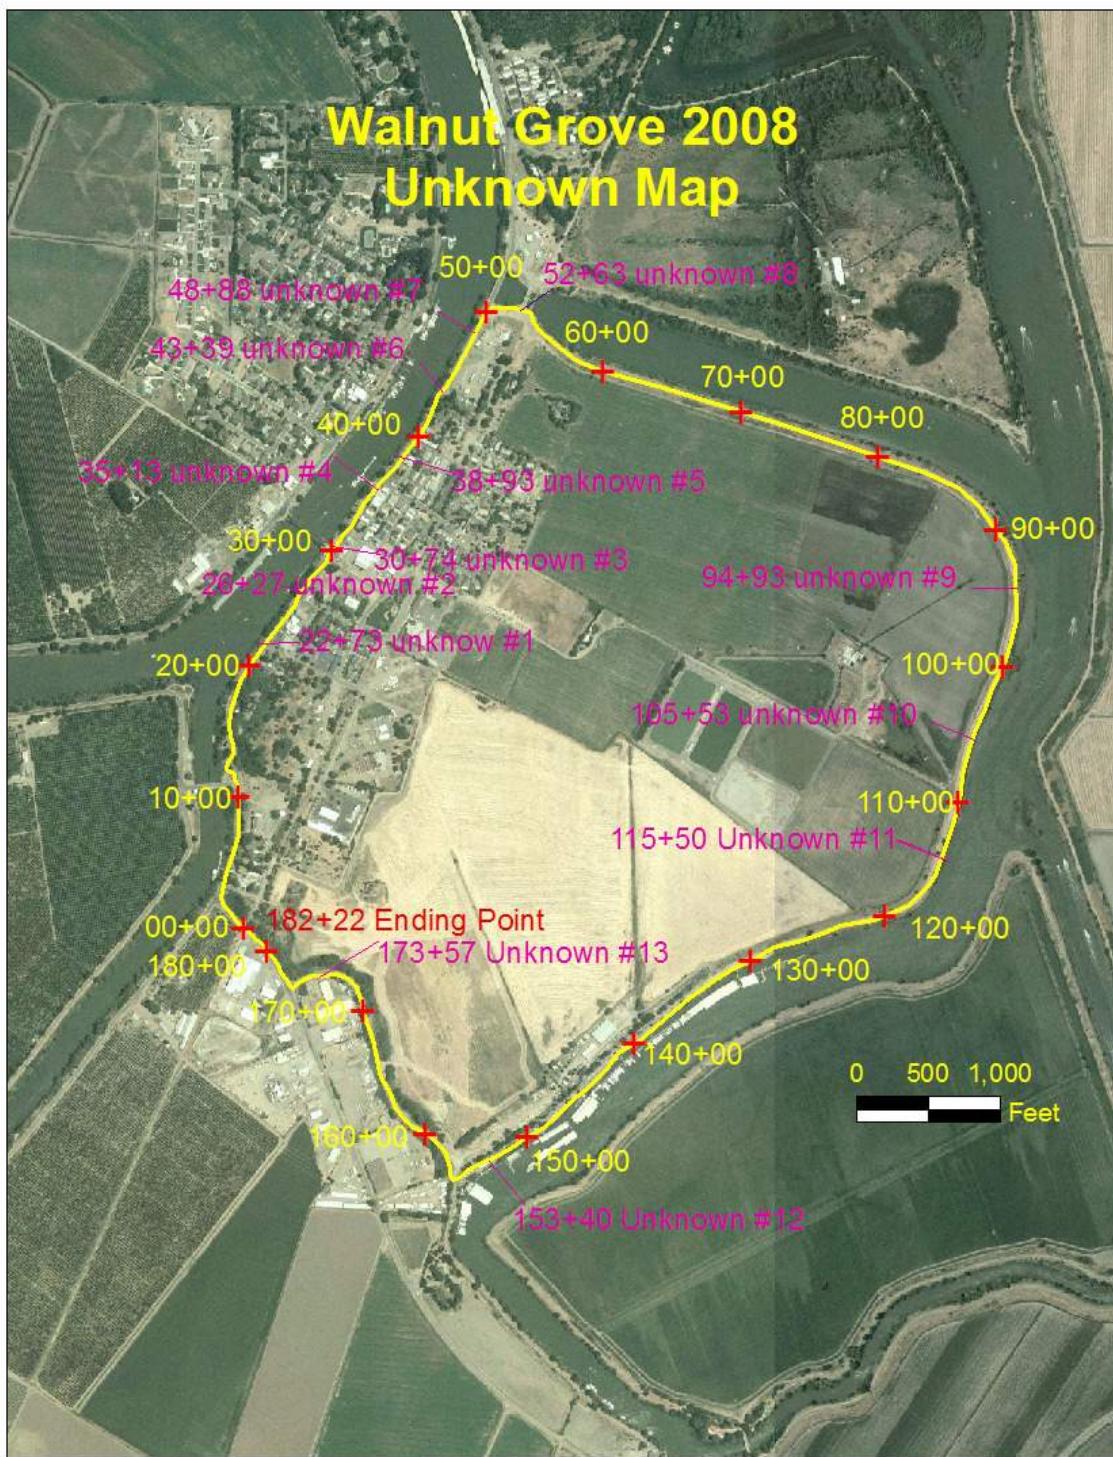
## Walnut Grove Unknown Map

2nd Name	Station	Em Station	Event	Event #	Latitude	Longitude	Discussion	Possible Depth (feet)
Walnut Grove	0022+73	2976	Unknown	1	3814.42051546,N	12130.94064901,W	difficult to id, in front 14205 address	
Walnut Grove	0026+27	3359	Unknown	2	3814.46833483,N	12130.89570060,W	difficult to id, post office door	
Walnut Grove	0030+74	3770	Unknown	3	3814.52679818,N	12130.84237904,W	center line of Bridge Road	
Walnut	0035+13	4175	Unknown	4	3814.58107352,N	12130.79334051,W	centerline of C street

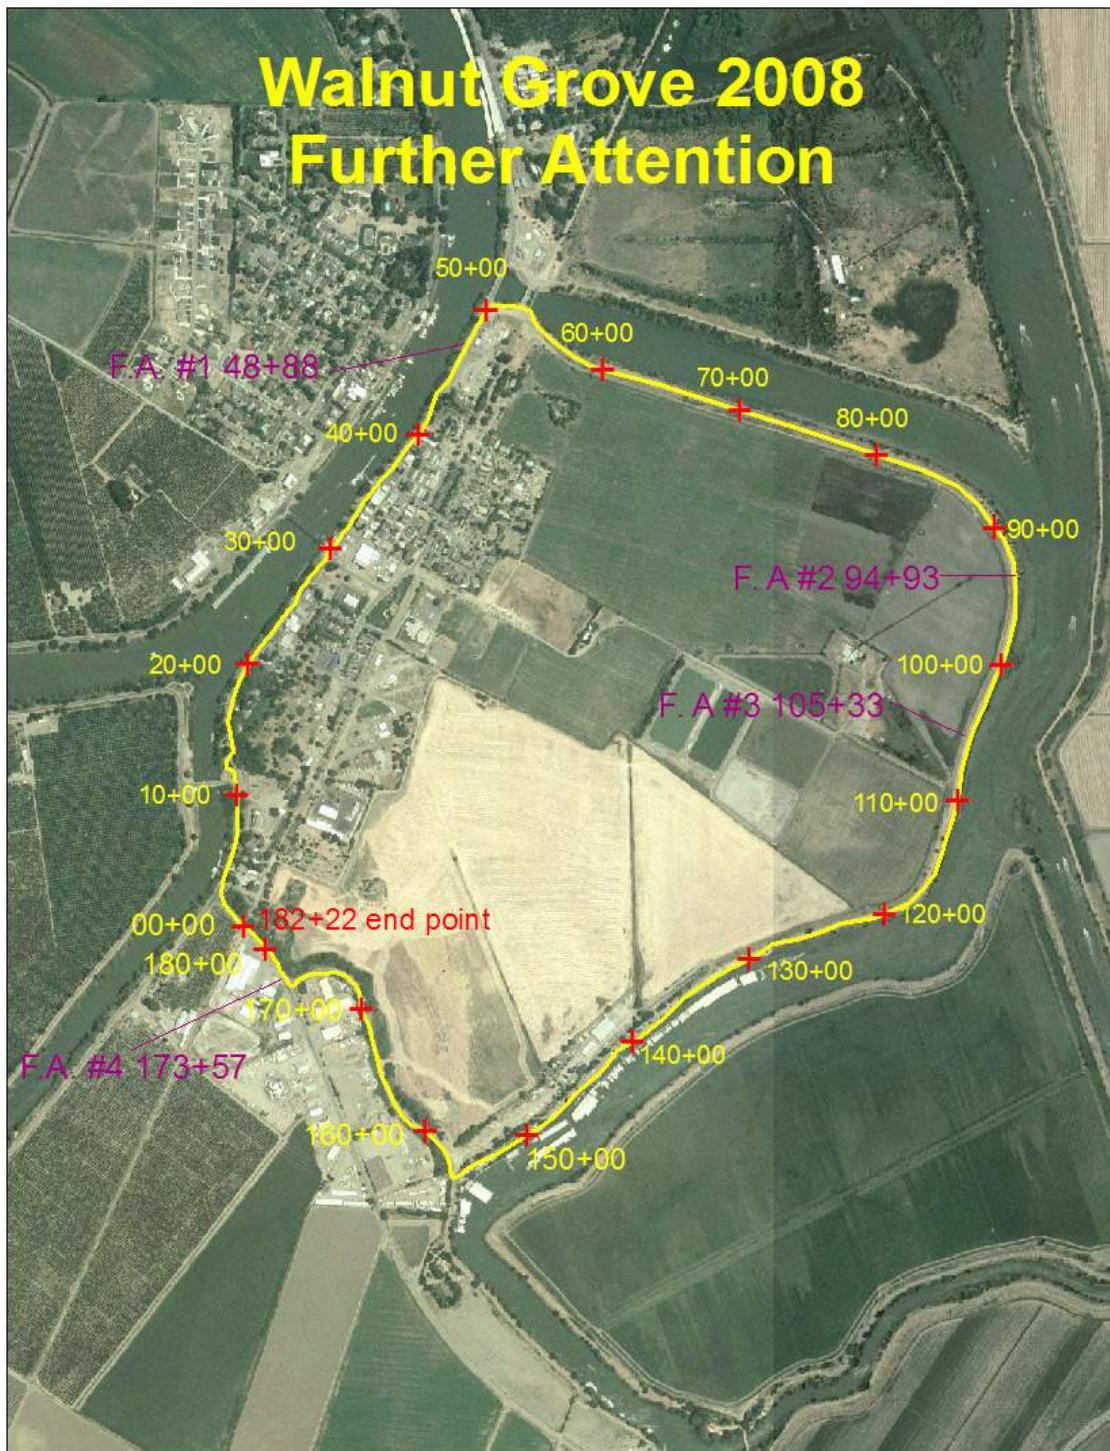
## Walnut Grove Further Attention Map

4 locations identified as Areas for Further Attention (phase 2 studies).

At the present time there are 4 areas that where it is felt a phase two study should be utilized. A phase two study would involve a short traverse with either the Em 31 and or the En 31-3 (when feasible) at different locations on the water and land side slopes, possibly followed by some borings. Before excavation truthing, **true** three dimensional modeling would yield very useful information at these sites. Finally, the use excavation or other truthing procedures would also be useful and aid in the eventual actual repair.
