Delta Annex Chapter 4 Reclamation District 341

4.1 Introduction

This chapter of the Delta Annex details the hazard mitigation planning elements specific to the Reclamation District 341 (RD 341), a previously participating jurisdiction to the Sacramento County Local Hazard Mitigation Plan (LHMP) Update. This chapter of the Delta Annex is not intended to be a standalone document, but appends to and supplements the information contained in the Base Plan document. As such, all sections of the Base Plan, including the planning process and other procedural requirements apply to and were met by the RD 341. This chapter of the Delta Annex provides additional information specific to RD 341, with a focus on providing additional details on the planning process, risk assessment, and mitigation strategy for this District.

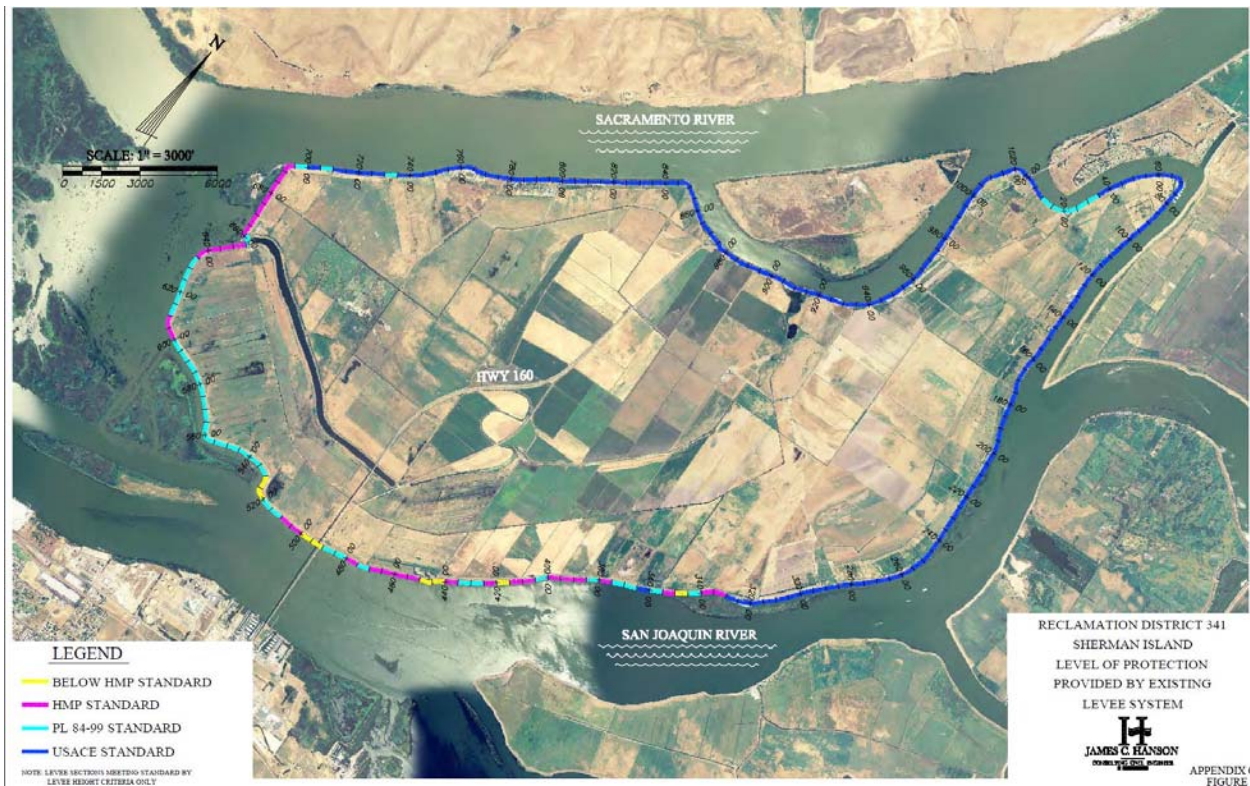
Figure 4-2 Level of Levee Flood Protection in Reclamation District 341

Areas of the existing levee system most susceptible to overtopping are those which do not meet the PL 84-99 height standard. An inventory of levee sections and their respective heights is maintained by the District. Analysis of this inventory shows that the levee along the San Joaquin River from about levee station 330+00 to 450+00, the Sacramento River from about 720+00 to 750+00 and Three Mile Slough from about 20+00 to 40+00 contains stretches which are below the PL 84-99 height standard (1.5 feet above 1:100 year flood event) and therefore are susceptible to overtopping. Figure 4-2 depicts levee flood protection levels for each individual section of the Sherman Island levees.
