**10.1 Introduction**

This Annex details the hazard mitigation planning elements specific to Reclamation District 563 (RD 563 or District), a previously participating jurisdiction to the 2016 Sacramento County Local Hazard Mitigation Plan (LHMP) Update. This Annex is not intended to be a standalone document, but appends to and supplements the information contained in the Base Plan document. As such, all sections of the Base Plan, including the planning process and other procedural requirements apply to and were met by the District. This Annex provides additional information specific to RD 563, with a focus on providing additional details on the risk assessment and mitigation strategy for this District.

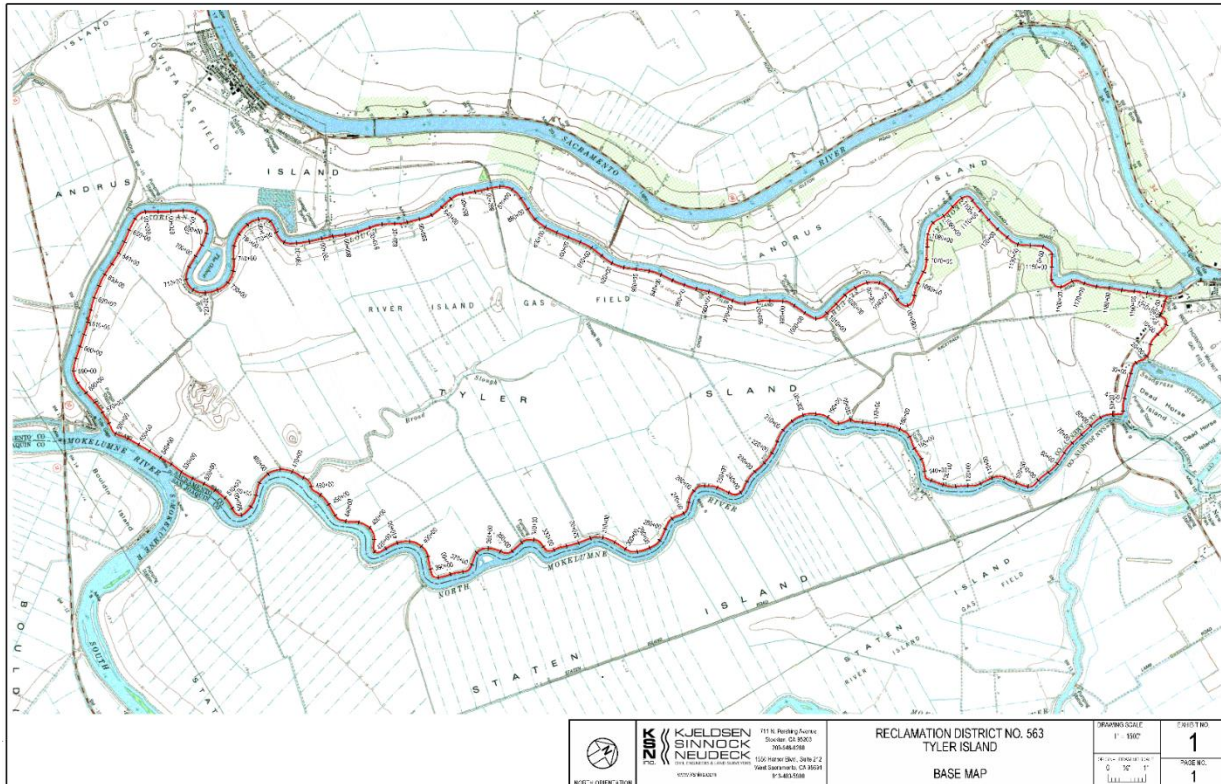
*Figure 10-4 RD 563 – Levee Protected Areas*

failure risk times can be hours to weeks, depending on the river flows that the levee holds back. When northern California dams and reservoirs are nearing maximum capacity, they release water through the river systems, causing additional burdens on County levees. Levees in the District are shown on Figure 10-4.
