Delta Flood Emergency Safety Plan
Sacramento County, California

RD 369

ESTIMATED TIME OF INUNDATION FOR A HYPOTHETICAL LEVEE FAILURE LOCATED AT SACRAMENTO RIVER

Figure D1B

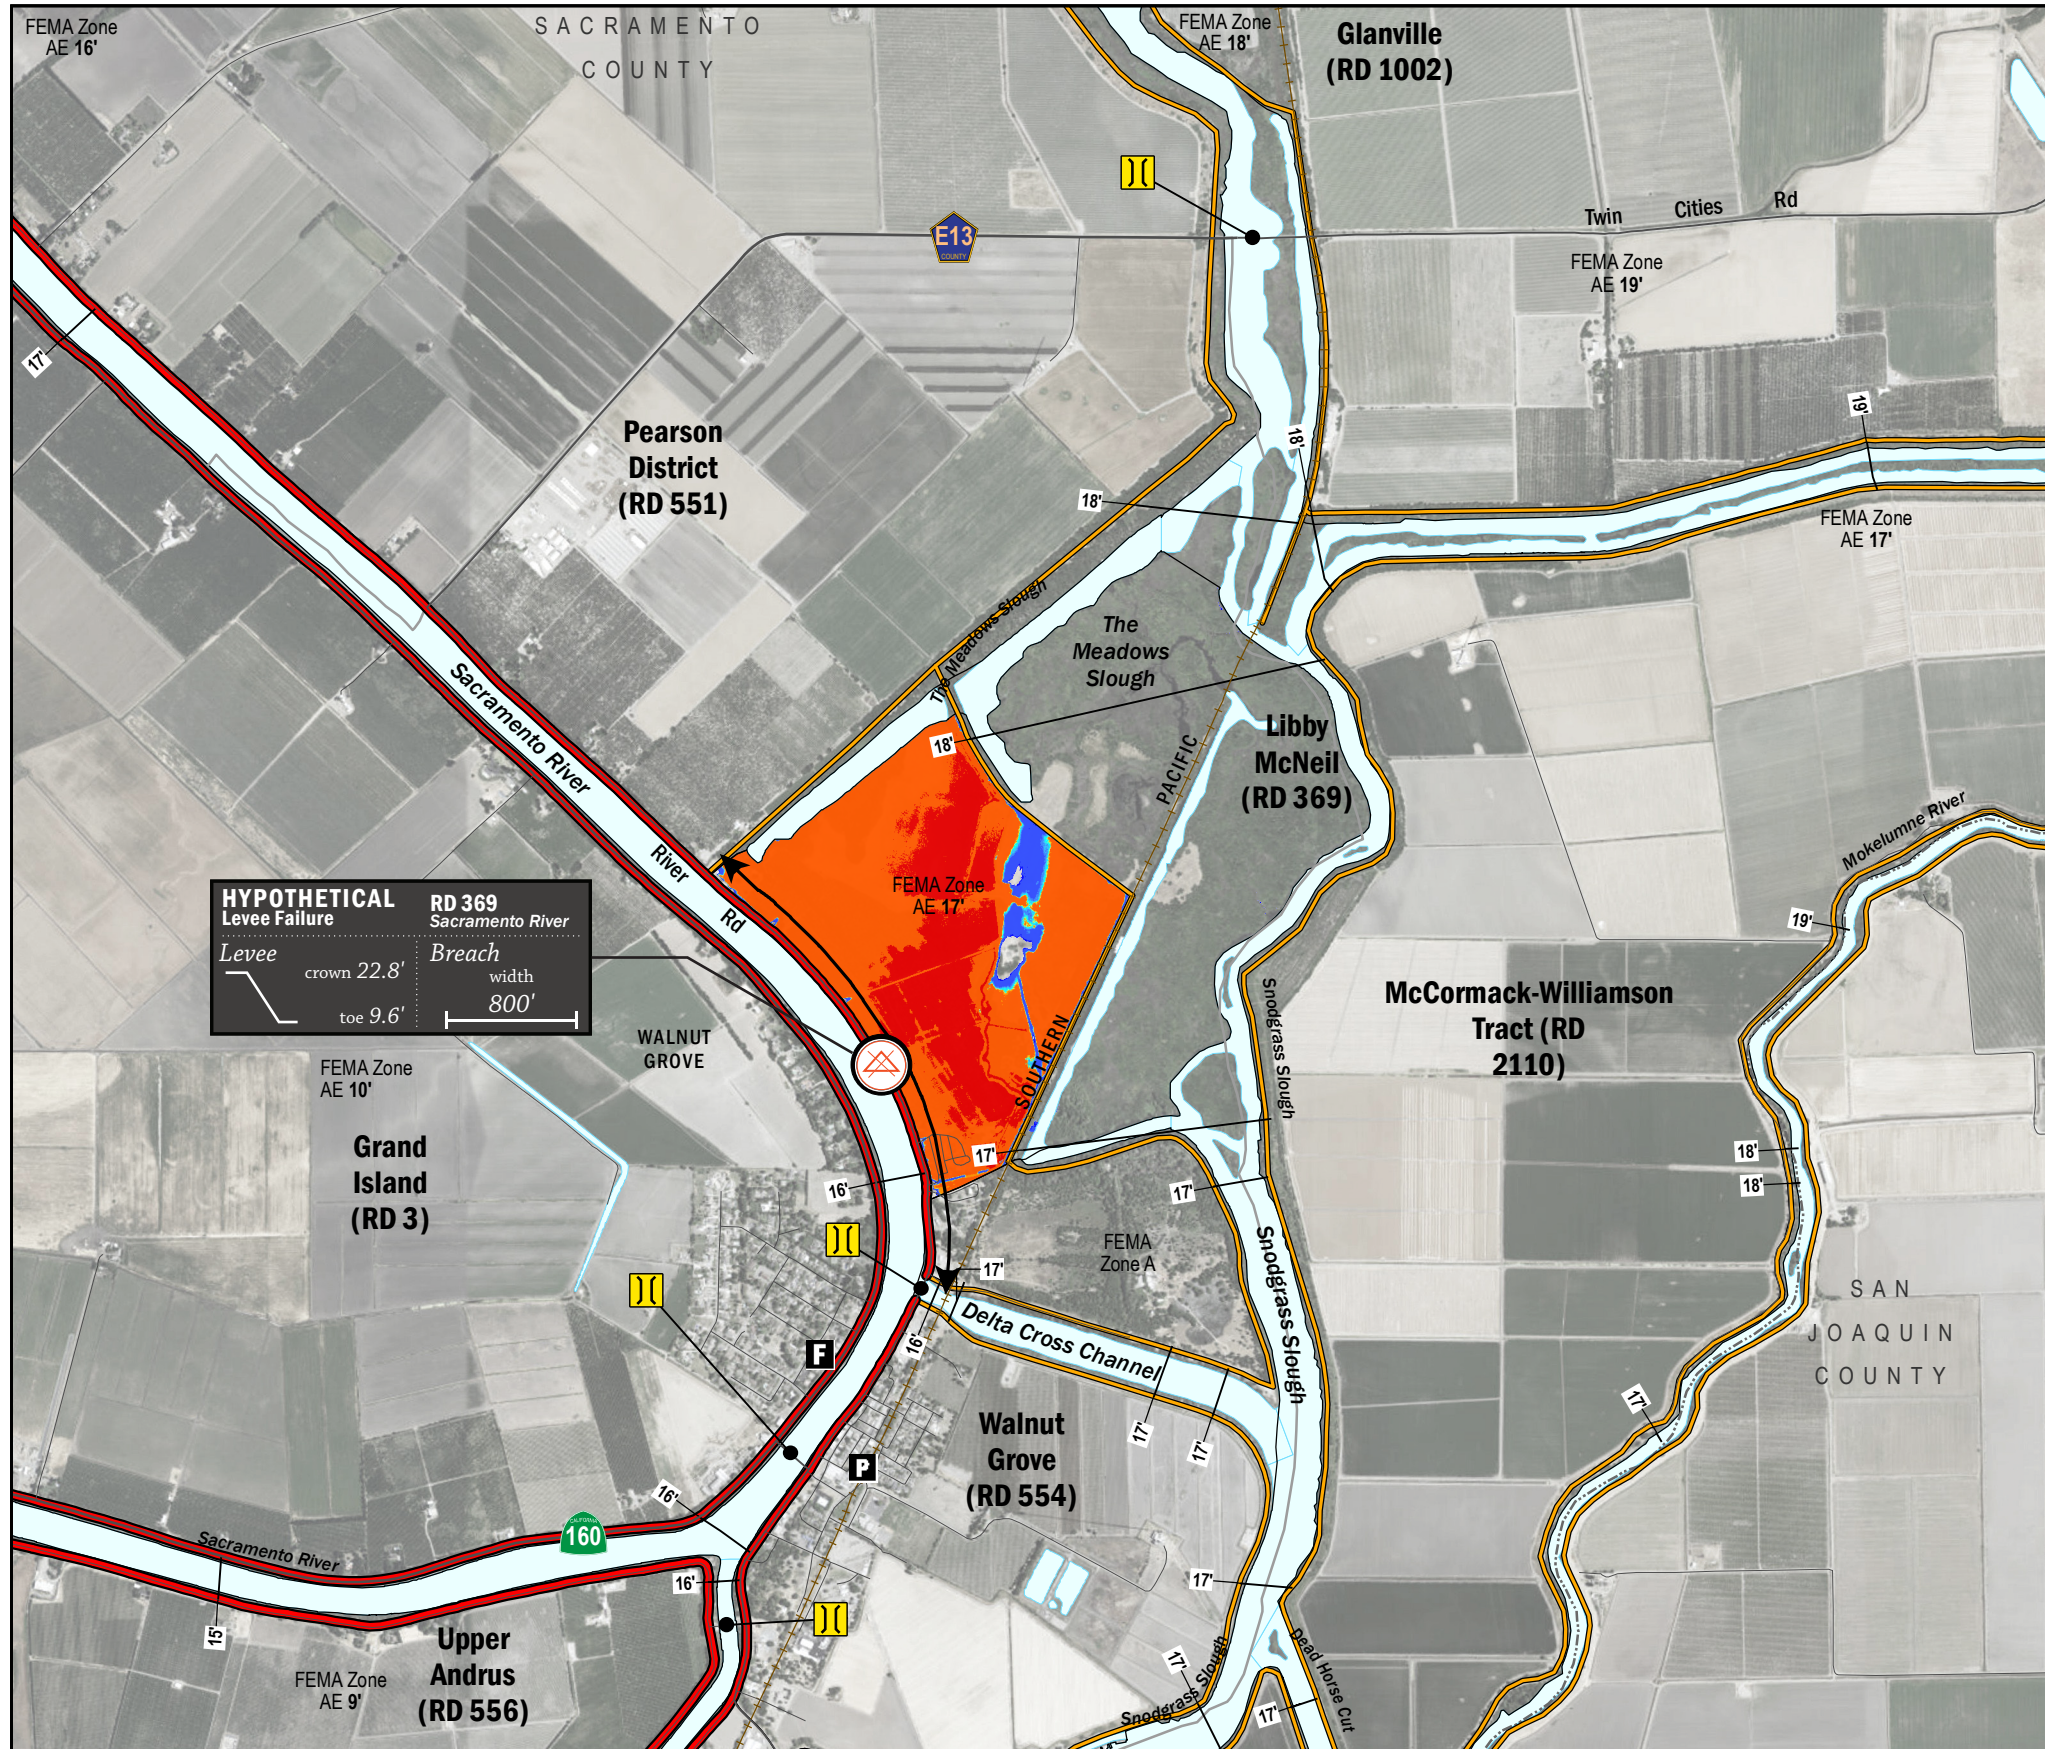
HYPOTHETICAL Levee Failure
 Levee crown 22.8' toe 9.6'
 Breach width 800'
 RD 369 Sacramento River

- The hypothetical levee failure is arbitrary. The time to one-foot of inundation is approximate. Similar results would occur within the vicinity of the levee failure shown on the map.
- Elevations are provided in NAVD88 datum.
- The levee failure opening width was an approximation based on the difference between the maximum water surface elevation and the landside toe times 50.
