# Delta Annex Chapter 13 RD 2111

## 13.1 Introduction

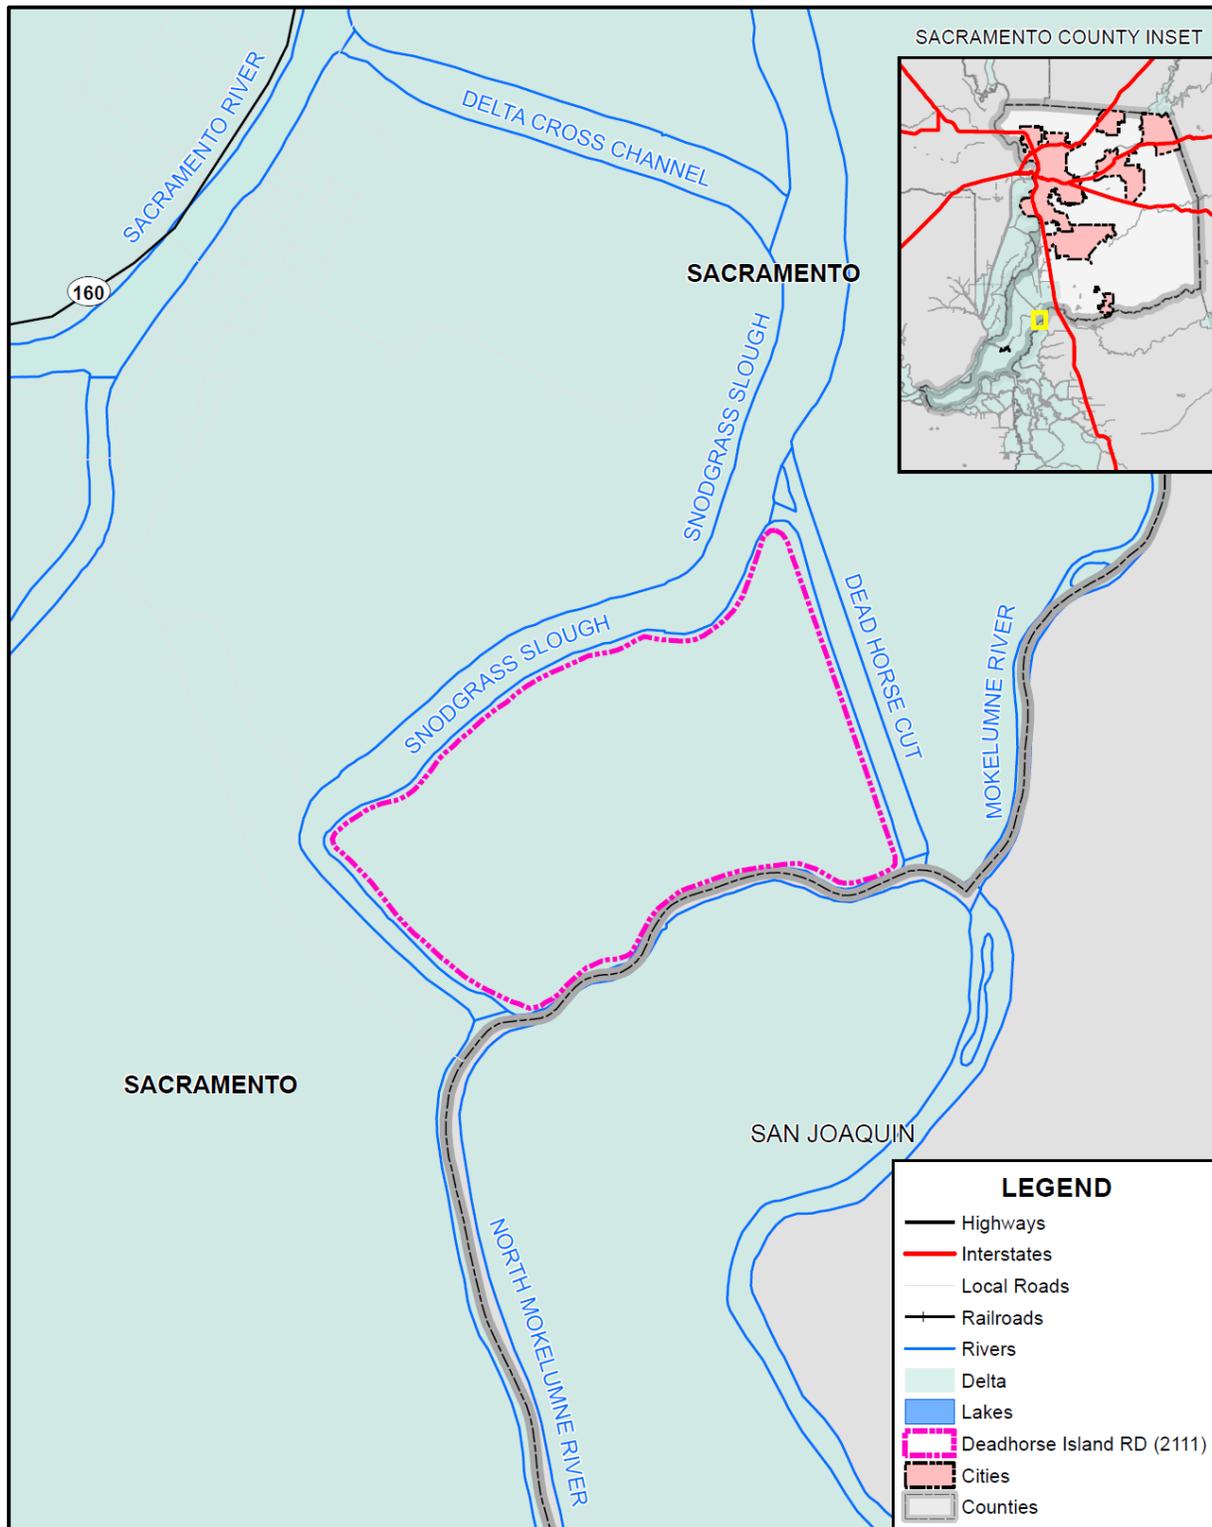
Figure 13-1 RD 2111

The District profile for RD 2111 is detailed in the following sections. Figure 13-1 and Figure 13-2 display a map and the location of the District within Sacramento County.

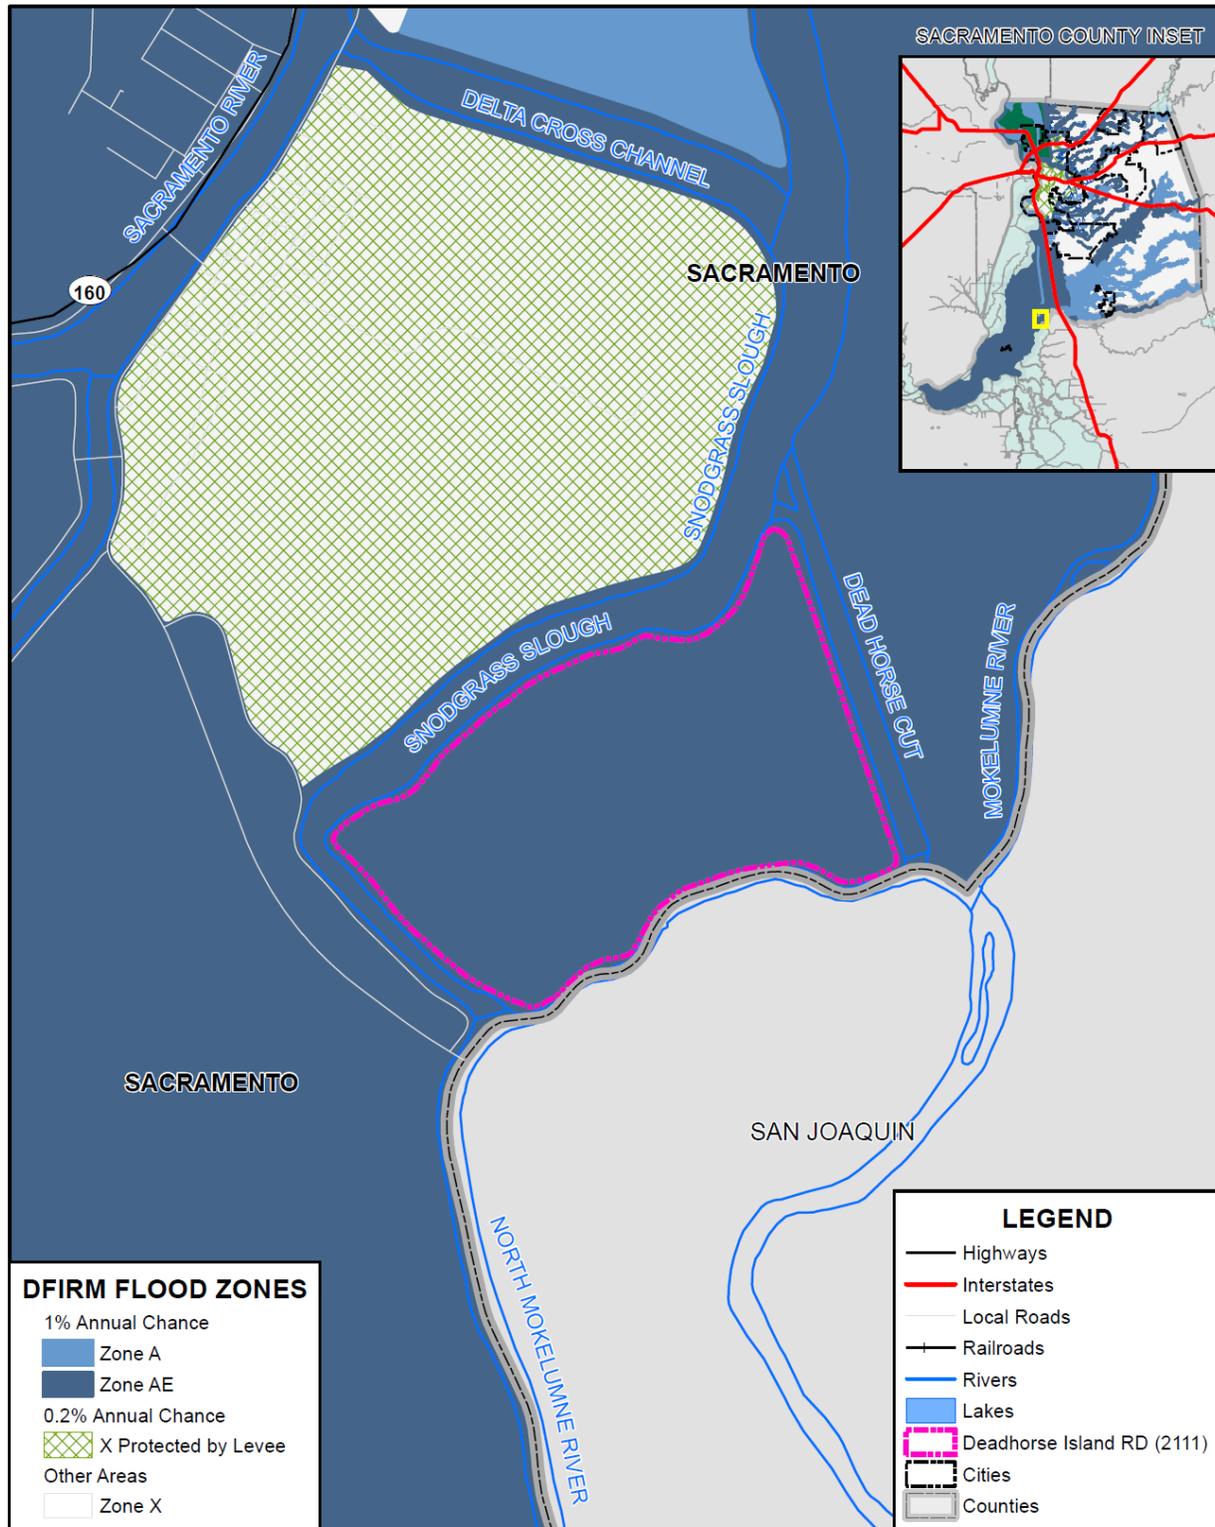
Figure 13-3 RD 2111 – FEMA DFIRM Flood Zones

RD 2111 has areas located in the 1% annual chance floodplain. This is seen in Figure 13-3.

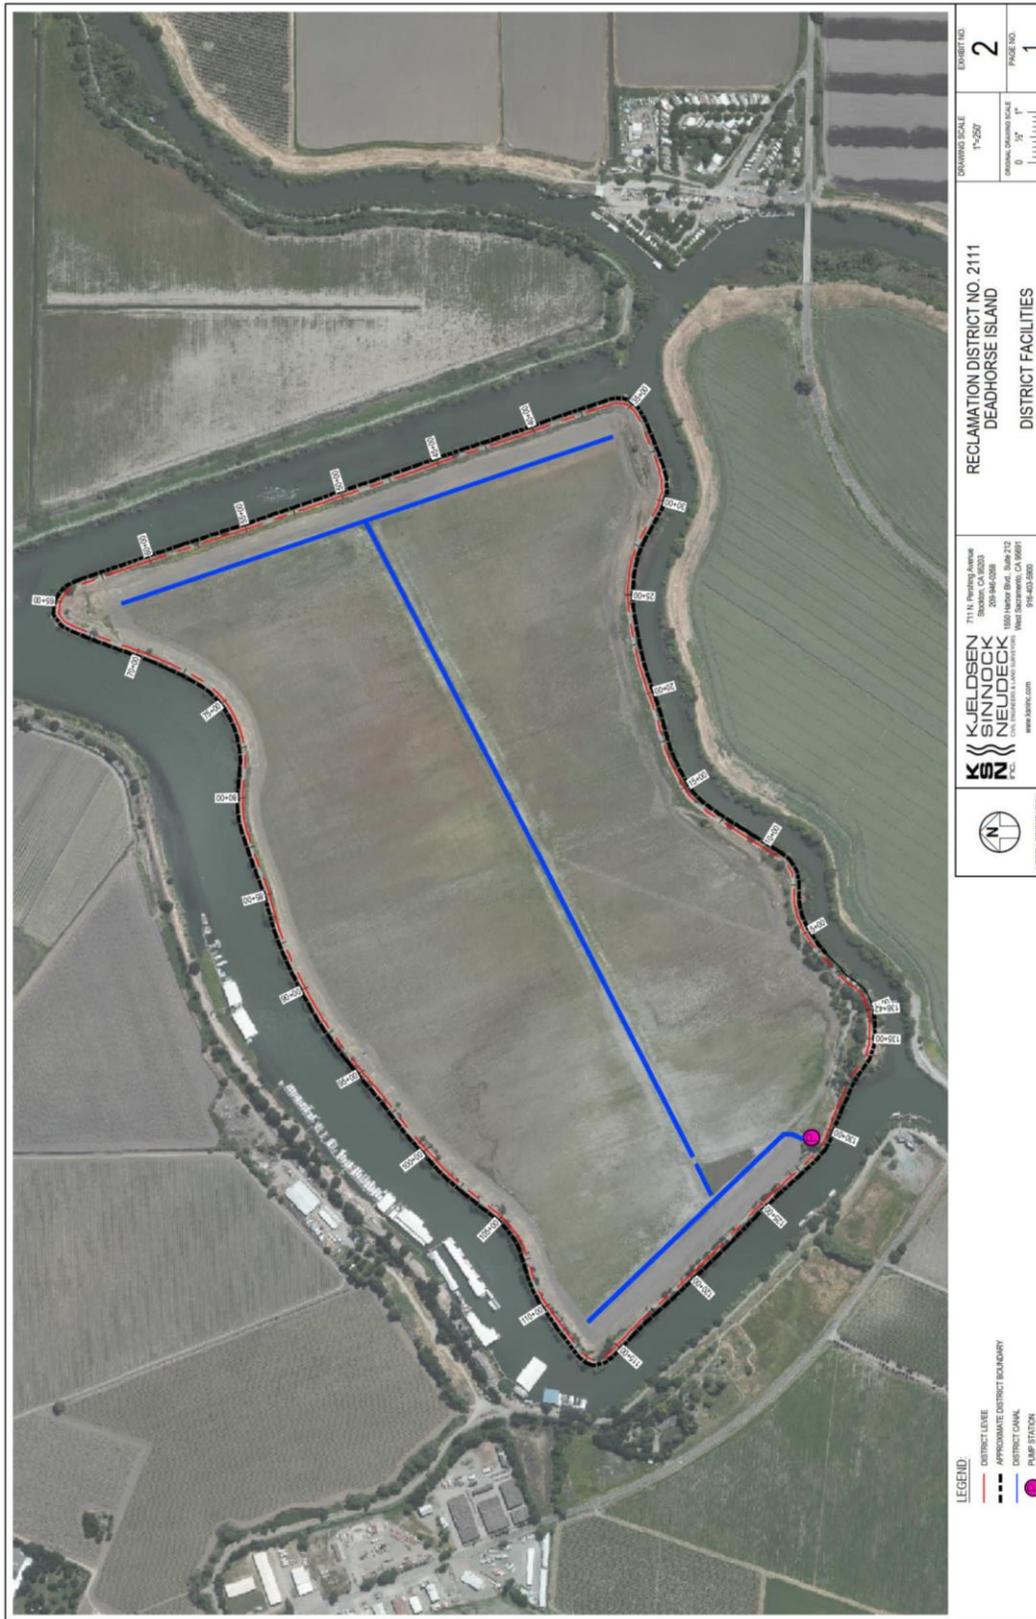
Figure 13-4 RD 2221 Drainage System

Historically, RD 2221 has been at risk to flooding primarily during the spring months when river systems in the County swell with heavy rainfall. The District has a drainage system set up deal with localized flooding. A map of this system can be seen on Figure 13-4

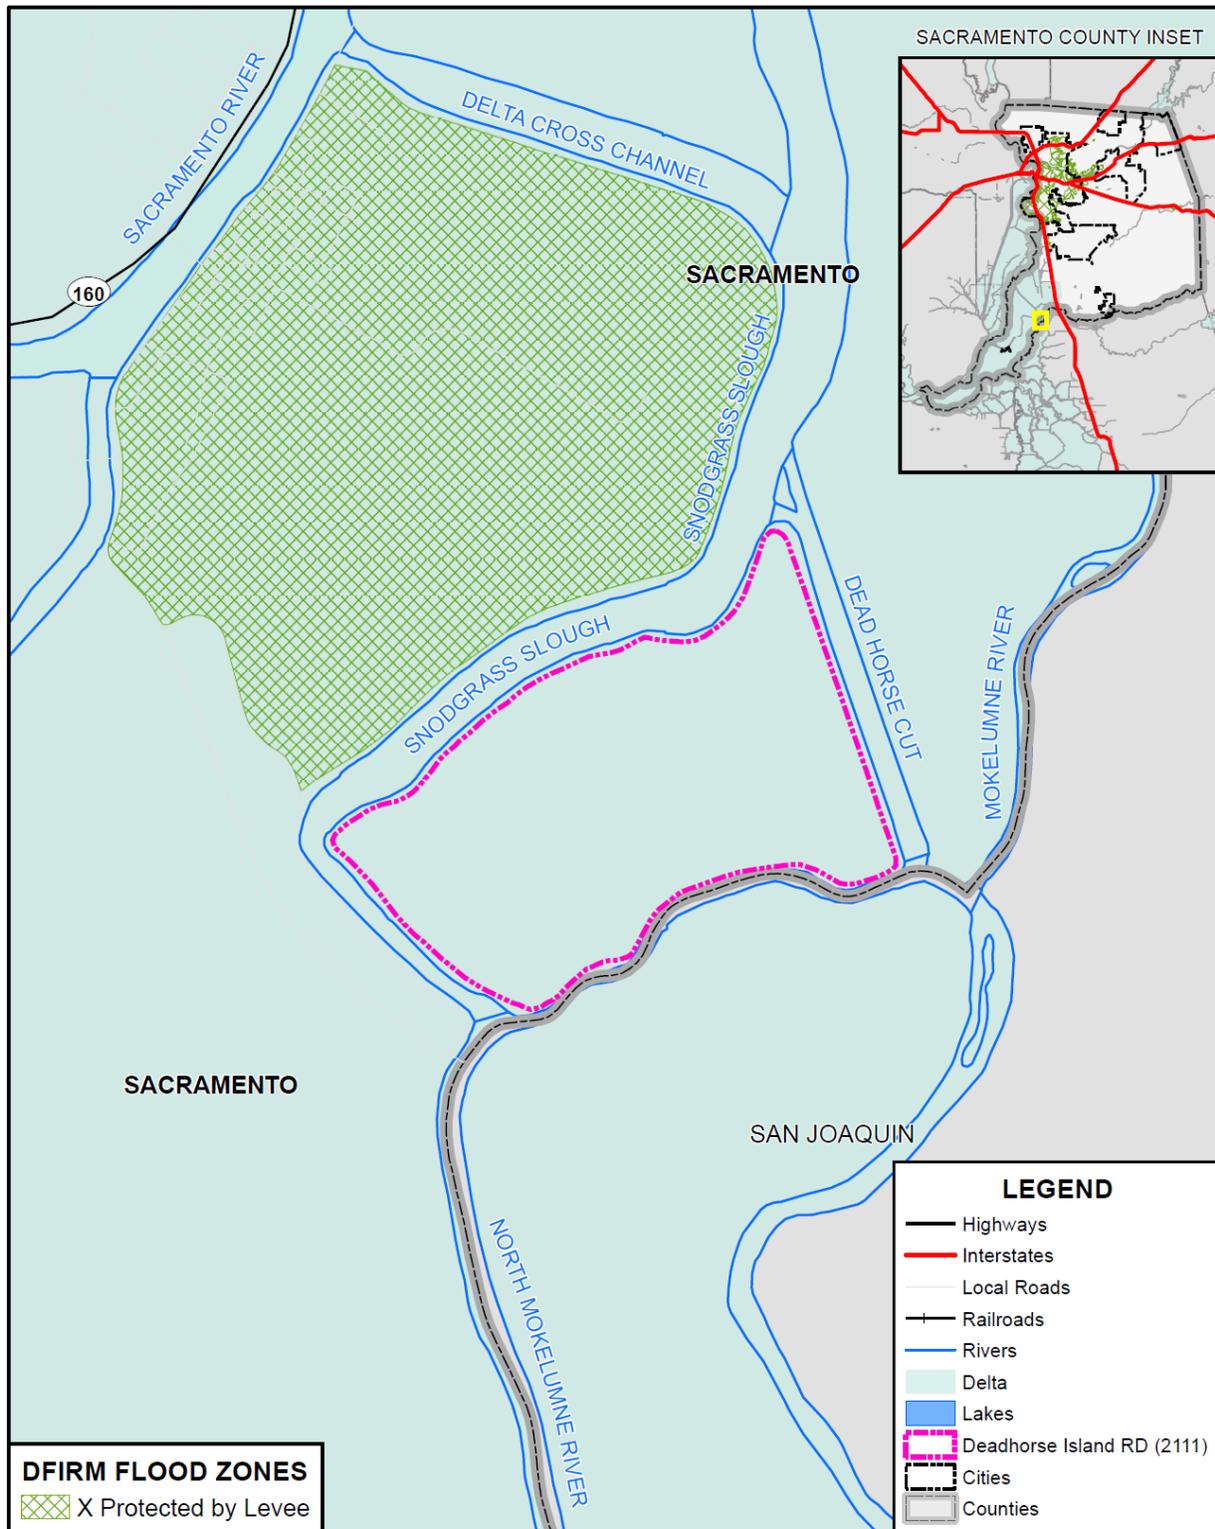
Figure 13-5 RD 2111 – Levee Protected Areas

There is not a scientific scale or measurement system in place for levee failure. Expected flood depths from a levee failure in the District vary by event and location. The speed of onset is slow as the river rises, but if a levee fails the warning times are generally short for those in the inundation area. The duration of levee failure risk times can be hours to weeks, depending on the river flows that the levee holds back. When northern California dams and reservoirs are nearing maximum capacity, they release water through the river systems, causing additional burdens on County levees. Levees in the District are shown on Figure 13-5.

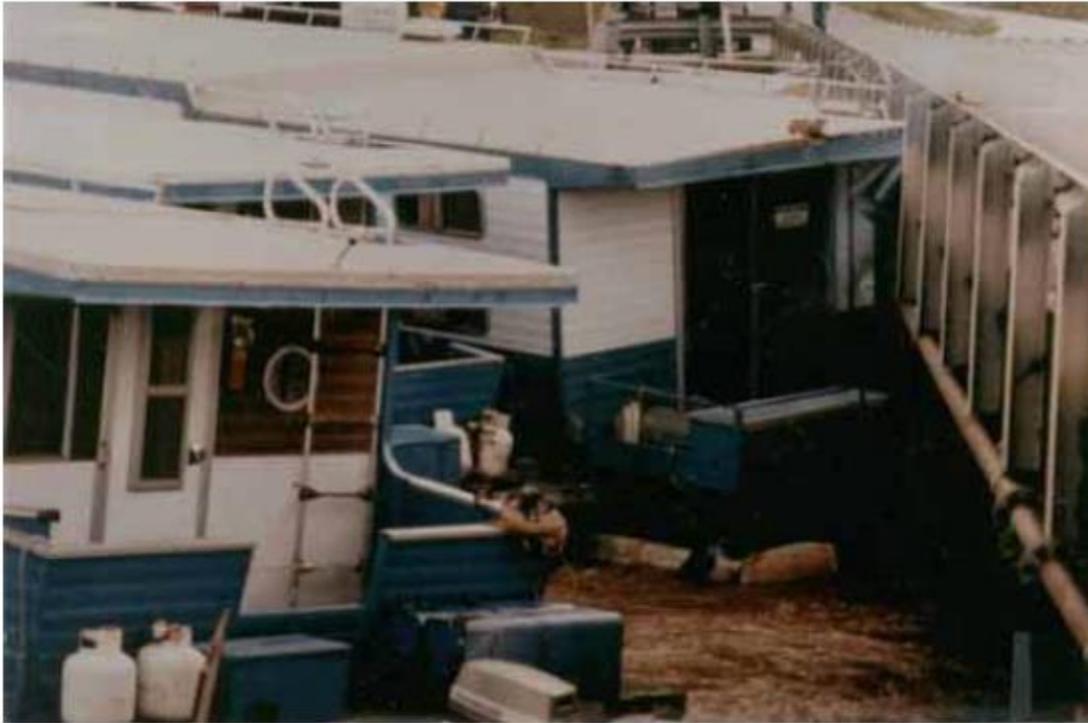
*Figure 13-6 1986 Flooding*

- February 1986 – The east end of the Island was overtopped. In the words of one of the District trustees, this flood event caused overtopping simultaneously “all over” the District. The location of the District at the confluence of the of the Mokelumne and Cosumnes Rivers caused a huge volume of water to overwhelm the District in a very short time, and the elevation of the levee was insufficient to protect the District against this rapid floodwater rise. The levee prism also failed as a result in the rapid pressure increase from the high water. In addition to the increased flow throughout the Delta, floodwaters around the District rose even further due to an unexpected flow restriction in the North Fork of the Mokelumne River at the New Hope Bridge, where several house boats had broken loose of their moorings and lodged against the bridge (see photo). The house boats had been docked at the New Hope Marina, located upstream of the split between the North Fork and South Fork of the Mokelumne River, near the western portion of the District levee. Note the marina blocking water that caused the RD 2111 levees to fail.

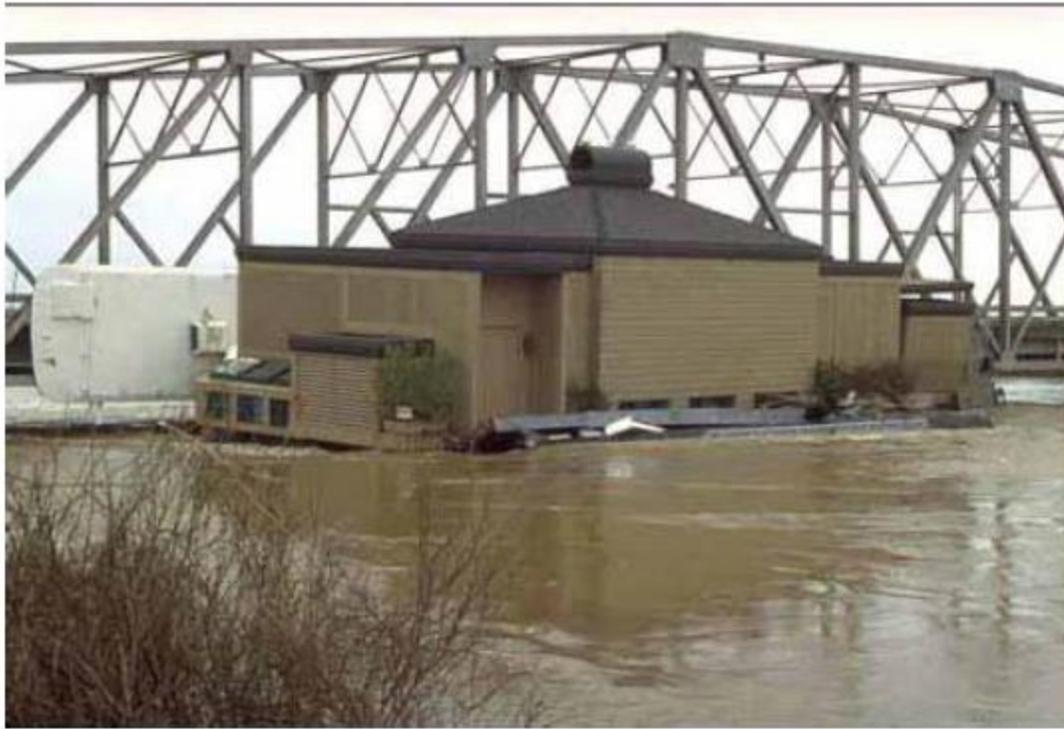
*Figure 13-7 1997 Flooding*

- January 1997 – The District levee failed at approximately Station 107+00 to 110+00 just as the levee was about to be overtopped. Consequences: A levee break occurred opposite the Walnut Grove Marina during a flood event. The District was fully inundated. Several boats and sections of the dock from the Walnut Grove Marina were pulled through the levee breach into the interior of the island. Other recreational boats, house boats, and sections of dock were also pulled into the Millers Ferry Bridge, including a two story floating home which particularly threatened to reduce flows down the North Fork of the Mokelumne River, increase the flood threat to adjacent islands, and possibly destroy the bridge, cutting off one of the few available emergency evacuation routes (see photo). The large houseboat was eventually destroyed and the debris was sucked under the bridge.

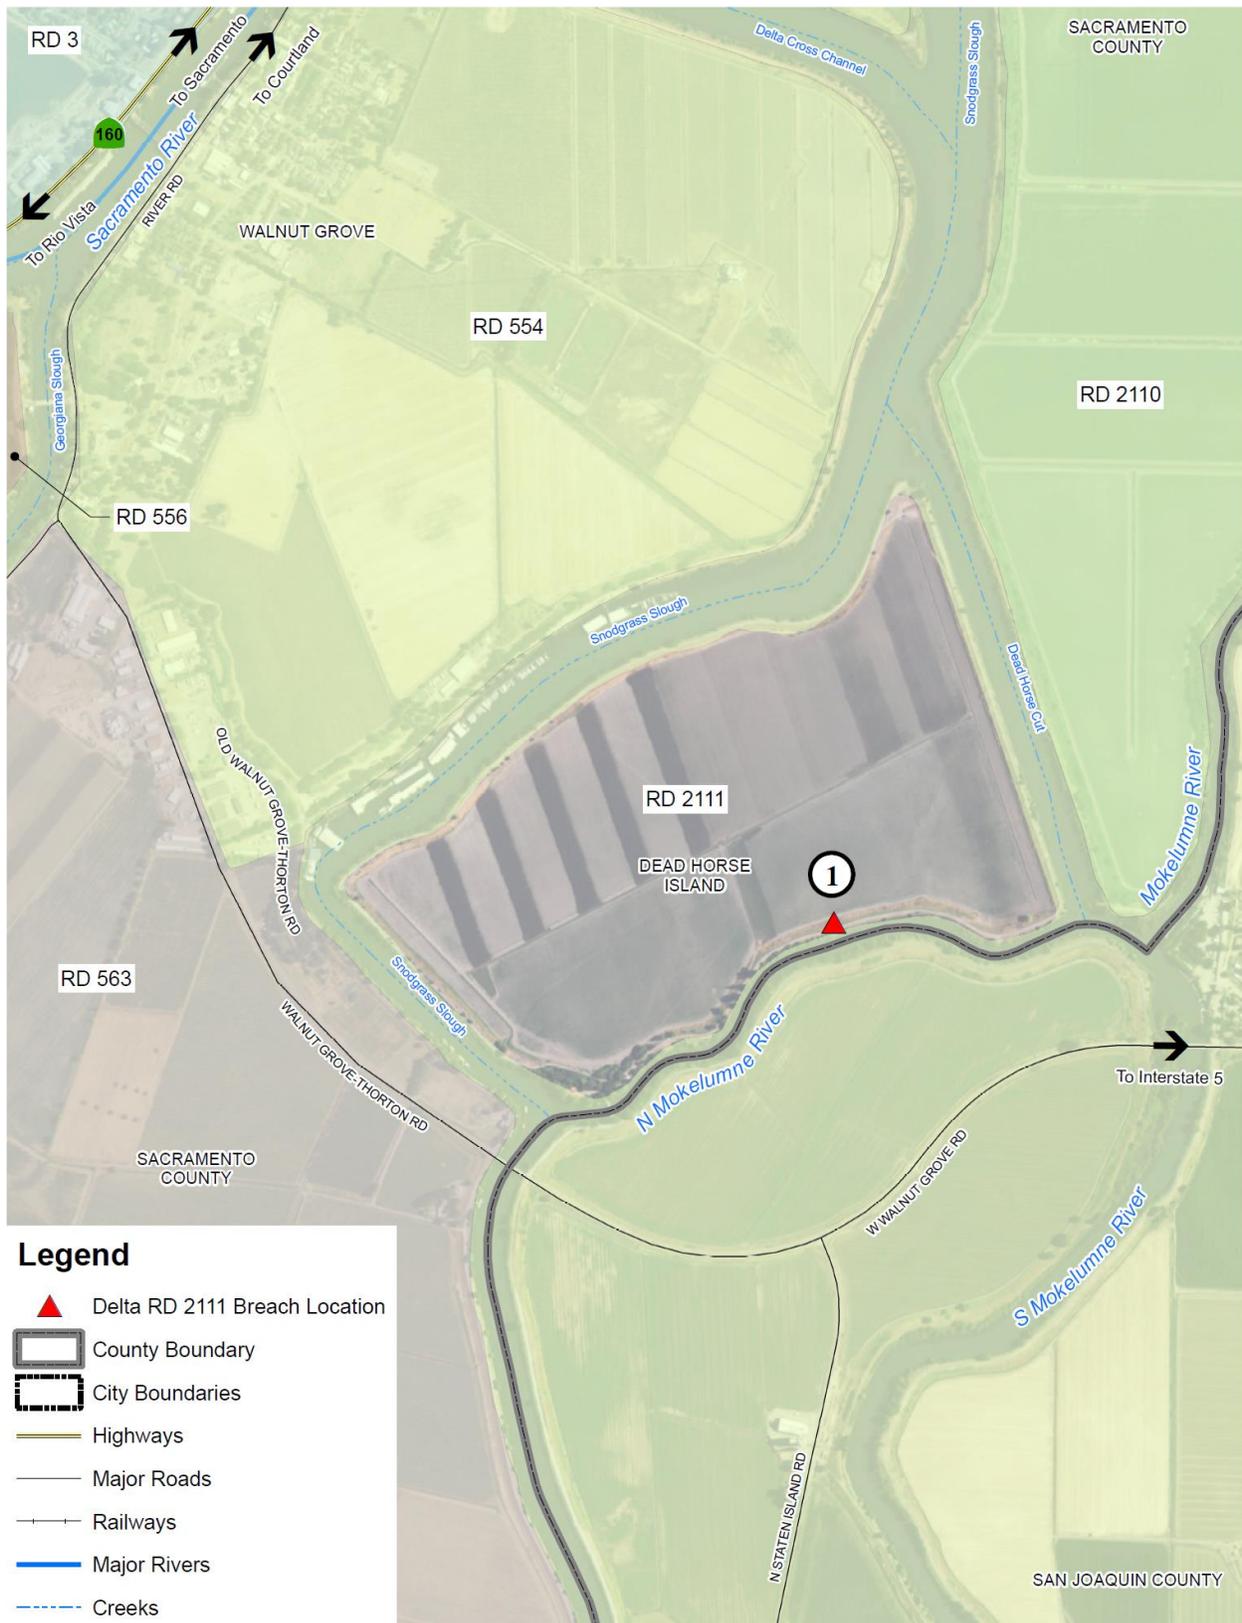
Figure 13-8 RD 2111 – Potential Levee Breach Location

For RD 2111, Figure 13-8 details the locations in the Delta within Reclamation District 2111 where flooding could occur. The red triangle denotes a hypothetical potential levee breach location. Maps for this levee breach scenario regarding time to one foot inundation (Figure 13-9), estimated flood depths (Figure 13-10), and suggested evacuation routes (Figure 13-11) are displayed below.
