Delta Annex Chapter 4 Reclamation District 341

4.1 Introduction

This Annex details the hazard mitigation planning elements specific to Reclamation District 341 (RD341), a previously participating jurisdiction to the 2016 Sacramento County Local Hazard Mitigation Plan (LHMP) Update. This Annex is not intended to be a standalone document, but appends to and supplements the information contained in the Base Plan document. As such, all sections of the Base Plan, including the planning process and other procedural requirements apply to and were met by the District. This Annex provides additional information specific to RD 341 with a focus on providing additional details on the risk assessment and mitigation strategy for this District.

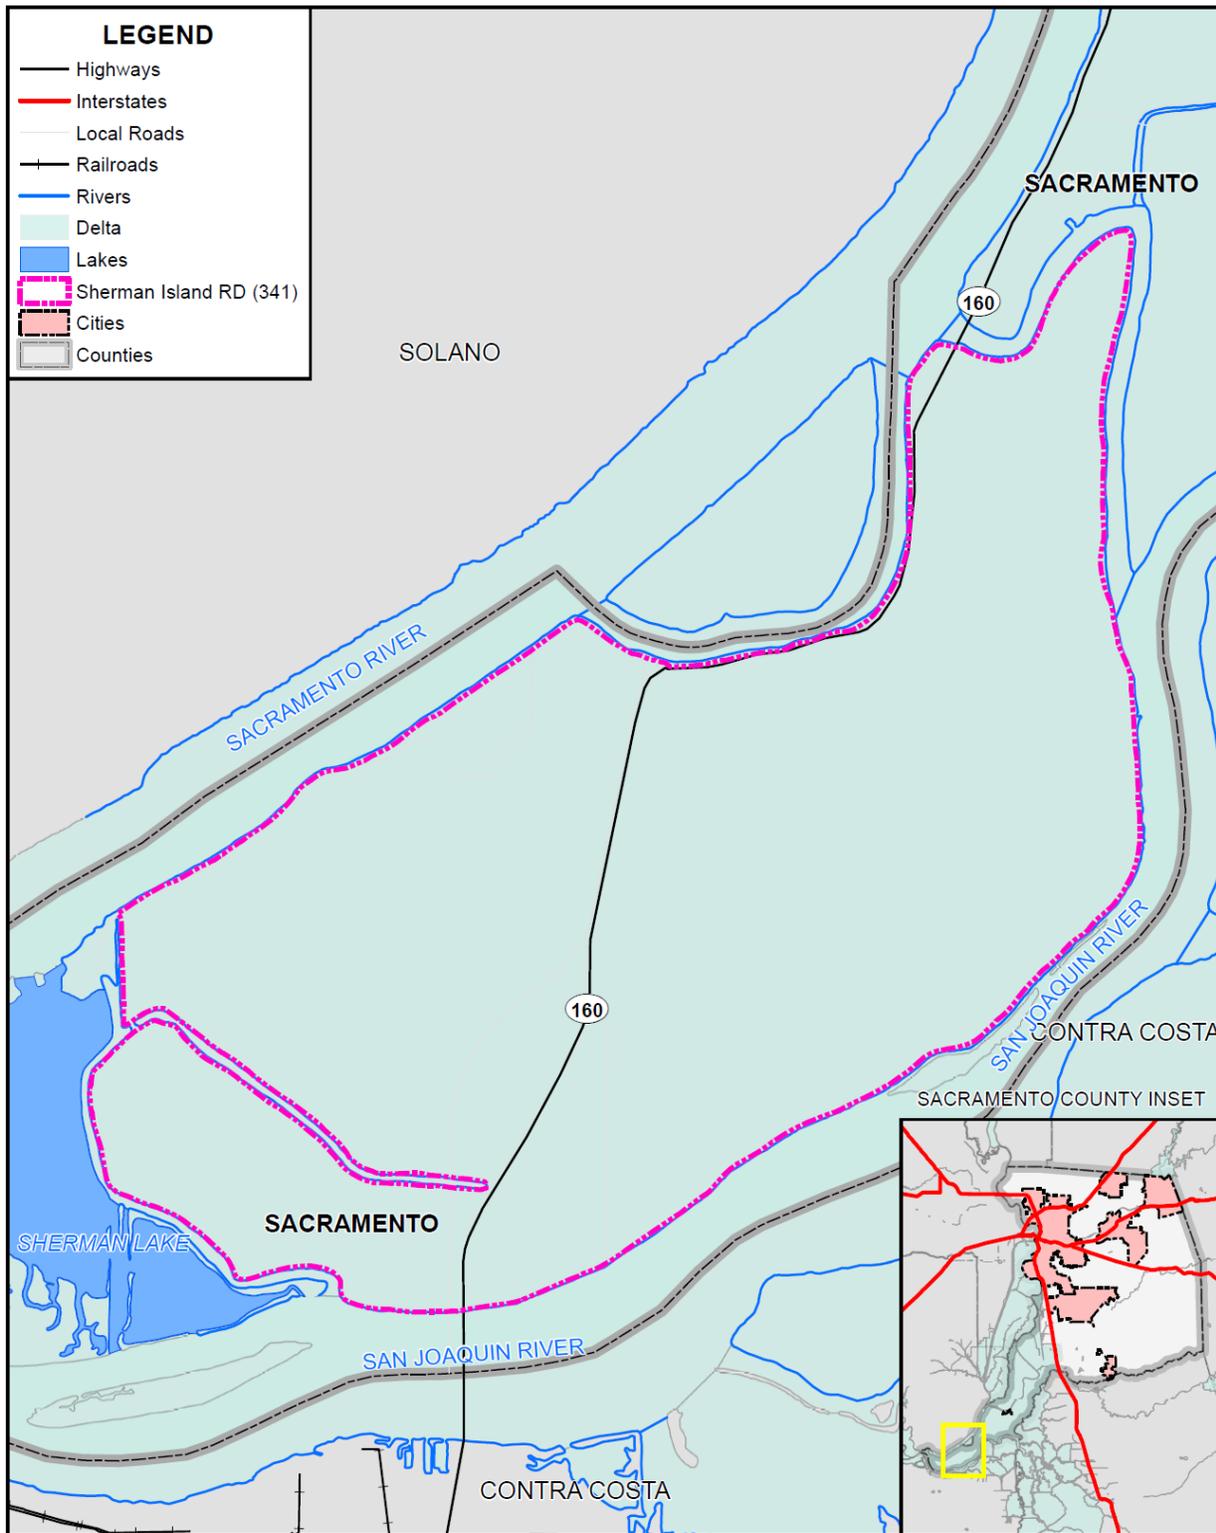
Figure 4-1 RD 341

The District profile for the RD 341 is detailed in the following sections. Figure 4-1 displays a map and the location of the District within Sacramento County.

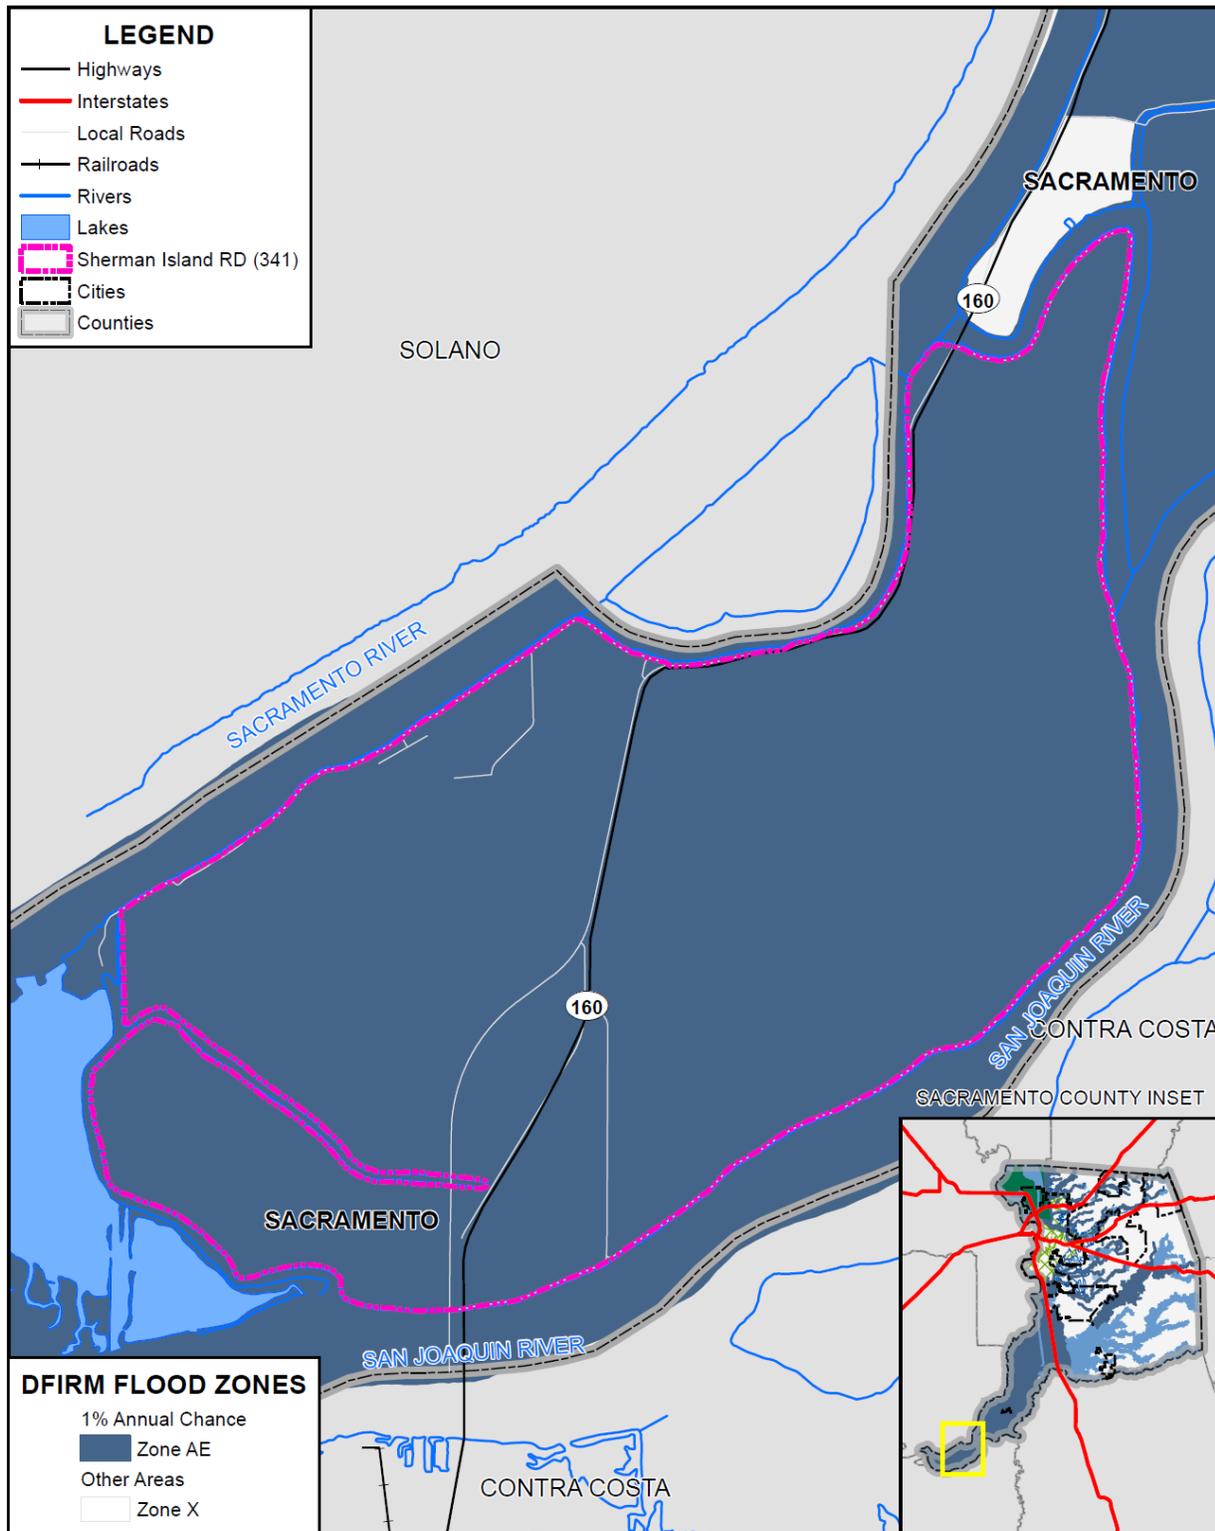
Figure 4-2 RD 341 – FEMA DFIRM Flood Zones

The RD 341 has areas located in the 1% annual chance floodplain. This is seen in Figure 4-2.

Table 4-5 details the DFIRM mapped flood zones within the 1% annual chance flood zone as well as other flood zones located within the District.

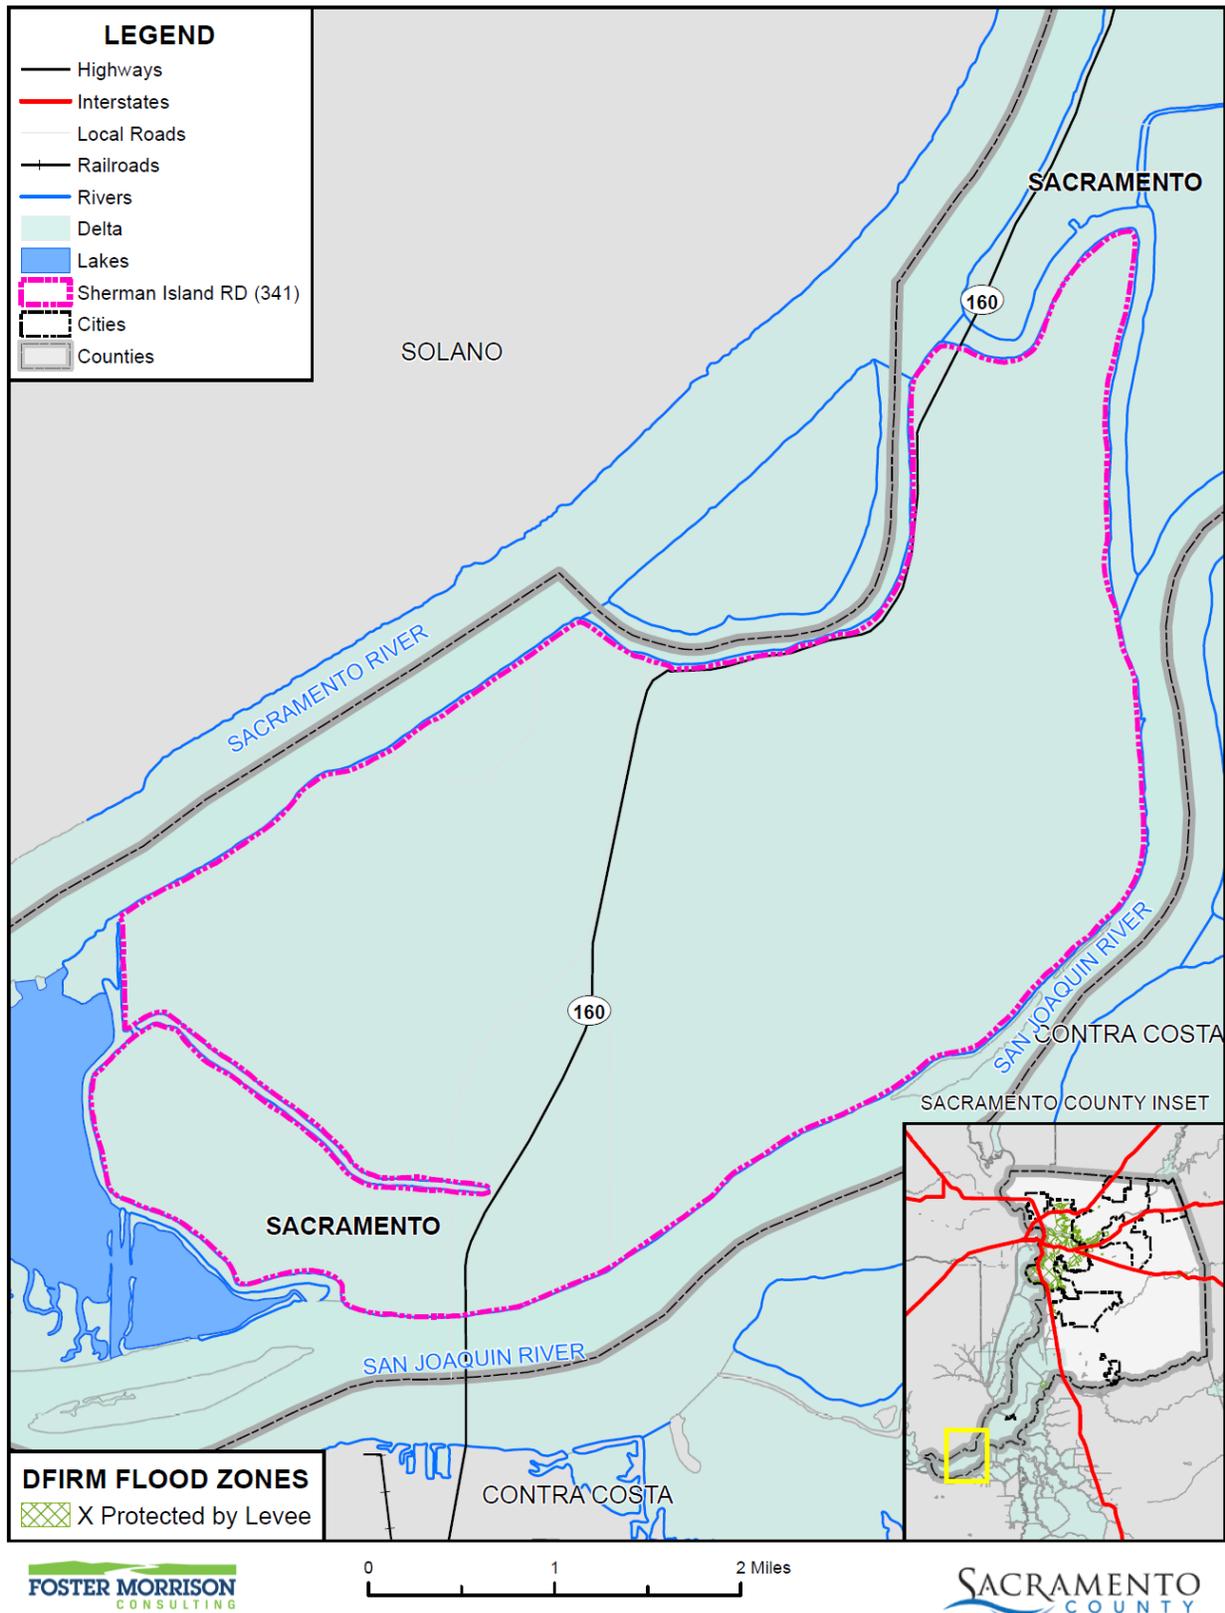
Figure 4-4 RD 341 – Levee Protected Areas

There is not a scientific scale or measurement system in place for levee failure. Expected flood depths from a levee failure in the District vary by event and location. The speed of onset is slow as the river rises, but if a levee fails the warning times are generally short for those in the inundation area. The duration of levee failure risk times can be hours to weeks, depending on the river flows that the levee holds back. When northern California dams and reservoirs are nearing maximum capacity, they release water through the river systems, causing additional burdens on County levees. Levees in the District are shown on Figure 4-4. As shown, the levees in the District are not currently shown as certified on the FEMA DFIRMs.

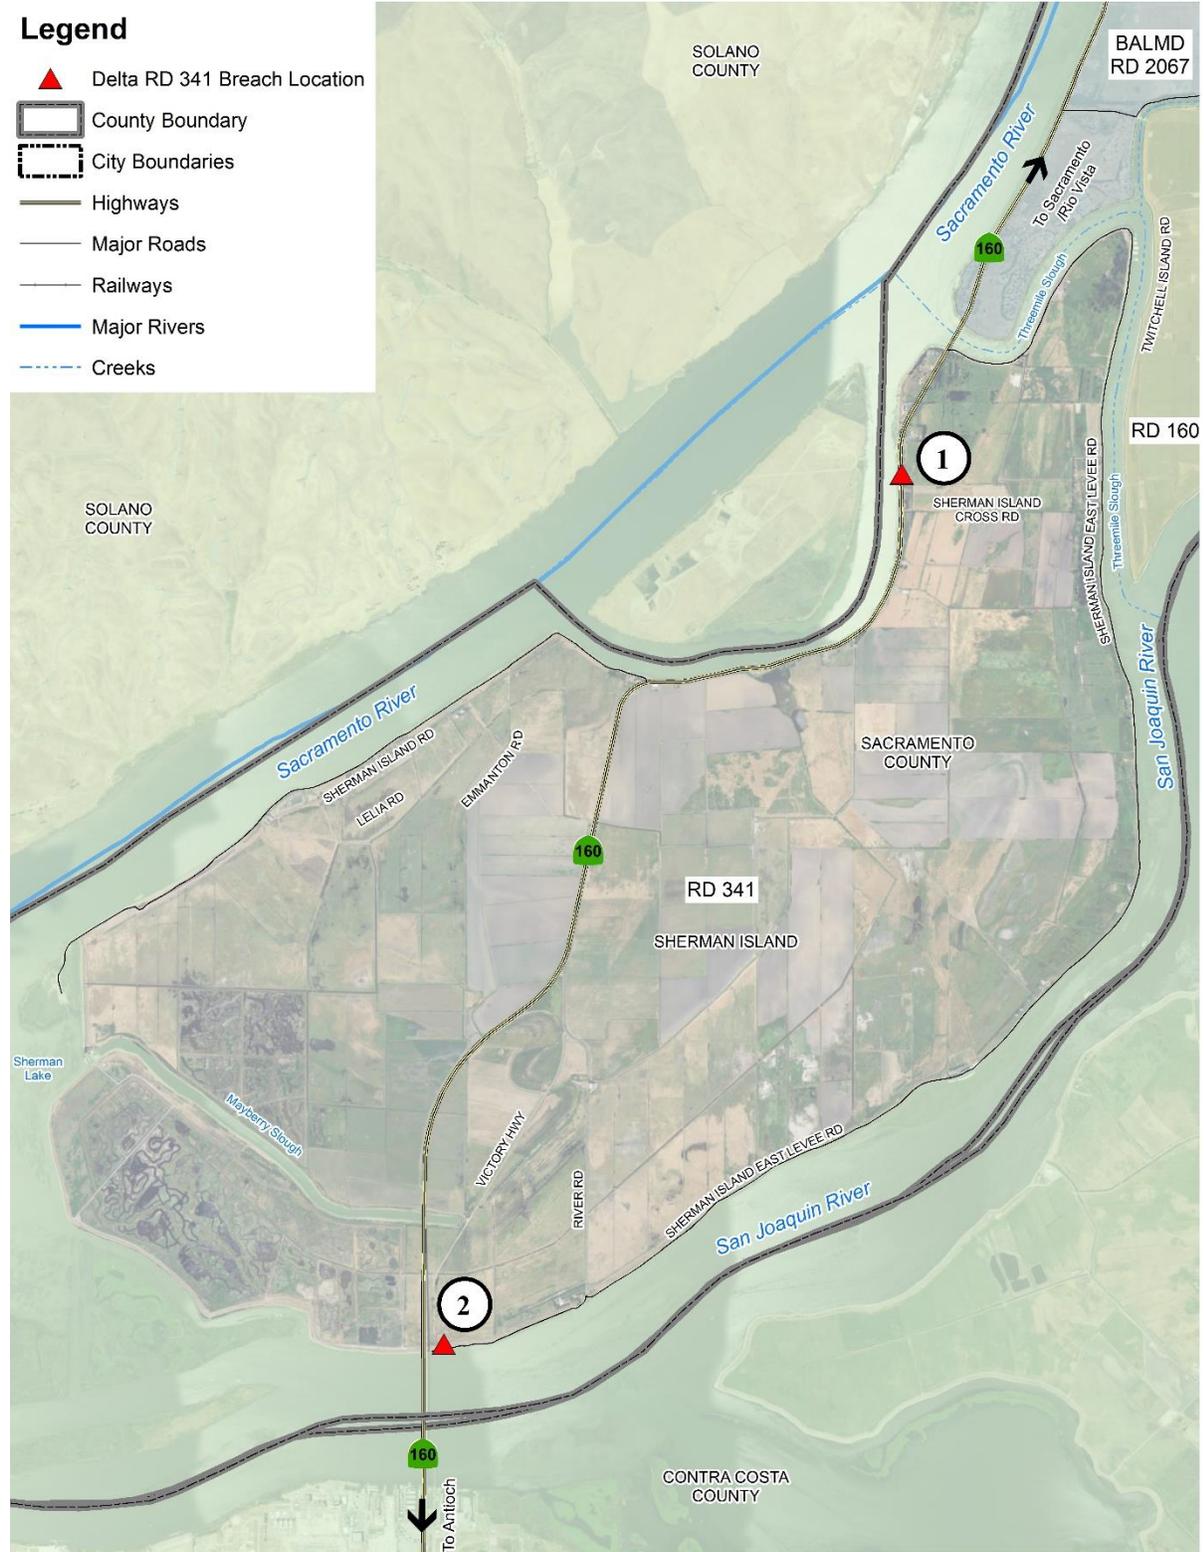
Figure 4-5 RD 341 – Potential Levee Breach Location

For RD 341, Figure 4-5 details the locations in the Delta within Reclamation District 341 where flooding could occur. The red triangles denote potential levee breach locations. RD 341 has two potential levee break scenarios. Maps for Scenario 1 regarding time to one foot inundation (Figure 4-6), estimated flood depths (Figure 4-7), and suggested evacuation routes (Figure 4-8) are displayed below. Maps for Scenario 2 can be found on the Sacramento County stormready.org website.
